CORNER RECORD

Document Number 03-48

Brief Legal Description SECTION CORNER COMMON TO SECTIONS 11, 12, 13 & 14, T.2N., R.6E., M.D.B.&M.

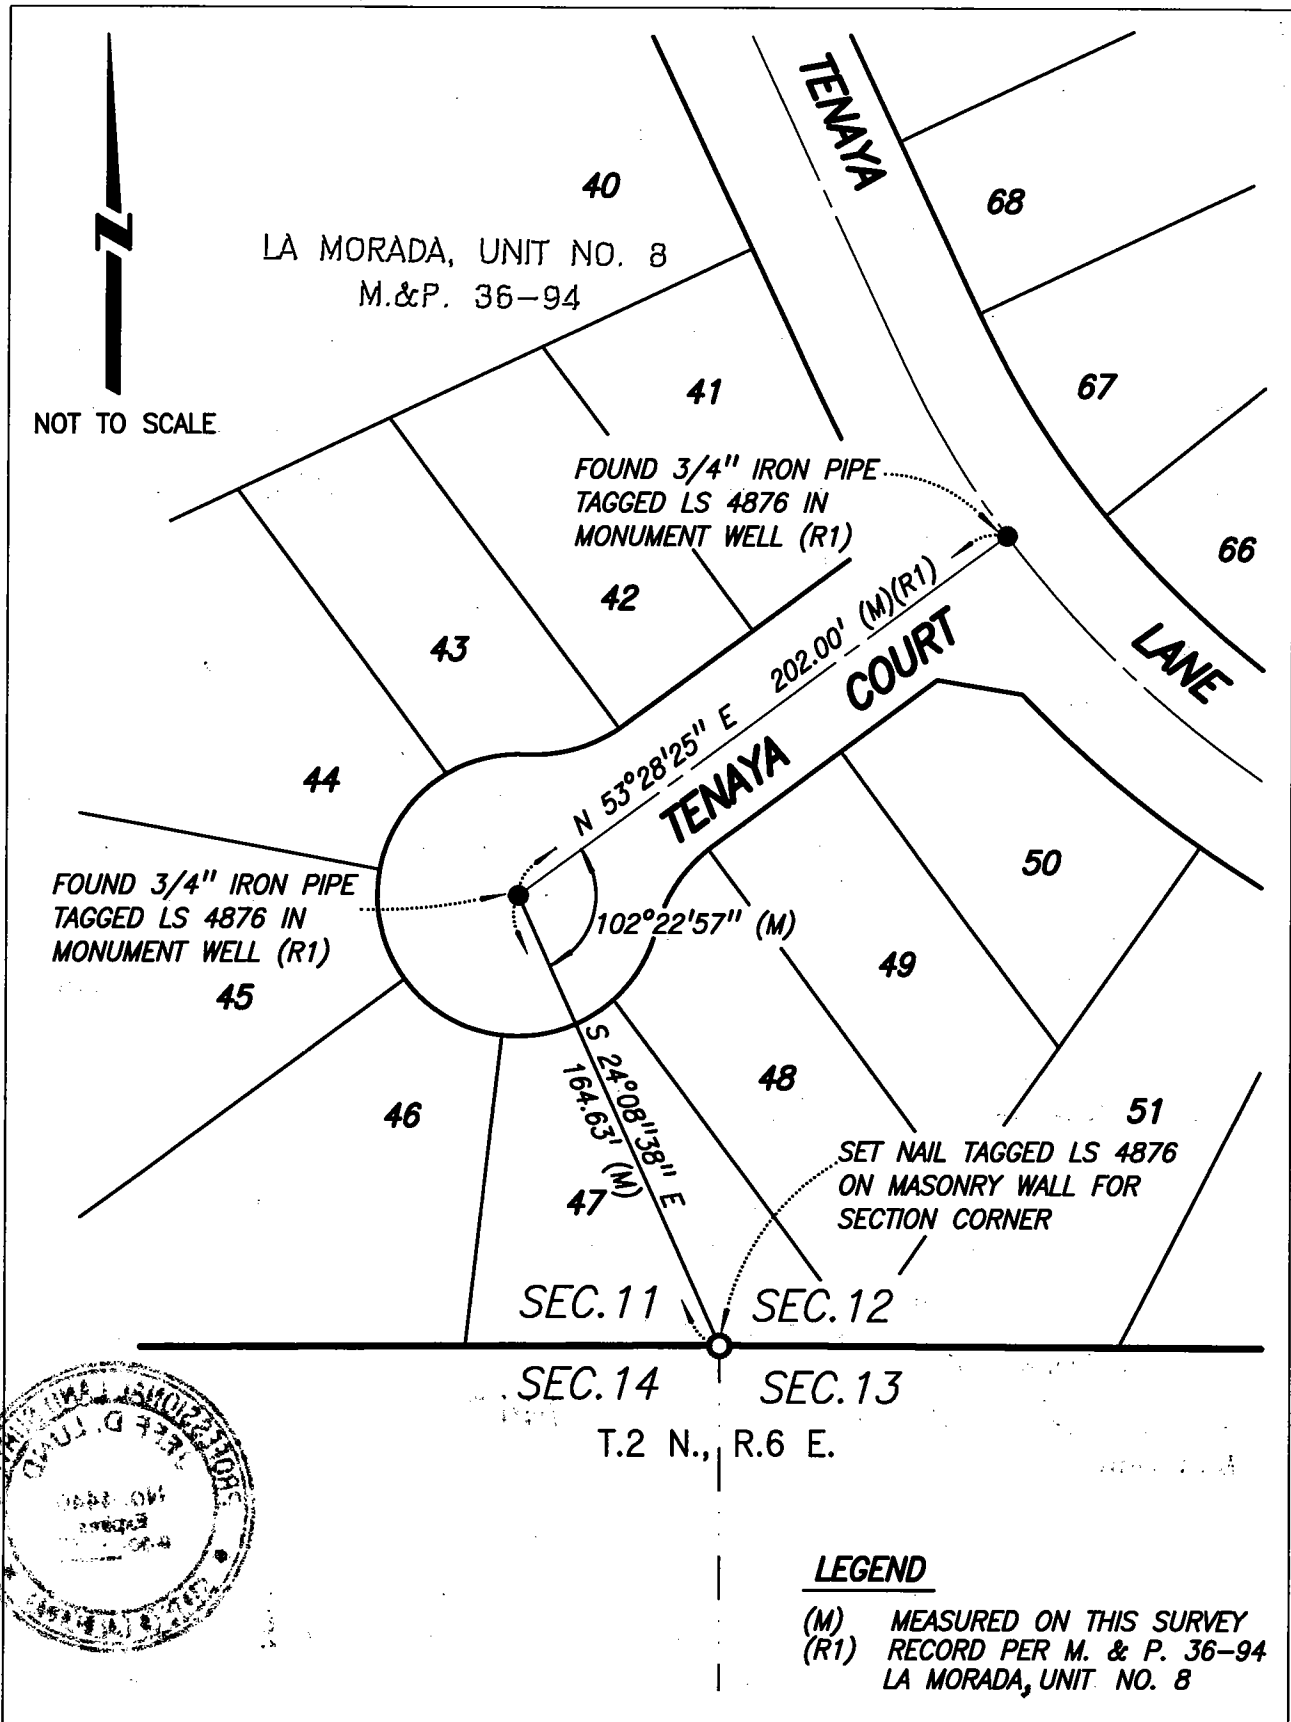
Identification and type of corner found: Evidence used to identify or procedure used to establish or reestablished the corner:
FOUND 3/4" IRON PIN TAGGED R.C.E. 8189 AT THE CORNER COMMON TO SECTIONS 11, 12, 13 AND 14
IN T.2 N., R.6 E., M.D.B.&M., AS SHOWN FOR RECORD IN BOOK 36 OF MAPS AND PLATS AT PAGE 94,
SAN JOAQUIN COUNTY RECORDS, WAS DESTROYED WITH THE CONSTRUCTION OF A MASONRY WALL.
RE-ESTABLISHED USING MONUMENTS SET PRIOR TO THE MONUMENT BEING DESTROYED, BEING FOUND
3/4" IRON PIPE TAGGED LS 4876 SET IN MONUMENT WELLS AS SHOWN ON M.&P. 36-94.

A description of the physical condition of the monument as found and as set or reset: _____
SET NAIL AND BRASS TAG STAMPED LS 4876 IN MASONRY WALL.
