CORNER RECORD

Document Number 06-08

Brief Legal Description EAST 1/4 CORNER OF SECTION 2 OF T3N, RTE OF MDB & M

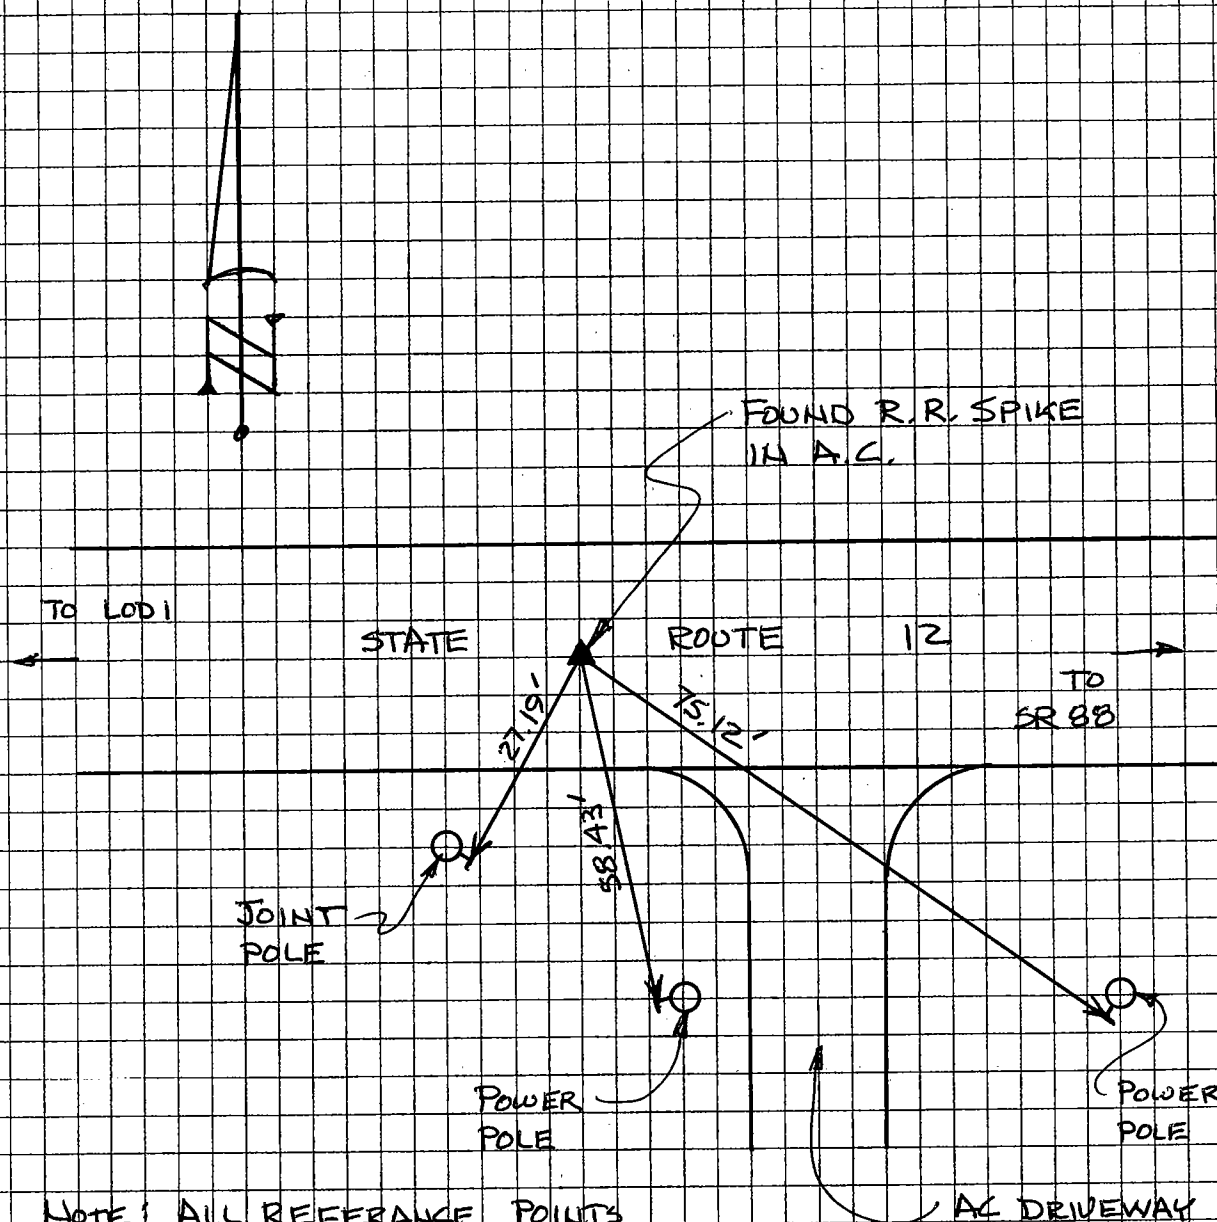
FOUND RAILROAD SPIKE IN A.C. DOWN 0.15' BELOW THE TOP OF THE
A.C. SURFACE.

GOOD CONDITION.

NOTE: ALL REFERENCE POINTS
ARE PK NAILS W/ BRASS
WASHER STAMPED "CALTRANS"

AC DRIVEWAY
@ 12024 E. STATE
ROUTE 12
