# CORNER RECORD

Document Number 06-15

City of LODI

Brief Legal Description WEST 1/4 CORNER OF SECTION 5 OF T3N, R7E OF THE MDB 1M

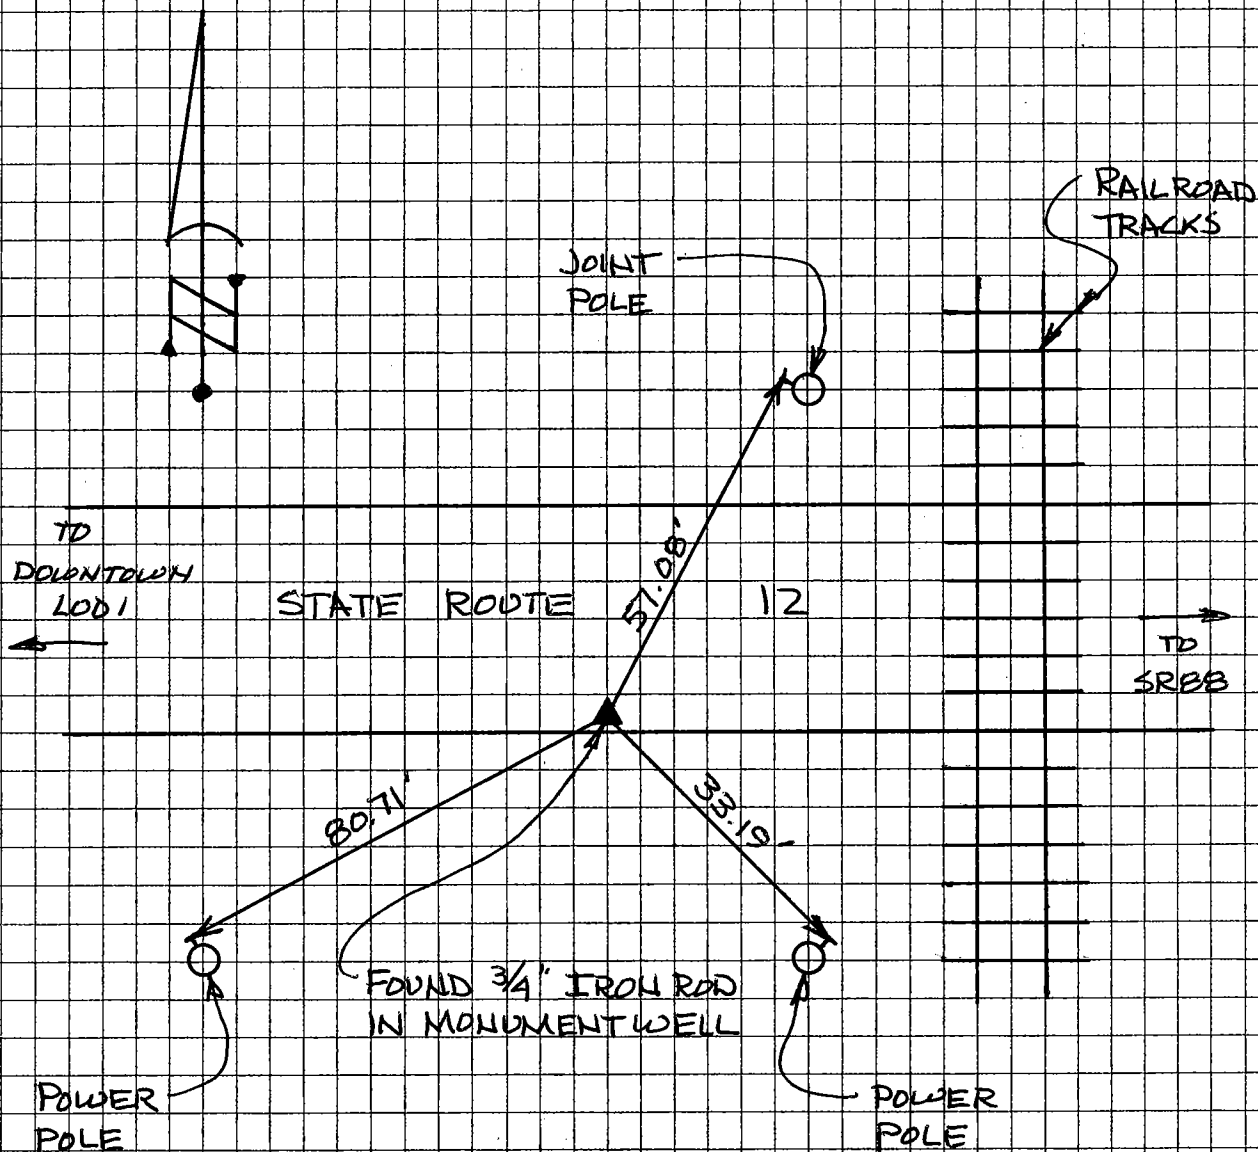
(D.D. SHEET NO. 16)

FOUND 3/4" IRON ROD WITH NO TAG IN MONUMENT WELL.  
MONUMENT IS 0.55' BELOW THE A.C. SURFACE.

MONUMENT WAS FOUND IN GOOD CONDITION.

NOTE: ALL REFERENCE POINTS  
ARE PK NAILS WITH  
BRASS WASHER STAMPED  
"CALTRANS" IN POLE.
