CORNER RECORD

Document Number 06-18

County of SAN JOAQUIN, California

Brief Legal Description APPROX. 1900' SOUTHWEST OF ALPINE ROAD ALONG THE CENTERLINE
OF STATE ROUTE 88 IN SECTION 82 OF THE C.M. WEBER GRANT

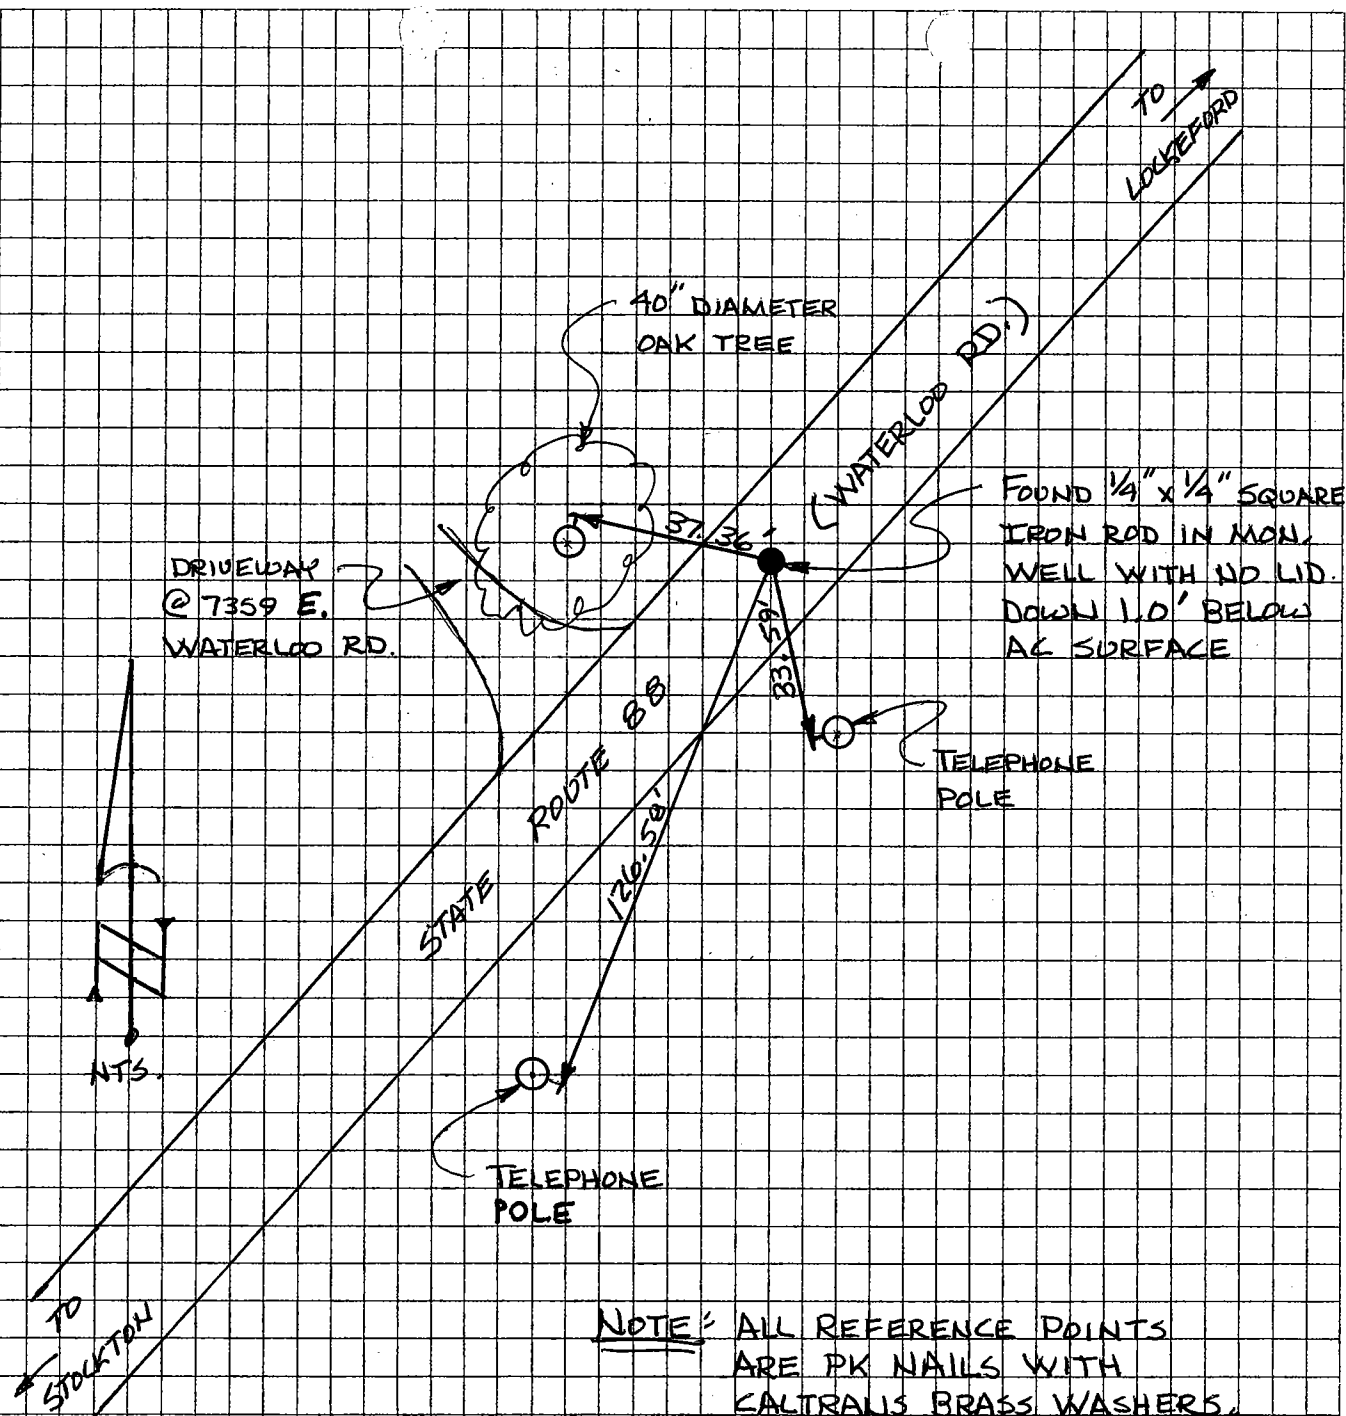
(D.D. SHEET NO. 33)

FOUND $\frac{1}{4}$ " x $\frac{1}{4}$ " SQUARE IRON ROD WITH NO TAG IN MONUMENT WELL WITHOUT LID. MONUMENT IS DOWN 1.0' BELOW THE A.C. SURFACE.

MONUMENT WAS FOUND IN GOOD ~~COND~~ CONDITION.
