CORNER RECORD

Document Number CR-09-53
County of San Joaquin, California

City of _____
Brief Legal Description AUSTIN ROAD 872' SOUTH OF LYNCH ROAD

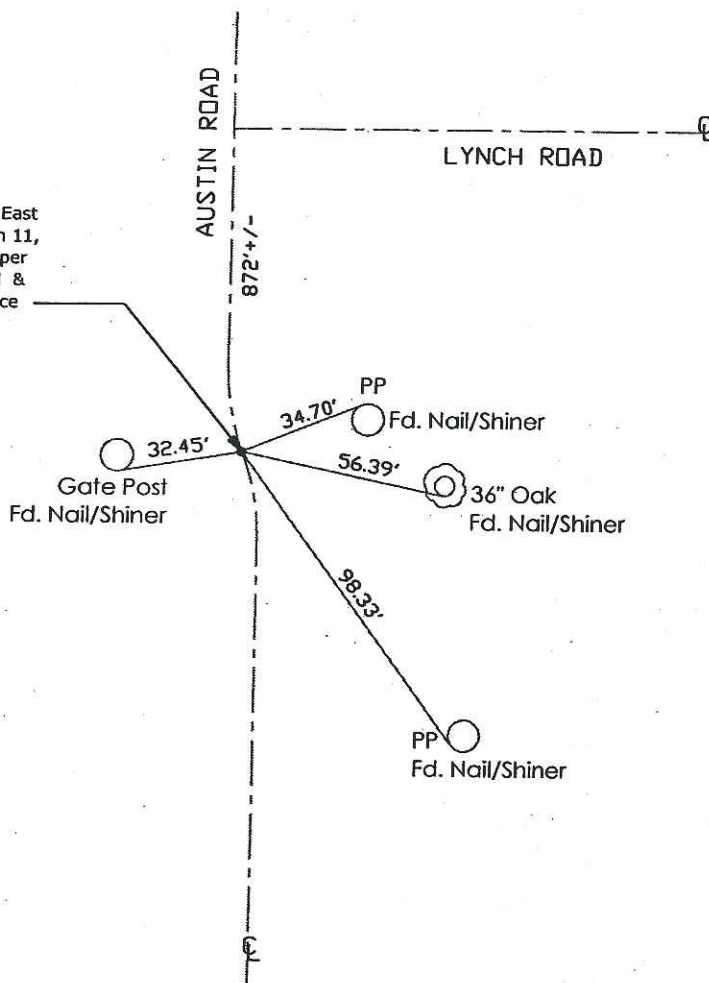
N.T.S.

Fd. SJ Co Brass Bolt & Washer 15.01' East
of the West 1/4 Sec. Corner of Section 11,
Township 1 South, Range 7 East per
RS 27-193, 6" deep. Set 6" Nail &
Washer Stamped SJ CO on Surface
