CORNER RECORD

City of STOCKTON

Document Number CR-10-74
County of SAN JOAQUIN, California

Brief Legal Description IN SECTION 36, C.M. WEBER GRANT

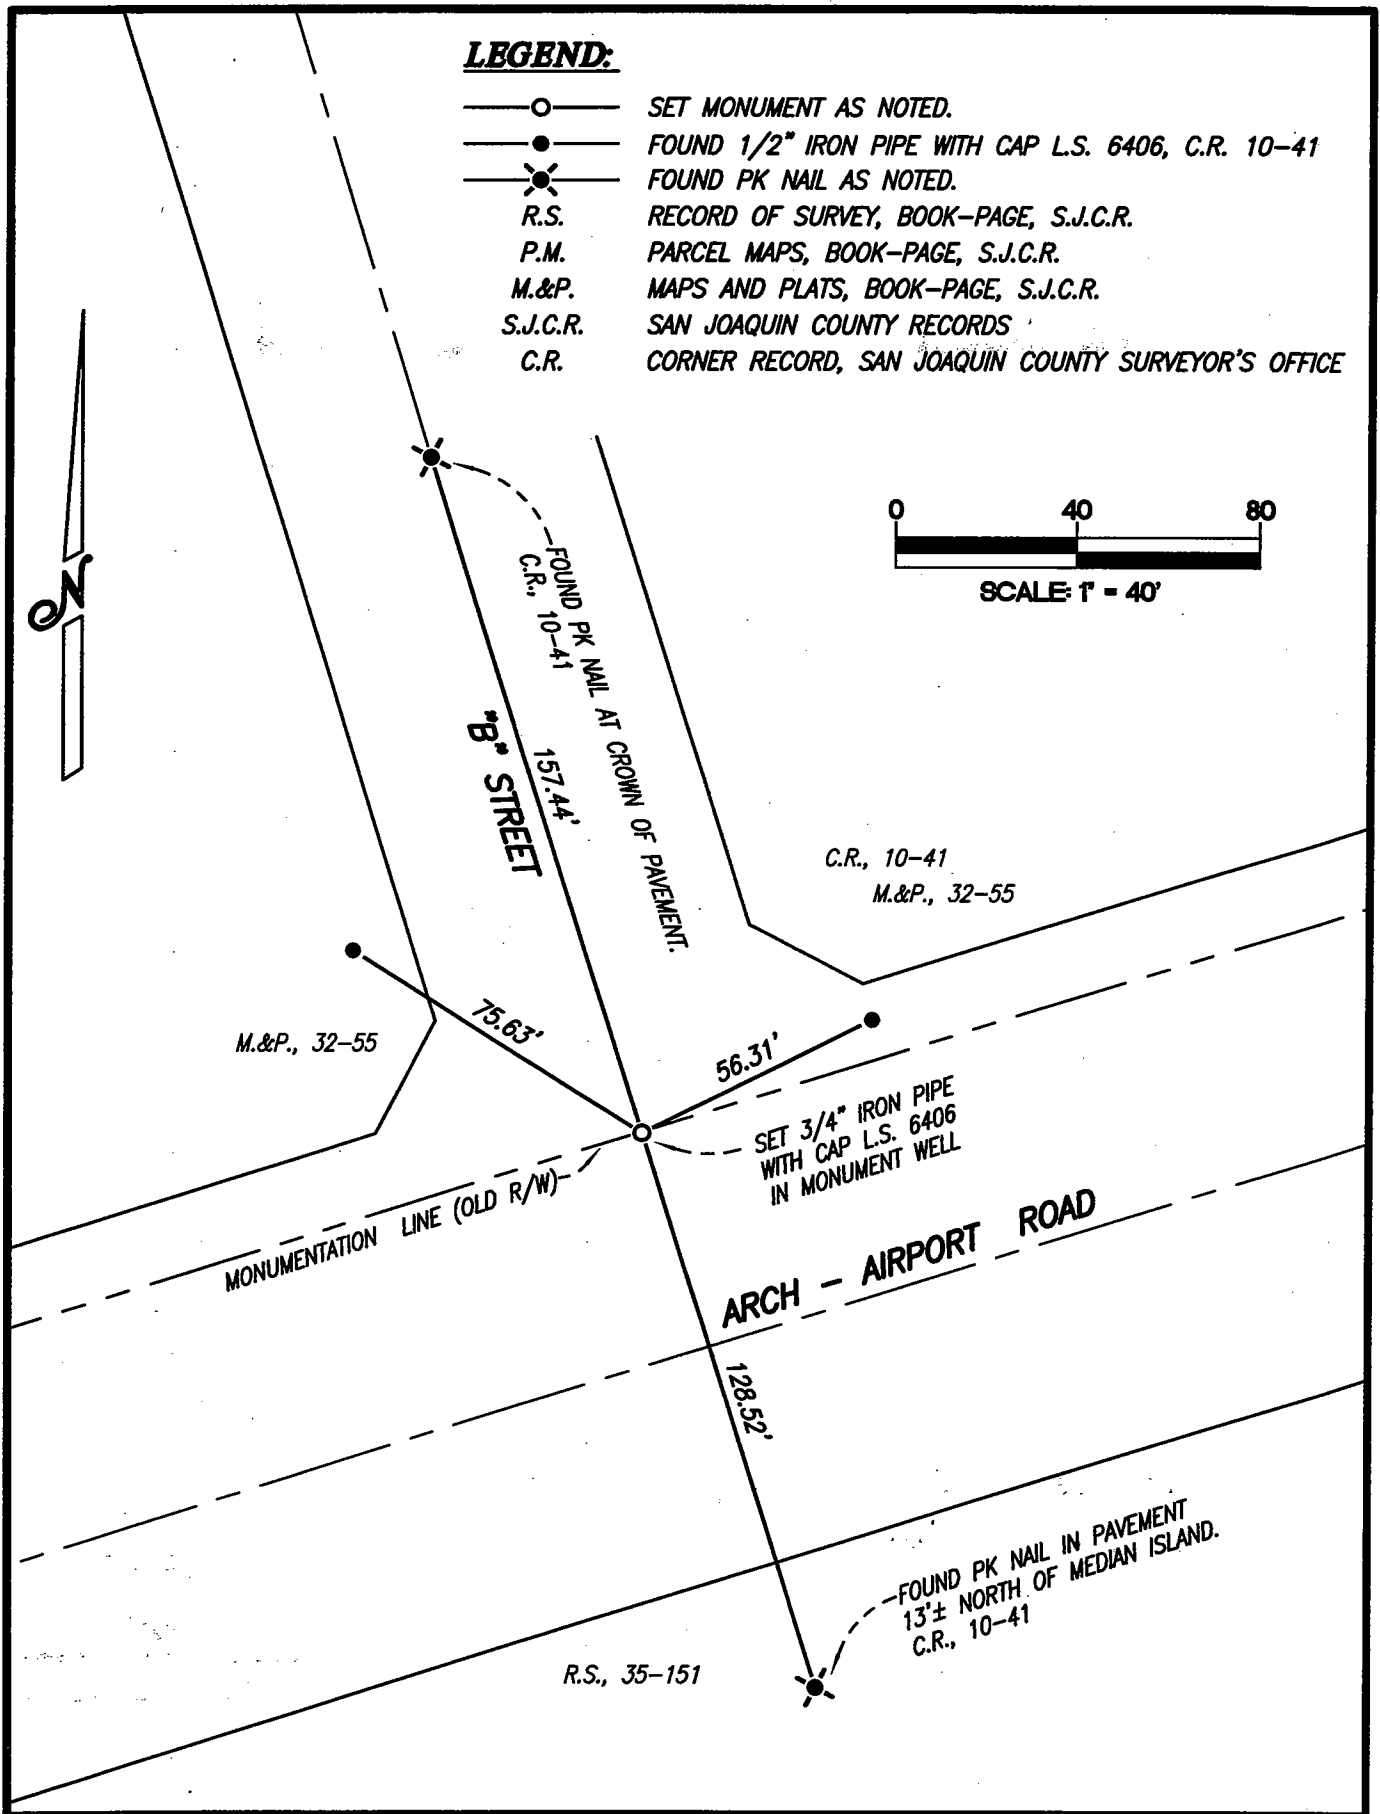
Identification and type of corner found: Evidence used to identify or procedure used to establish or reestablish the corner:
CENTERLINE MONUMENT NORTH SIDE ARCH-AIRPORT ROAD AT "B" STREET.
MONUMENT DESTROYED DURING RE-CONSTRUCTION.
RESET FROM TIES AS SHOWN ON PAGE 2.

A description of the physical condition of the monument as found and as set or reset:
SEE PAGE 2
