CORNER RECORD

Document Number CR-13-59

Brief Legal Description Witness corner of the NE corner of Lot 12 of Block 3 per M.&P. 10-25, S.J.C.R.

PRE-CONSTRUCTION CORNER RECORD

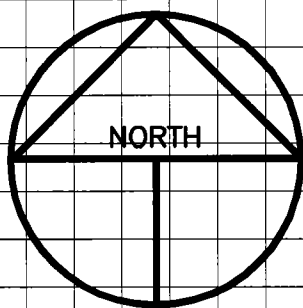
SCALE: 1" = 6'
2012-221 CR5

Set two 1-1/4" Magnetic Nail ties as shown on sheet 2.

○ SET 1-1/4"
MAGNETIC NAIL

27.81'(M)

FD. OLD CHISELED
CROSS

SET 1-1/4"
MAGNETIC NAIL

13.42'(M)

Fd. old Chiseled Cross witness corner of the Northeast corner of Lot 12 of Block 3 per M.&P. 10-25, S.J.C.R.
