CORNER RECORD

Document Number CR-13-60City of StocktonCounty of San Joaquin, CaliforniaBrief Legal Description Witness corner of the NW corner of Lot 1 of Block 4 per M.&P. 10-25, S.J.C.R.

PRE-CONSTRUCTION CORNER RECORD

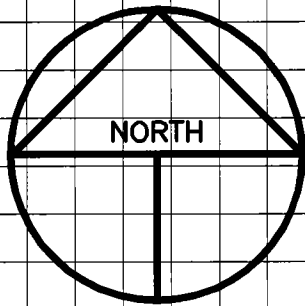
SCALE: 1" = 6'
2012-221 CR6

SET 1-1/4"
MAGNETIC NAIL

20.44'(M)

12.55'(M)

FD. OLD
CHISELED
CROSS

NO ATTEMPT WAS MADE TO VERIFY THE
POSITION OF THE MONUMENT

Set two 1-1/4" Magnetic Nail ties as shown on sheet 2.**SURVEYOR'S STATEMENT**
