CORNER RECORD

Document Number CR-13-62

City of Stockton

Brief Legal Description Witness corner of the SW corner of Lot 2 of Block 73 East of Center.

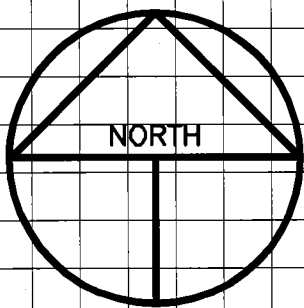
SCALE: 1" = 6'
2012-221 CR8

SET 1-1/4"
MAGNETIC NAIL

15.84'(M)

FD. LARGE
CHISELED CROSS

10.20'(M)

Set two 1-1/4" Magnetic Nail ties as shown on sheet 2.
