CORNER RECORD

Document Number CR-13-94

County of San Joaquin, CaliforniaBrief Legal Description Monuments in Sections 13 & 25, T1N R7E, MDB&M and Section 67, Weber Grant

CLSA CENTRAL VALLEY CHAPTER
 SUMMER 2012 SAN JOAQUIN COUNTY
 CHIP SEAL PROJECTS
 CORNER RECORD

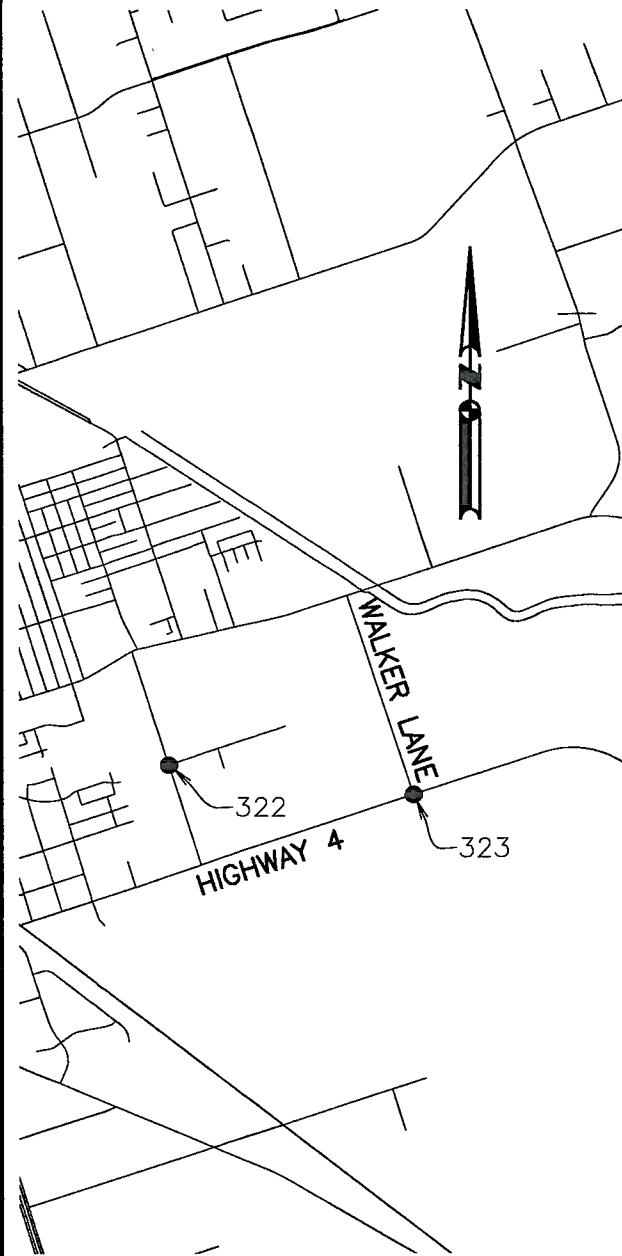
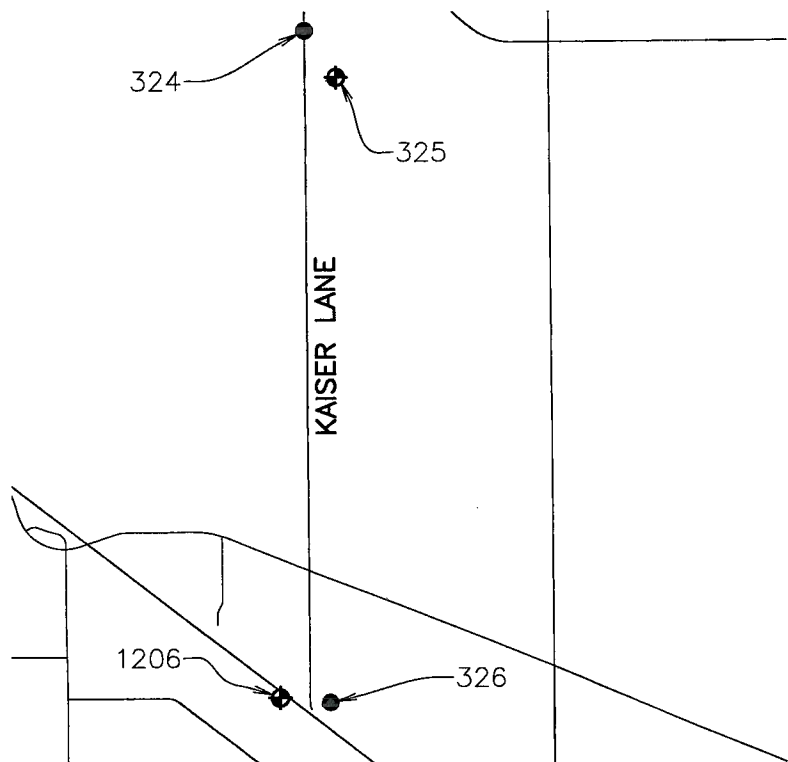
MONUMENT LIST

POINT NUMBER: 322
 DESCRIPTION: FOUND NAIL AND SHINER.
 NORTHING: 2169480.69 EASTING: 6353987.53

POINT NUMBER: 323
 DESCRIPTION: FOUND IRON PIN.
 NORTHING: 2168832.55 EASTING: 6359284.92

POINT NUMBER: 324
 DESCRIPTION: FOUND METAL OBJECT 21" BELOW
 HOLE IN PAVEMENT.
 NORTHING: 2166104.57 EASTING: 6369526.04

POINT NUMBER: 325
 DESCRIPTION: SET REBAR AND ALUMINUM DISK
 STAMPED "PLS 8489".
 NORTHING: 2166112.39 EASTING: 6369510.42

POINT NUMBER: 326
 DESCRIPTION: FOUND NAIL IN MON WELL.
 NORTHING: 2151713.61 EASTING: 6369651.81

POINT NUMBER: 1206
 DESCRIPTION: SET REBAR AND ALUMINUM DISK
 STAMPED "PLS 8489".
 NORTHING: 2151685.56 EASTING: 6369612.69
