CORNER RECORD

Document Number CR-14-18

County of SAN JOAQUIN, California

Brief Legal Description CENTER 1/4 CORNER OF SECTION 3 OF T3N, RTE OF MDB & M

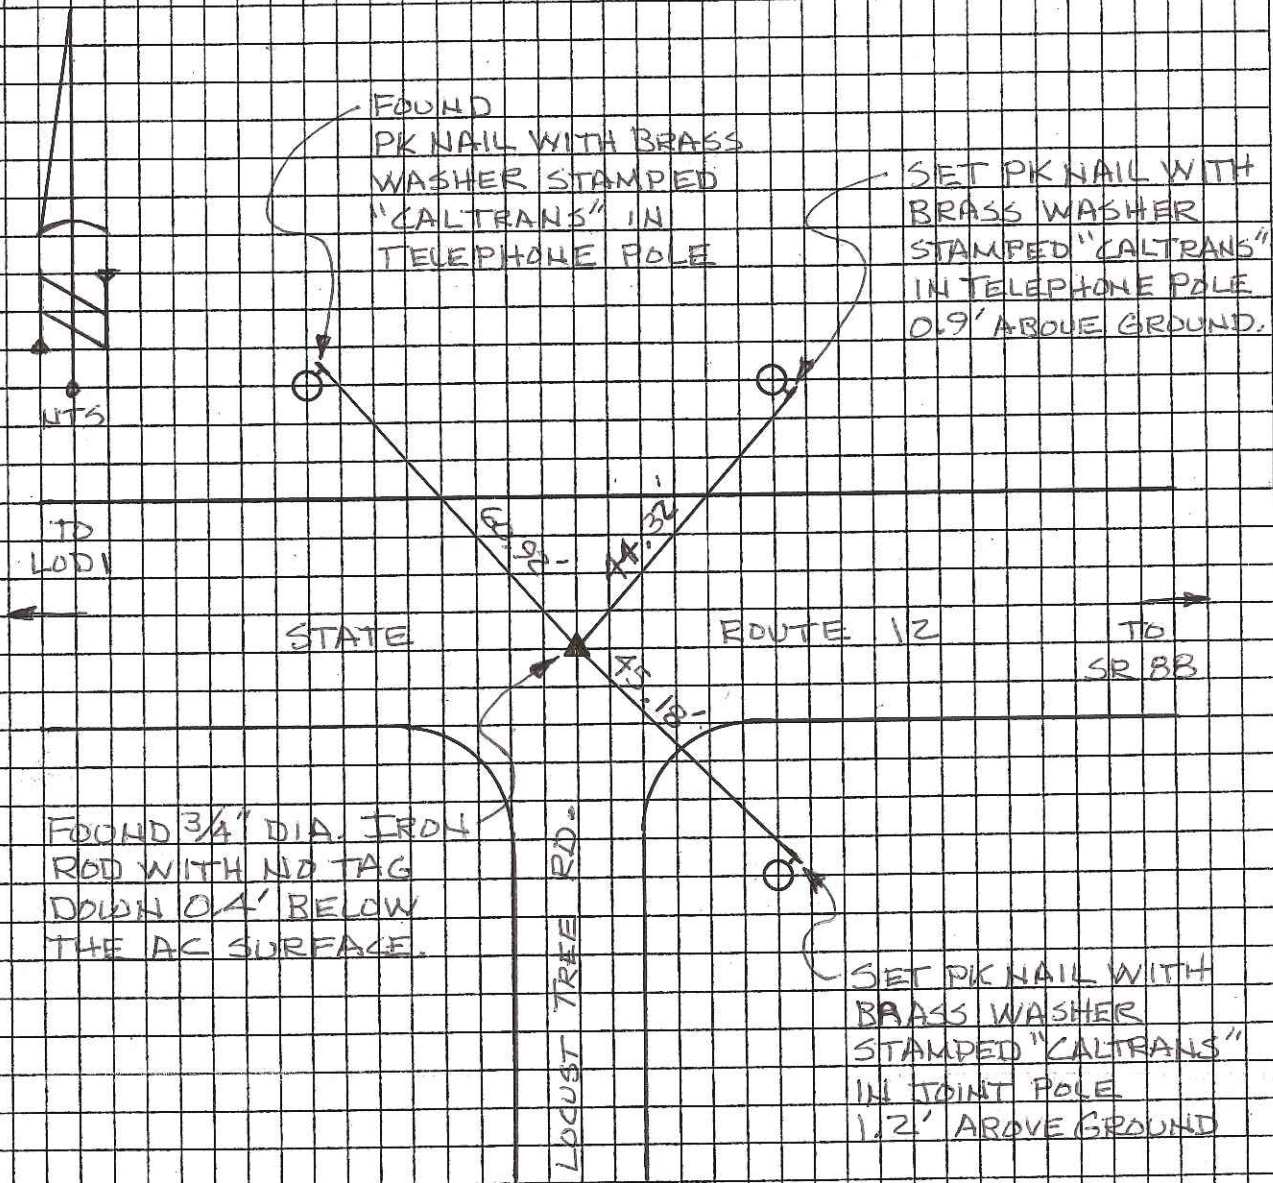
FOUND 3/4" DIA. IRON ROD WITH NO TAG DOWN 0.4' BELOW AC SURFACE.
FOUND ONE OF THE REFERENCE POINTS FROM THE PREVIOUS CORNER
RECORD (06-11).

MONUMENT WAS FOUND IN GOOD CONDITION. SET TWO NEW
REFERENCE POINTS AND MEASURED DISTANCES TO MONUMENT.
VERIFIED DISTANCE FROM EXISTING REFERENCE POINT TO MONUMENT.

THE TIES SHOWN HEREON ARE FOR THE PURPOSE OF PERPETUATING THE MONUMENTATION CURRENTLY EXISTING. NO ATTEMPT WAS MADE TO DETERMINE THE VALIDITY OF THE MONUMENT OR ITS PROPER LOCATION IN RELATION TO LEGAL BOUNDARY LINES IN THE AREA.
