CORNER RECORD

Document Number CR-14-133
City of _____ County of San Joaquin, California

Brief Legal Description ROSELAWN AVENUE 480' ± EAST OF MISSION ROAD
(WITHIN SECTION A, C.M. WEBER GRANT)

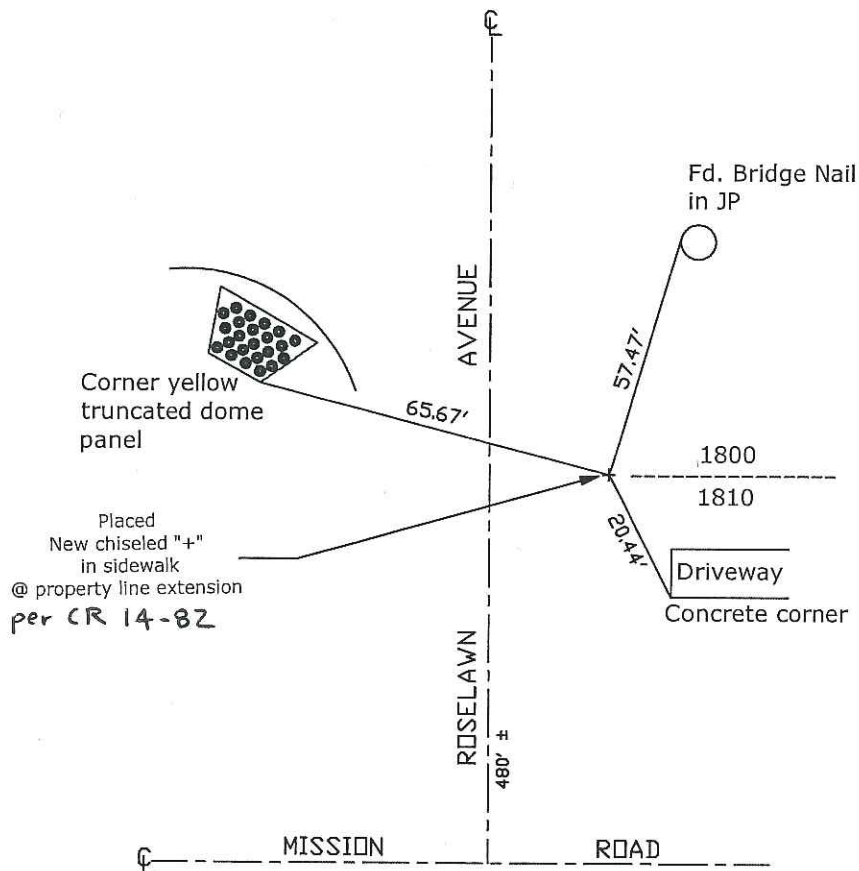
Identification and type of corner found: Evidence used to identify or procedure used to establish or reestablish the corner:
SEE SKETCH ON BACKSIDE.

A description of the physical condition of the monument as found and as set or reset:
SEE SKETCH ON BACKSIDE.
