CORNER RECORD

Document Number CR-14-208
County of San Joaquin, California

Brief Legal Description HARNEY LANE 653' ± WEST OF HIBBARD ROAD

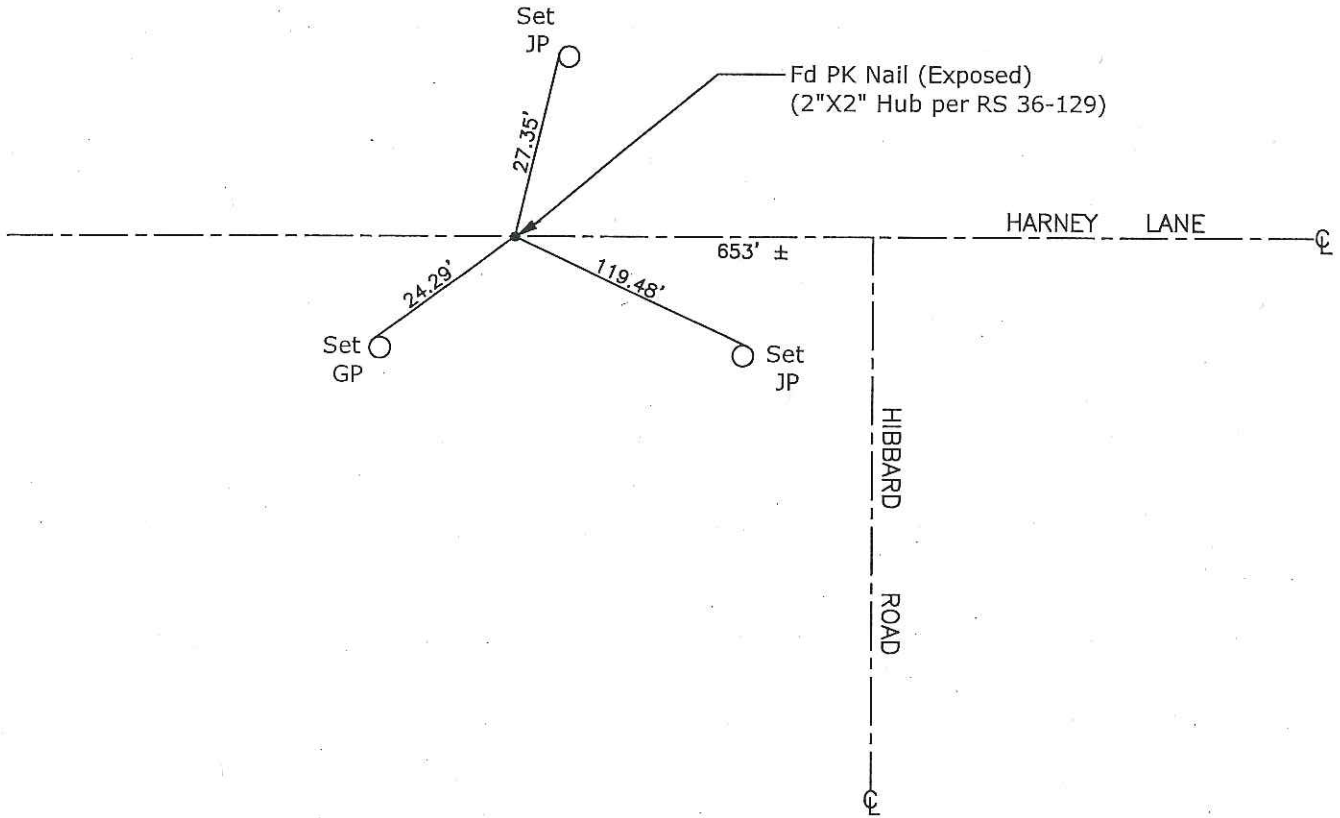
Identification and type of corner found: Evidence used to identify or procedure used to establish or reestablish the corner:
SEE SKETCH ON BACKSIDE.

A description of the physical condition of the monument as found and as set or reset:
SEE SKETCH ON BACKSIDE.
