CORNER RECORD

Document Number CR 15-29
County of San Joaquin, California

Brief Legal Description CARROLTON ROAD @ DODDS ROAD

T1S R8E
MDB&M

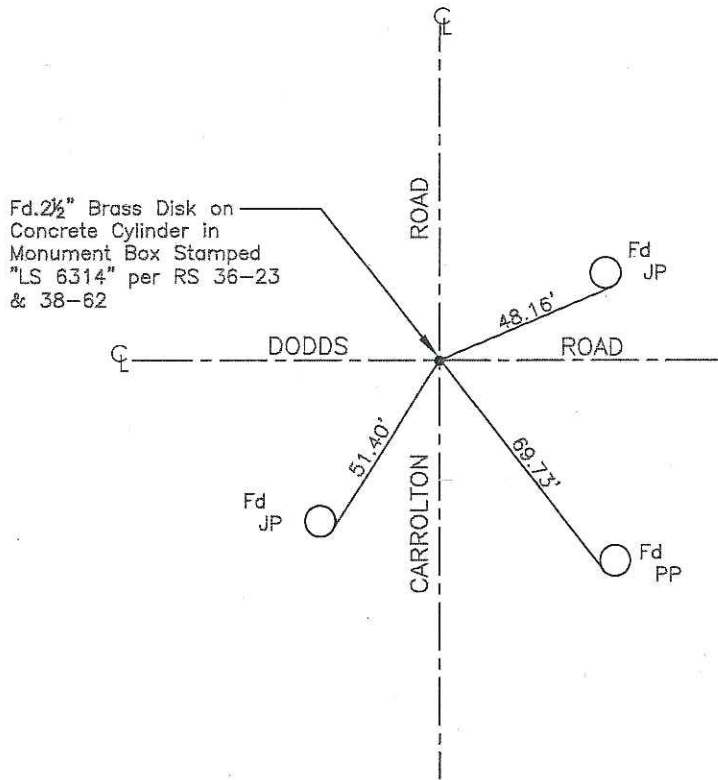
Fd. 2½" Brass Disk on
 Concrete Cylinder in
 Monument Box Stamped
 "LS 6314" per RS 36-23
 & 38-62

Identification and type of corner found: Evidence used to identify or procedure used to establish or reestablish the corner:
SEE SKETCH ON BACKSIDE.

A description of the physical condition of the monument as found and as set or reset:
SEE SKETCH ON BACKSIDE.
