CORNER RECORD

Document Number CR-15-293

Brief Legal Description CENTERLINE OF TOKAY COLONY RD, 51'± EAST OF STATE ROUTE 88

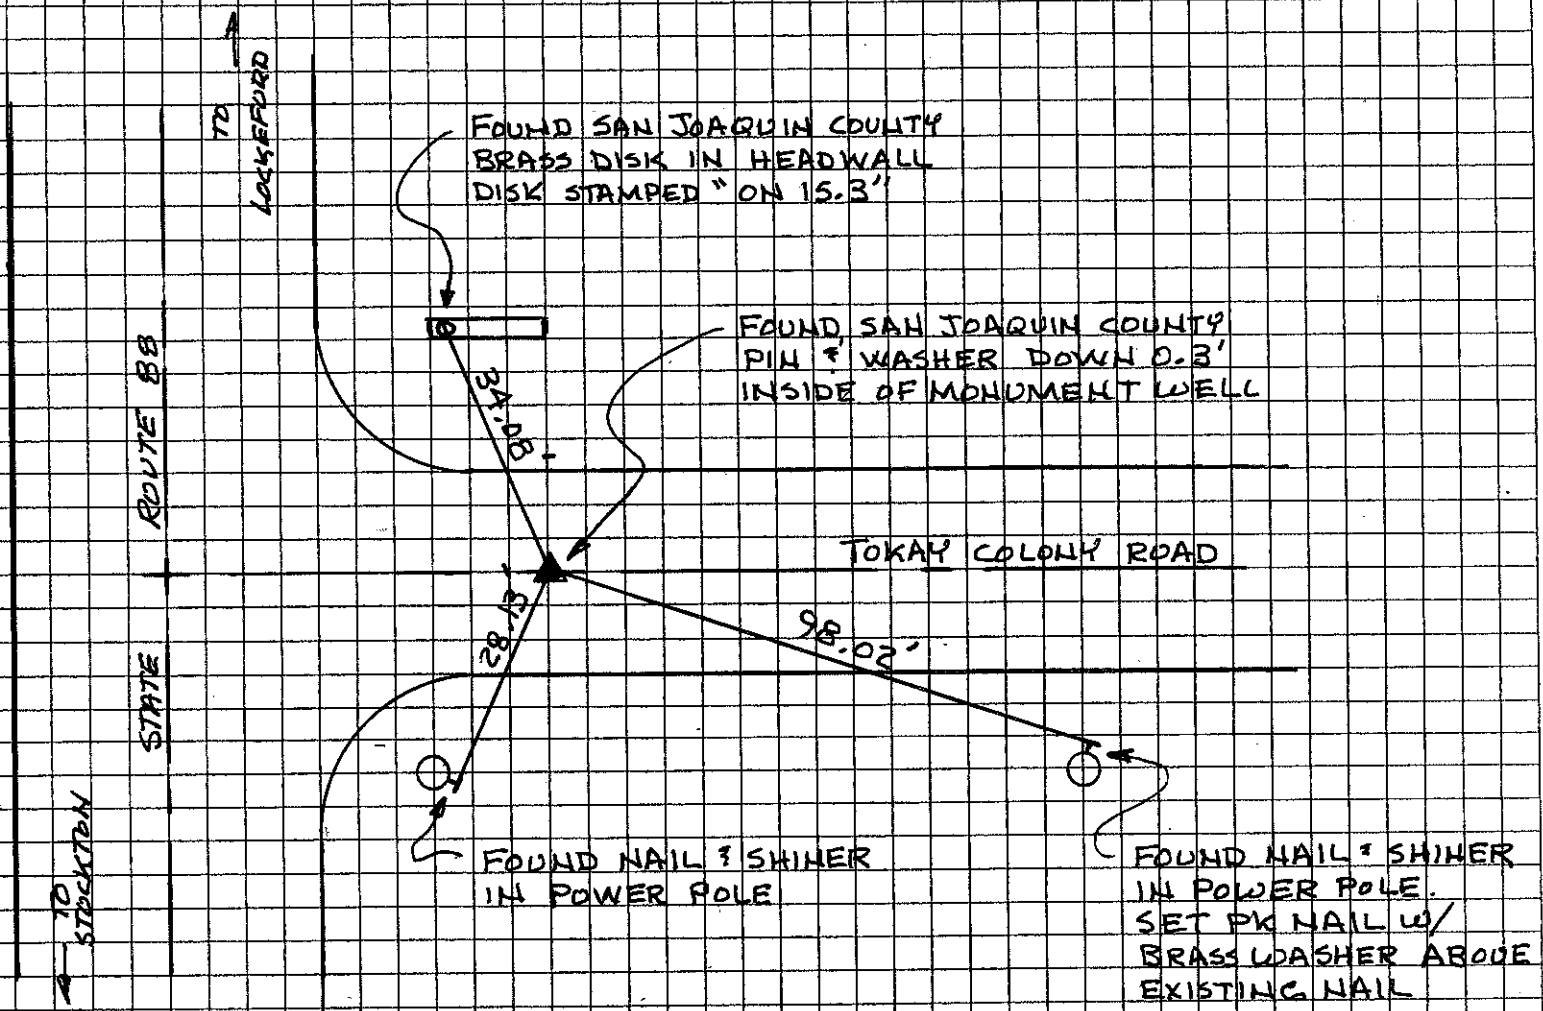
FOUND CENTERLINE MONUMENT OF TOKAY COLONY ROAD APPROXIMATELY 51 FEET EAST OF STATE ROUTE 88 AS PER PARCEL MAP VOLUME 24 PAGE 28 AND CORNER RECORD DOCUMENT #08-117

A description of the physical condition of the monument as found and as set or reset: FOUND SAN JOAQUIN COUNTY PIN AND WASHER DOWN 0.3' INSIDE OF A MONUMENT WELL. FOUND 3 REFERENCE MARKS FROM PREVIOUS CORNER RECORD. SET 1 REFERENCE MARK. MEASURED DISTANCES FROM MONUMENT TO NEW AND OLD REFERENCE MARKS.
