CORNER RECORD

Document Number CR-16-122

Brief Legal Description Centerline of State Route 4 at the intersection with Inland Drive, Sec's 14 & 23 TIN R5E

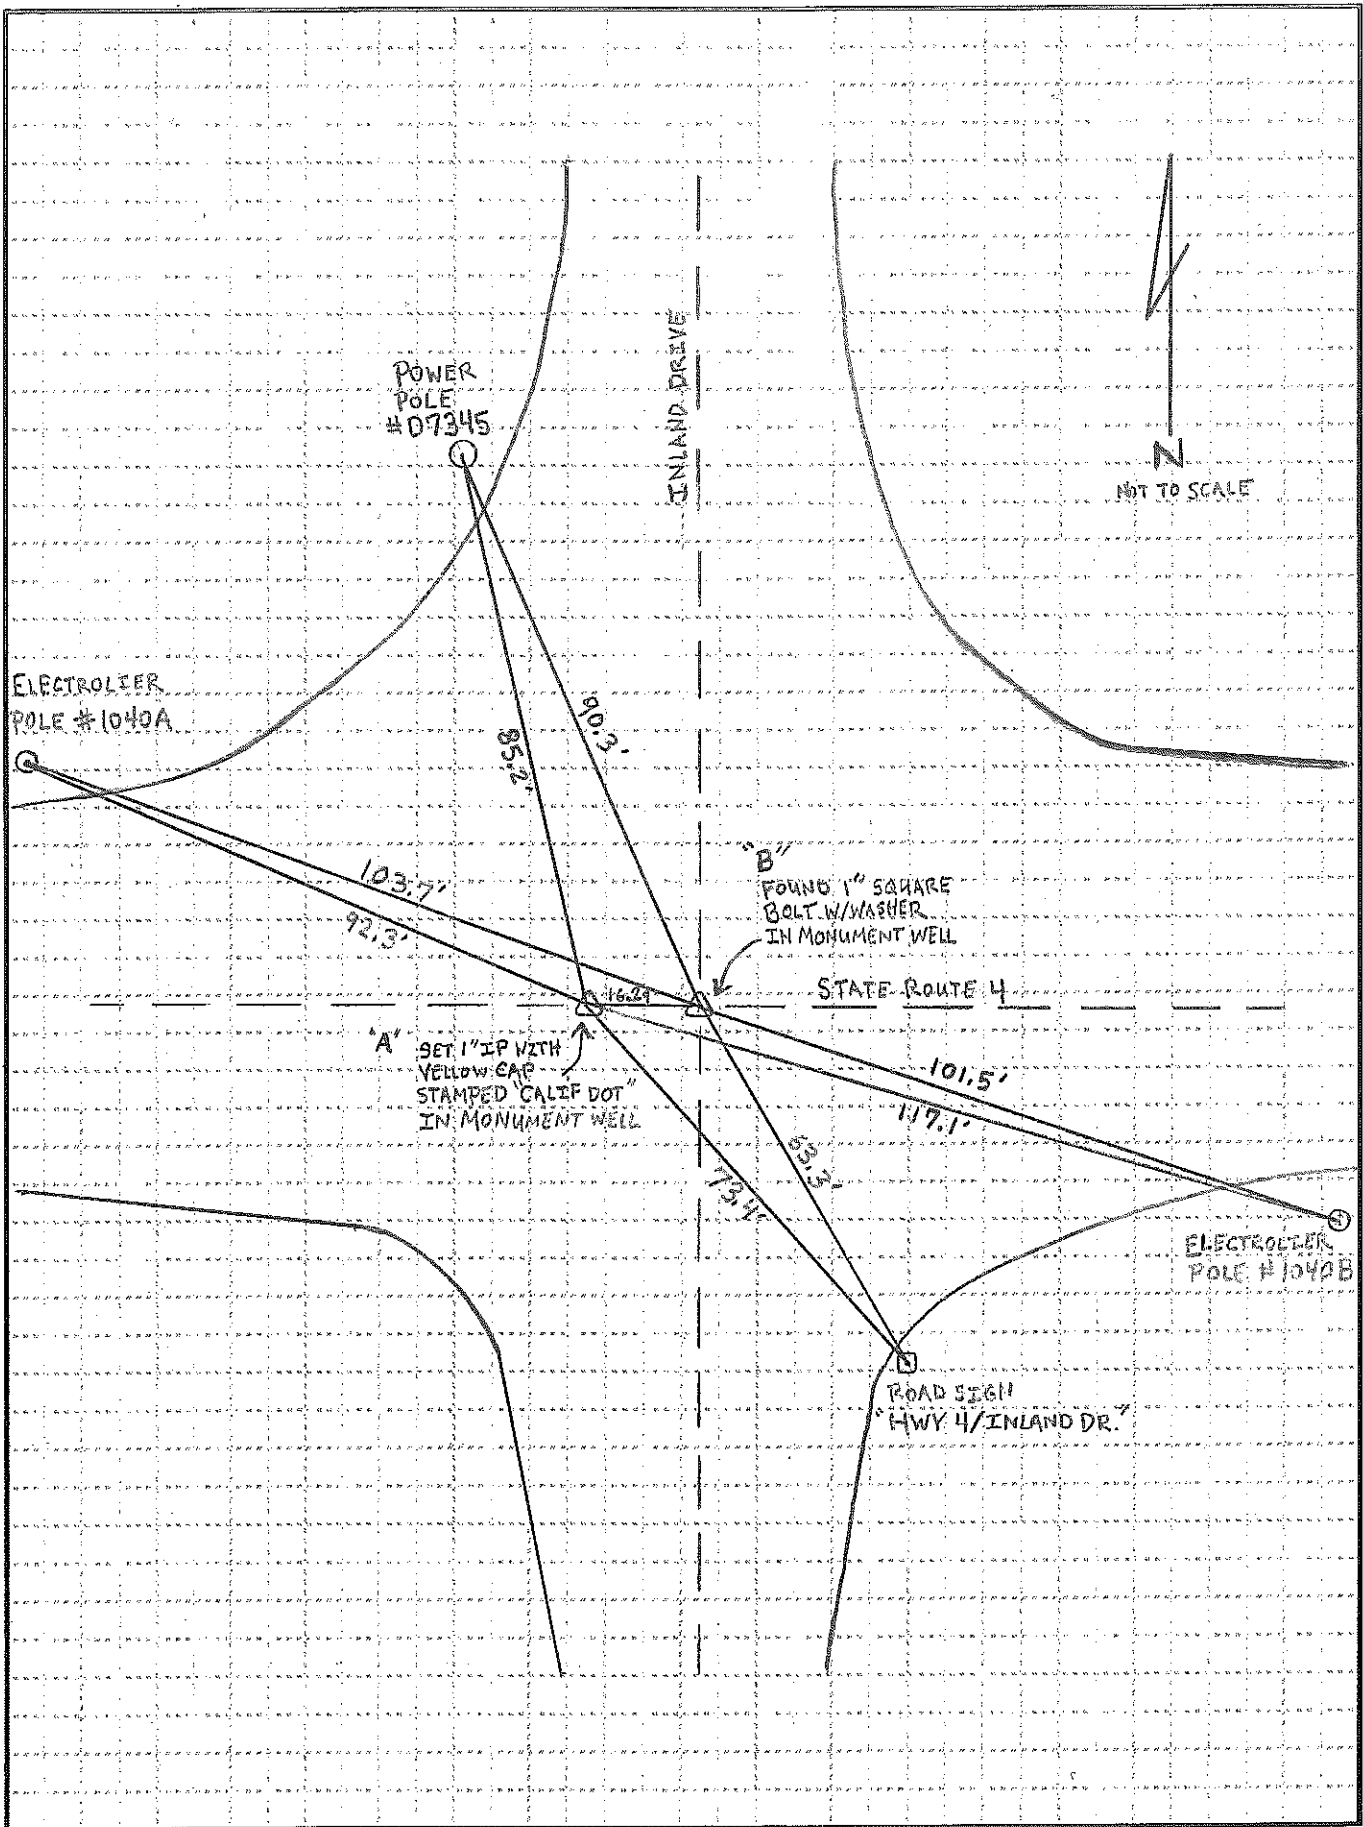
"A": Found 1" square bolt with washer in a/c pavement. (14-S-11 S.J.C.R.).

"B": Found 1" square bolt with washer in a/c pavement. (14-S-11 S.J.C.R.).

"A": Monument was disturbed by the rehabilitation construction and was replaced with an 1" iron pipe with yellow plastic cap stamped "Calif DOT" in a monument well.

"B": Found 1" square bolt with washer in good condition. Monument well was installed at the new pavement surface.
