# CORNER RECORD

Document Number CR-16-184  
County of San Joaquin, California

City of \_\_\_\_\_  
Brief Legal Description WASHINGTON STREET @ DAWES AVENUE  
( WITHIN SECTION 55, C.M. WEBER GRANT)

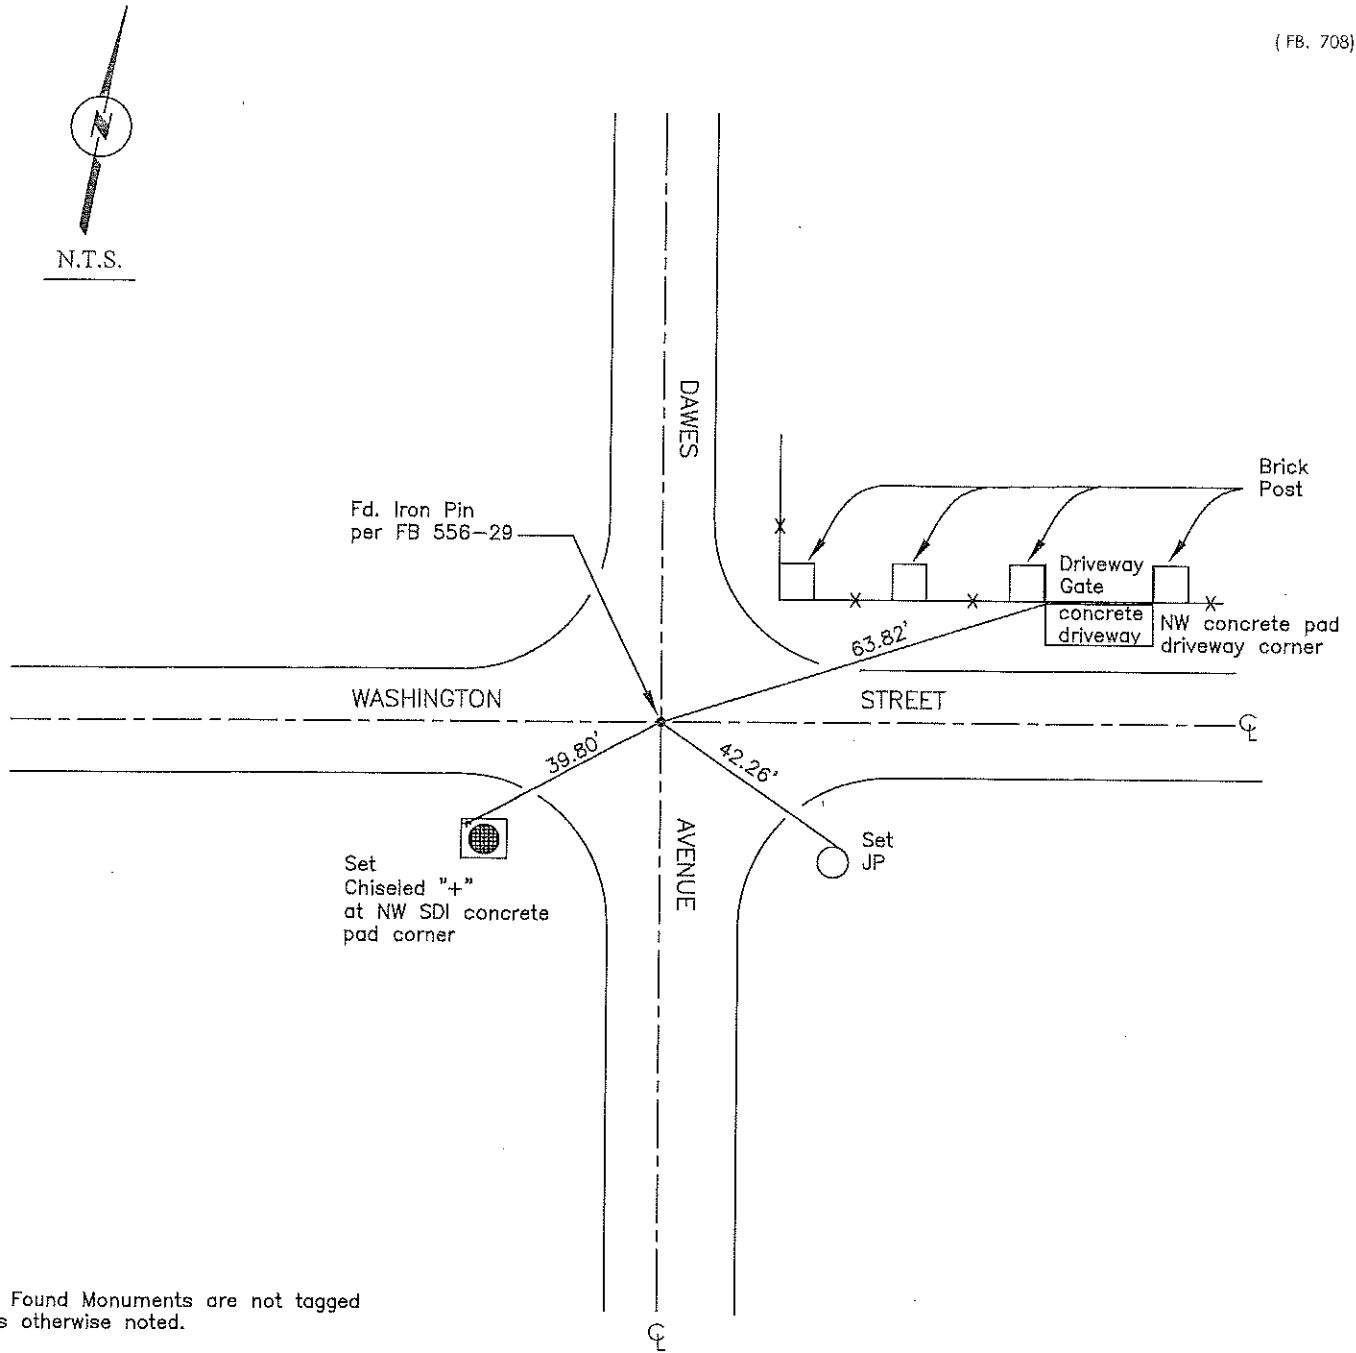
Identification and type of corner found: Evidence used to identify or procedure used to establish or reestablish the corner:  
SEE SKETCH ON BACKSIDE.

A description of the physical condition of the monument as found and as set or reset:  
SEE SKETCH ON BACKSIDE.

Note: Found Monuments are not tagged unless otherwise noted.

"No Attempt Was Made to Verify the Monument(s)"
