# **CORNER RECORD**

COL	KINEL	KEC	JK	U	Docu	ment N	umber (	CR-16-	250
City of S	Stockton				Cour		San Joaqu		, California
Brief Legal [	Description _	Colonial West, U	Jnit No.	4, Volu	ume 19	of Map	s & Plats,	Page 71.	
	_	CO	RNER T	YPE			C	OORDINATES	(Optional)
1 7 T. 2 N., R. 6 E.	, M.D.B.&M.	Government Corner Meander Rancho  Date of Survey D	ecembe	Control Property Other r 16, 20		X X	E		NADV88 X Imperial X
Corner -	Left as found	Found a	nd tagged		Establis	hed	Rees	tablished X	Rebuilt
	itional surve	er found: Evidence us y methods and Cl							
Set cut cross	with brass ta	ondition of the monungs stamped L.S. 7 own on page 2.					3/4" iron j		r.e.
the Land Surve	eyor's Act on	COUNTY SURVEYO	nder my cember L.S. or F DR'S STA 16	direction 22, R.C.E. No	2015 o.: T ZOL6		d examined	JAME  JAME	WARREN D SMITH NO 4842
Title <u>Cou</u> County Surv	,	•						C. S. C.	OF CALIFORNIA

THE PURPOSE OF THIS SURVEY IS TO RECORD AND REESTABLISH THE LOCATION OF MONUMENTS ORIGINALLY SHOWN ON CR 16— DISTURBED AFTER THE CONSTRUCTION OF UNDERGROUND IMPROVEMENTS. THE PURPOSE OF THIS SURVEY IS NOT TO MAKE PROPERTY LINE DETERMINATIONS. LOT LINES SHOWN HEREON ARE FOR GENERAL LOCATION AND INFORMATIONAL PUR

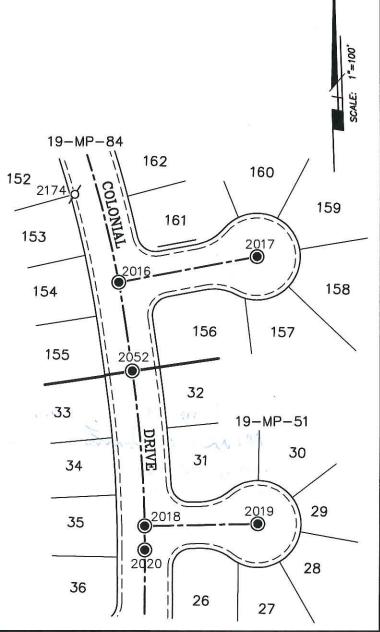
FIELD EFFORT INCLUDED A SEARCH FOR EXISTING CUT CROSSES AT THEIR TYPICAL LOCATION, ONLY THOSE FOUND ARE SHOWN.
