CORNER RECORD

City of San Joaquin , California Brief Legal Description Northwesterly corner of Lot 3 per M. & P. 14-115 S.J.C.R. CORNER TYPE	CORNER TYPE Government Corner Contro Meander Prope Rancho Other Date of Survey May 18, 2016 M.D.B. & M. Corner - Left as found Found and tagged Control dentification and type of corner found: Evidence used to identify of See Sheet 2	r M. & P. 14-115	COORI N Zone NAD83 Epoch Elev. Vert. Datum: ! Meas. Units: !	NGVD29 Metric Rebu	nal) NAD83 NADV88 Imperial
CORNER TYPE COORDINATES(Optional) Control	Government Corner Control Meander Prope Rancho Other 2. 5, T.2N., R.7E., Date of Survey May 18, 2016 M.D.B. & M. Corner - Left as found Found and tagged Control dentification and type of corner found: Evidence used to identify of See Sheet 2	el	COORI N E Zone NAD83 Epoch Elev. Vert. Datum: I Meas. Units: I	NGVD29 ☐ Metric ☐ Rebu	NADV88 Imperial K
Government Corner Control E. Soft Control E. NAD27 NAD28 NAD27 NAD28	Government Corner Control Meander Prope Rancho Other 2. 5, T.2N., R.7E., M.D.B. & M. Corner - Left as found Found and tagged Corner found: Evidence used to identify of See Sheet 2	ety 🔀	N E Zone NAD83 Epoch Elev. Vert. Datum: ! Meas. Units:

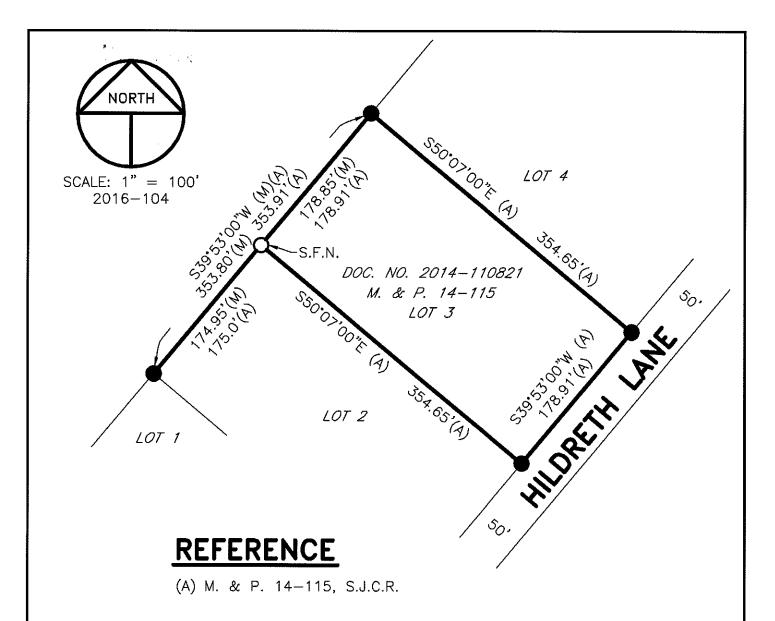
INDICATES FOUND 3/4" IRON PIPE, NOT TAGGED, NO REFERENCE, SET PLASTIC CAP STAMPED LS 4450, CALLED 1-1/2" IRON PIPE W/TAG STAMPED LS 2368 PER (A)

-O-INDICATES SET 3/4" x 30" IRON PIPE WITH PLASTIC CAP STAMPED LS 4450 M. & P. INDICATES MAPS AND PLATS, VOLUME AND PAGE, S.J.C.R.
