CORNER RECORD

Document Number CR-16-425
County of San Joaquin, California

City of Stockton
Brief Legal Description Centerlines of Swain Rd. and Montauban Ave.

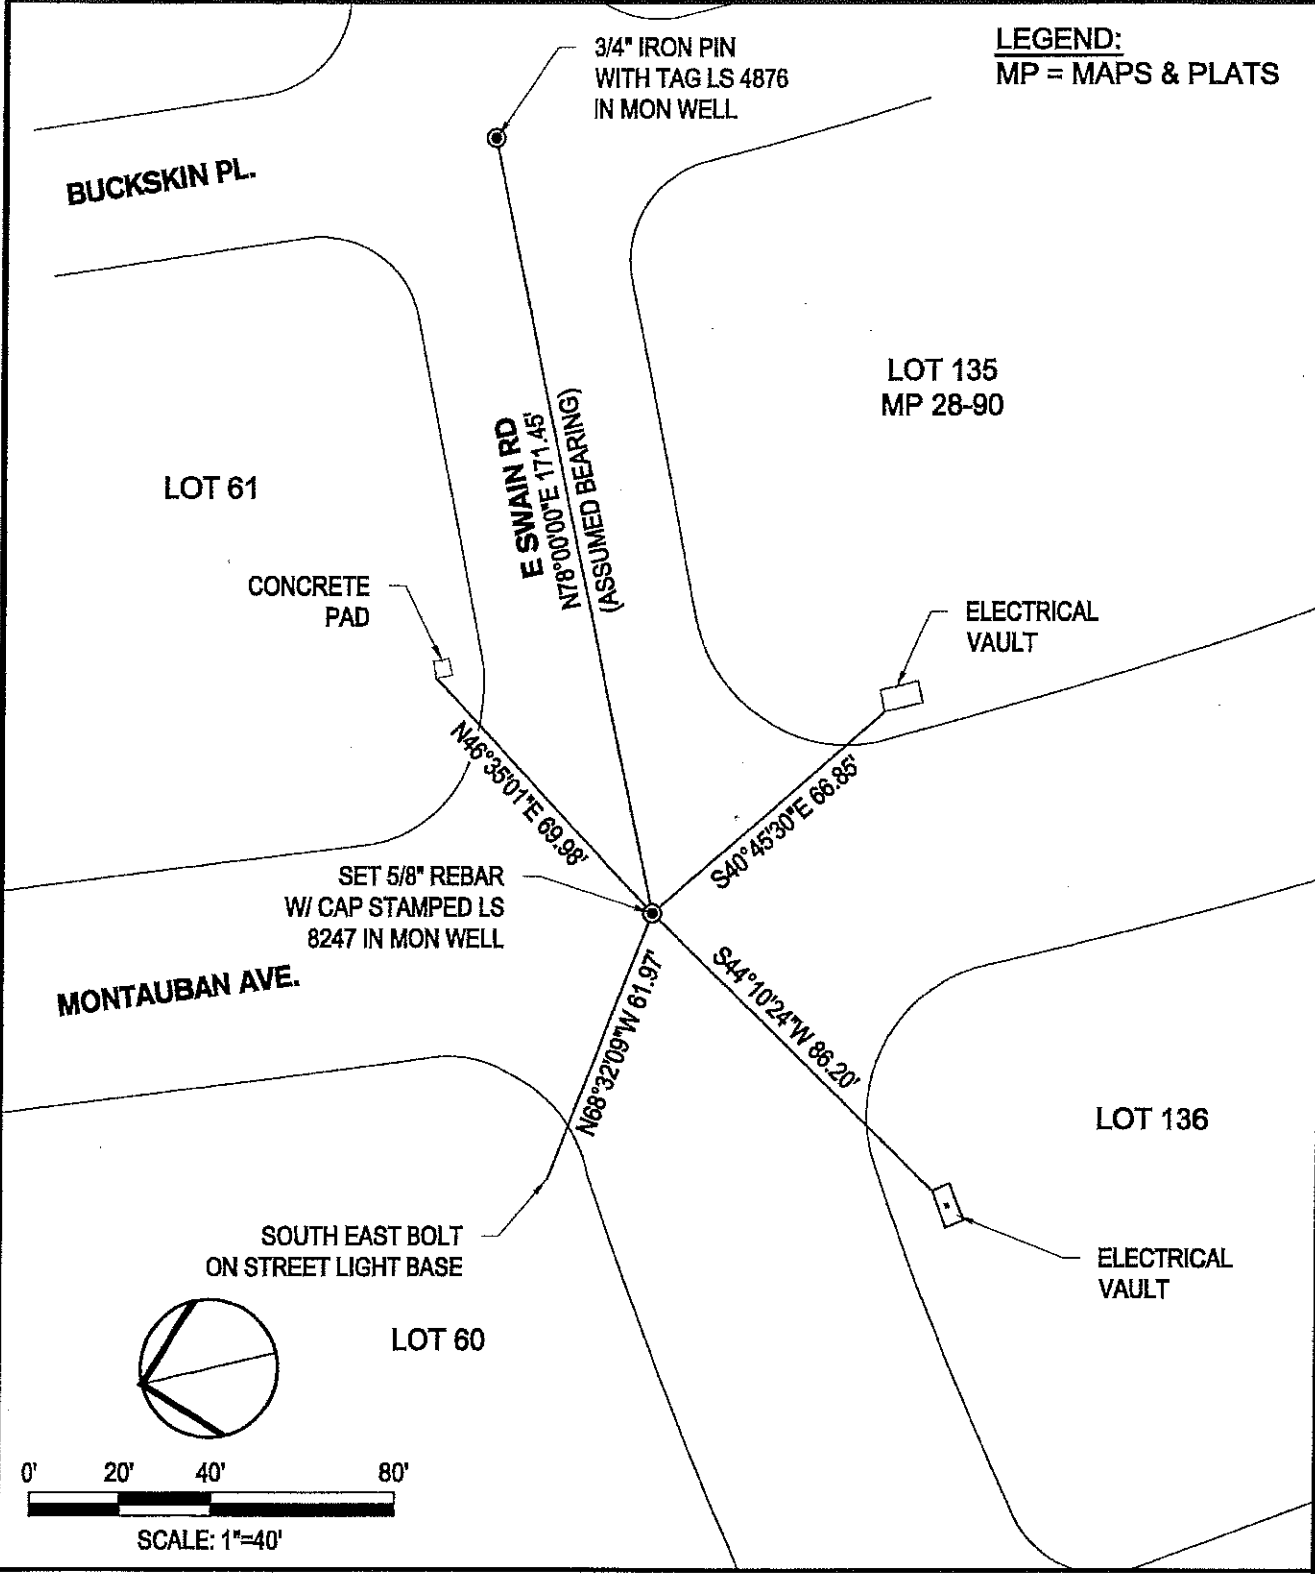
Found 3/4" Iron Pin with tag stamped L.S. 4876 in a monument well.

Monument was destroyed during construction of traffic circle and replaced with 5/8" rebar with cap, L.S. 8247, in a monument well.
