# CORNER RECORD

Agency Index CR-17-233  
Document Number \_\_\_\_\_

City of Stockton County of San Joaquin, California  
Brief Legal Description Lincoln Village West, Unit No. 18, Book 19 of Maps & Plats, Page 78.

See sheet #2 for description(s) :

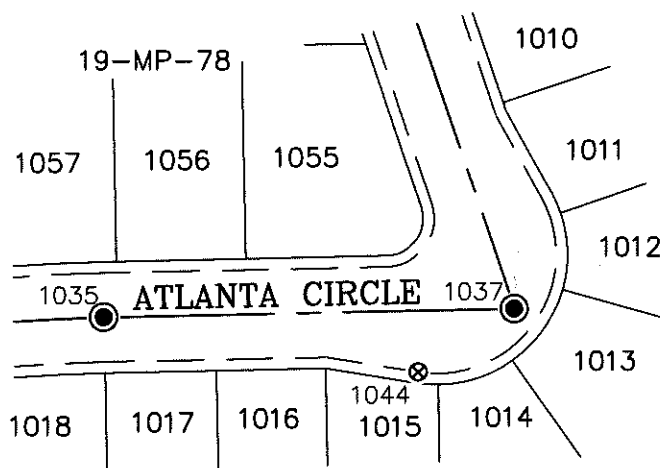
Used conventional survey methods and CR 16-166 to reestablish the position of obliterated cut crosses, as shown on page 2. Set cut cross with brass tags stamped L.S. 7051 in concrete. Also, found 3/4" iron pins with brass tags stamped R.C.E. 8189 as shown on page 2.

THE PURPOSE OF THIS SURVEY IS TO RECORD AND REESTABLISH THE LOCATION OF MONUMENTS ORIGINALLY SHOWN ON CR 16-166 DISTURBED AFTER THE CONSTRUCTION OF UNDERGROUND IMPROVEMENTS. THE PURPOSE OF THIS SURVEY IS NOT TO MAKE PROPERTY LINE DETERMINATIONS. LOT LINES SHOWN HEREON ARE FOR GENERAL LOCATION AND INFORMATIONAL PURPOSES ONLY.

- ⊗ INDICATES SET CUT CROSS WITH BRASS TAG, TAGGED L.S. 7051
- INDICATES FOUND IRON PINS, 3/4" IN DIAMETER, WITH BRASS TAG ATTACHED STAMPED "R.C.E. 8189" IN CAST IRON MONUMENT WELL.

FIELD EFFORT INCLUDED A SEARCH FOR EXISTING CUT CROSSES AT THEIR TYPICAL LOCATION, ONLY THOSE FOUND ARE SHOWN.
