CORNER RECORD

Agency Index CR-18-49

City of _____ County of San Joaquin, CaliforniaBrief Legal Description 1/4 corner Sections 15 & 22, T.1N., R.9E., M.D.M.**CORNER TYPE****COORDINATES (Optional)**

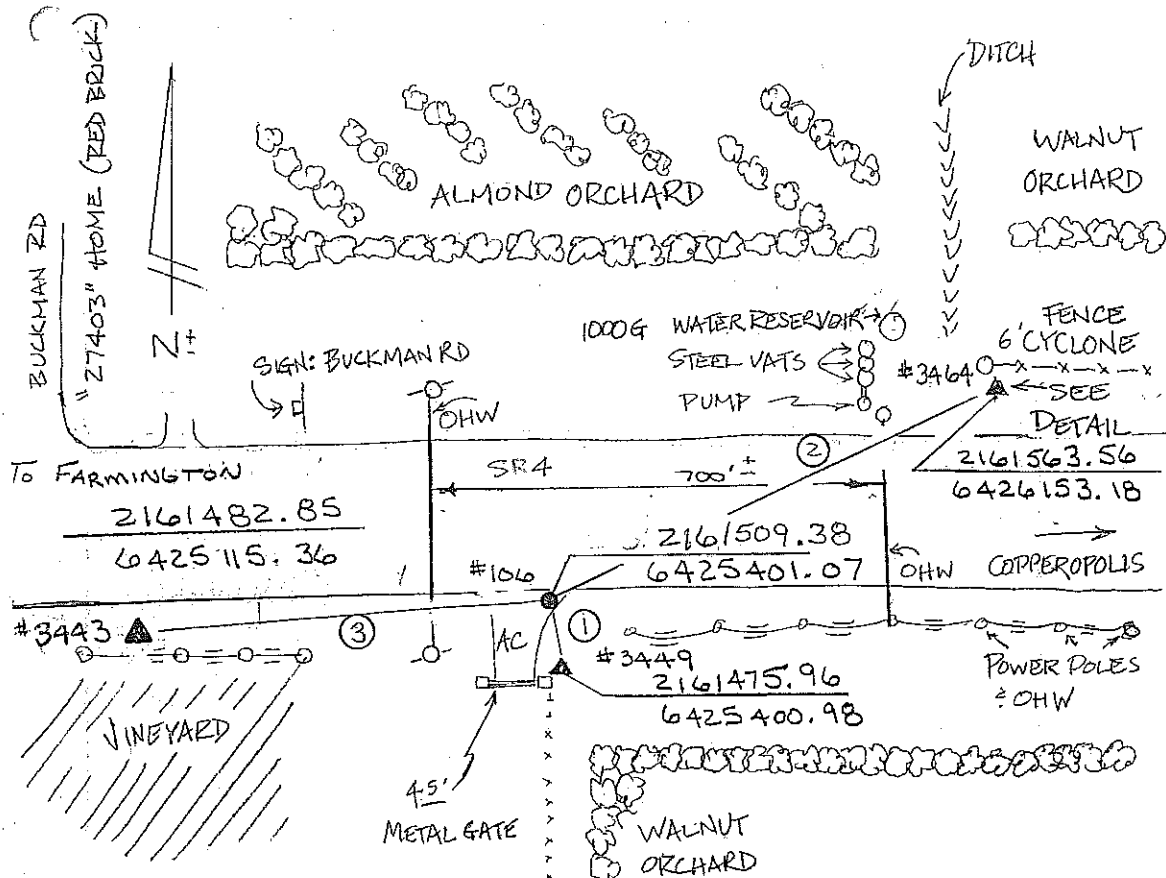
DETAIL

Found 1" Iron Pipe with "Calif. DOT" plastic cap per R.S. 35-29 M.&P., S.J.C.R.. No attempt was made to determine validity of monument or its proper location in relation to the legal boundary lines in the area. Coordinates provided per static survey and conventional ties. See "Sheet 2".

- FOUND 1" IRON PIPE TAG DESTROYED
- ▲ SET 1" IRON PIPE WITH 1/2" ALUMINUM CALTRANS CAP

- ① N 0° 09' 01" E 33.43
- ② S 85° 52' 46" W 754.06
- ③ N 84° 41' 38" E 286.94

BRASS CAP
IN CONCRETE
