# CORNER RECORD

Agency Index CR-18-96  
Document Number \_\_\_\_\_

City of \_\_\_\_\_ County of San Joaquin, California  
Brief Legal Description block corner in Sec 34 T.1 S., R.8 E. M.D.M.

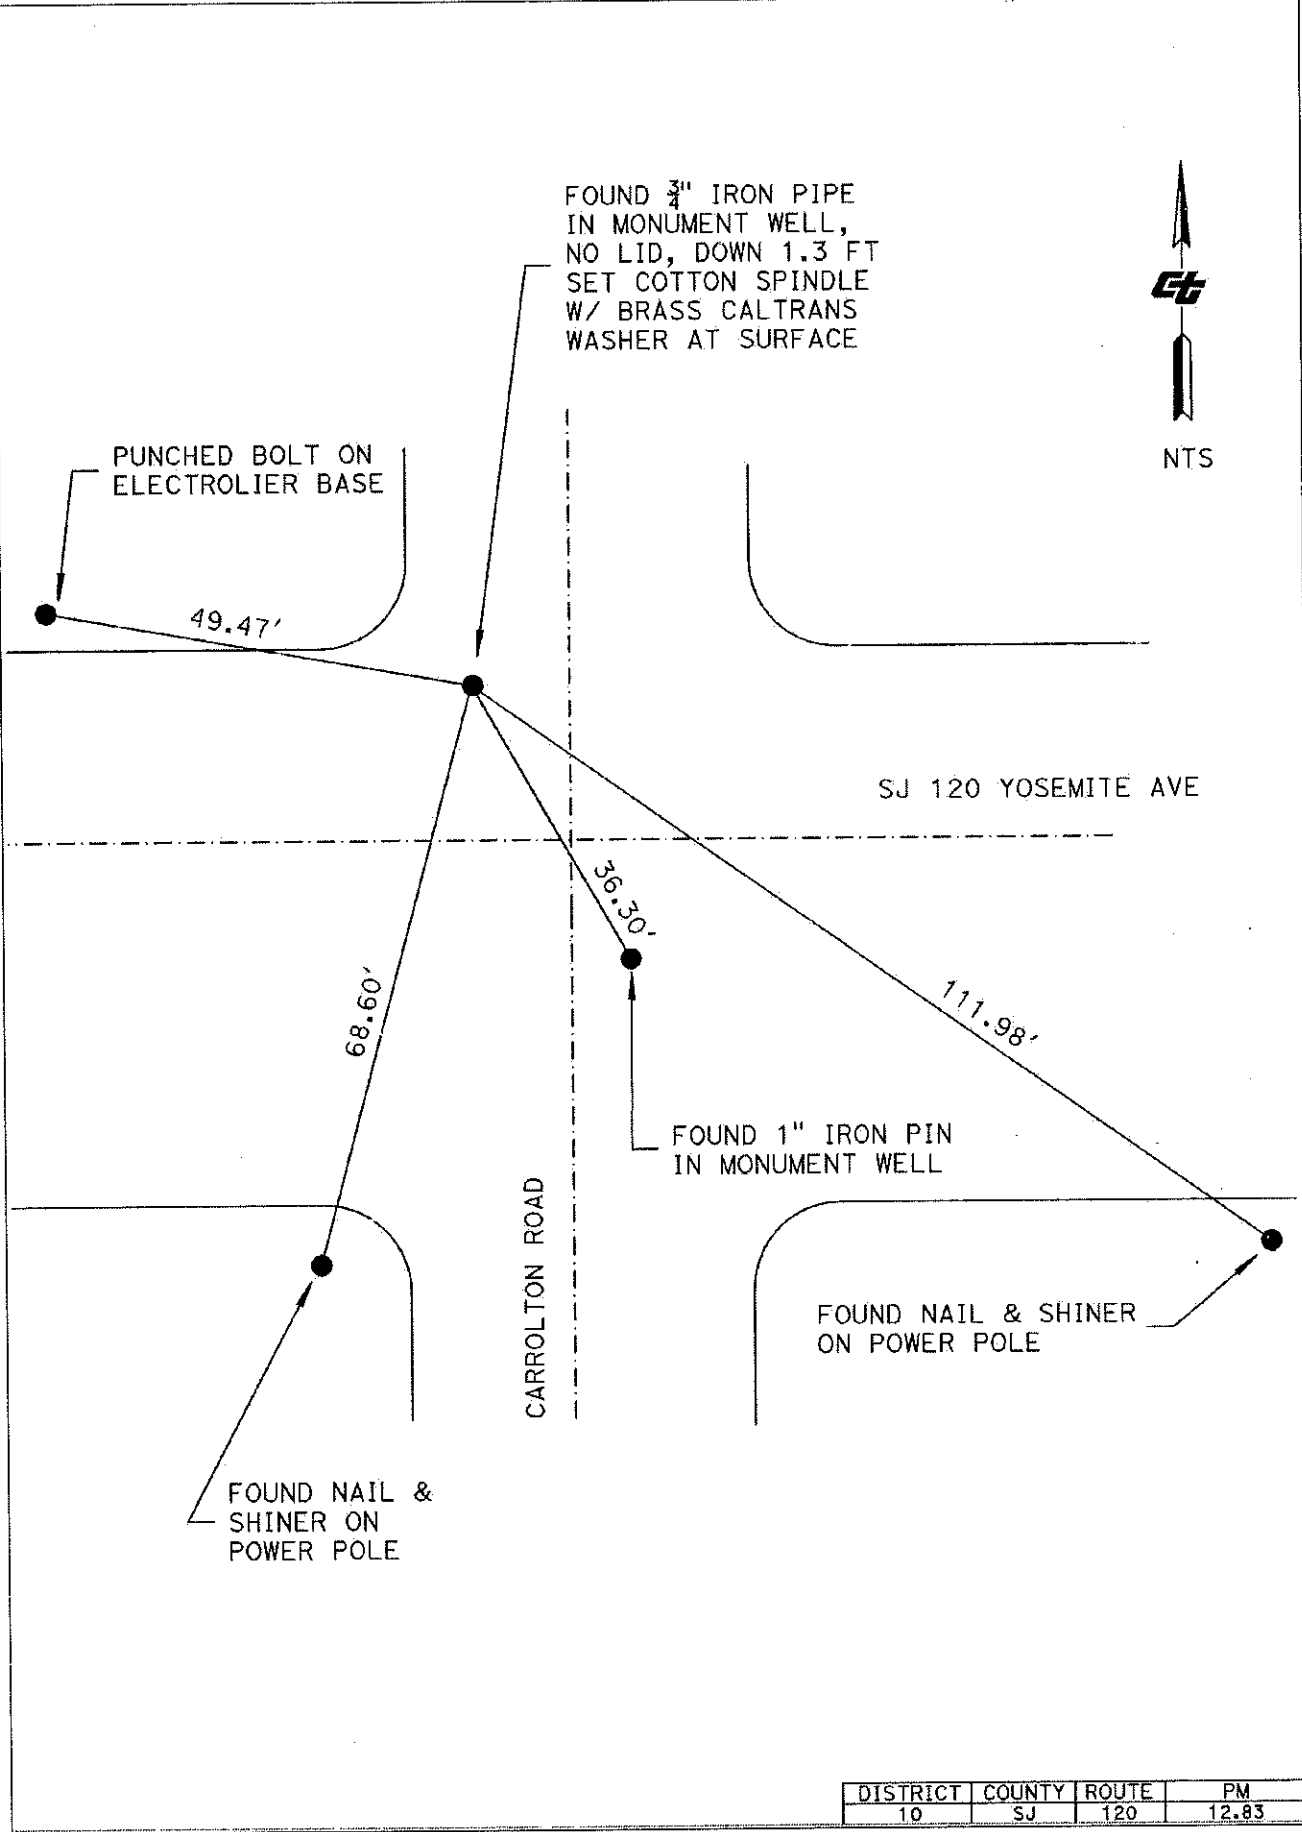
See sheet #2 for description(s):

Found 3/4" iron pipe (shown on RS 36-143 as former property corner) in monument well with no lid, down 1.3 ft, set cotton spindle with brass Caltrans washer at surface.
