CORNER RECORD

Agency Index CR-19-119

City of Stockton County of San Joaquin, CaliforniaBrief Legal Description MOST SOUTHERLY CORNER OF LOT 6, PER BOOK 25 OF MAPS AND PLATS, PAGE 108.**CORNER TYPE****COORDINATES (Optional)**

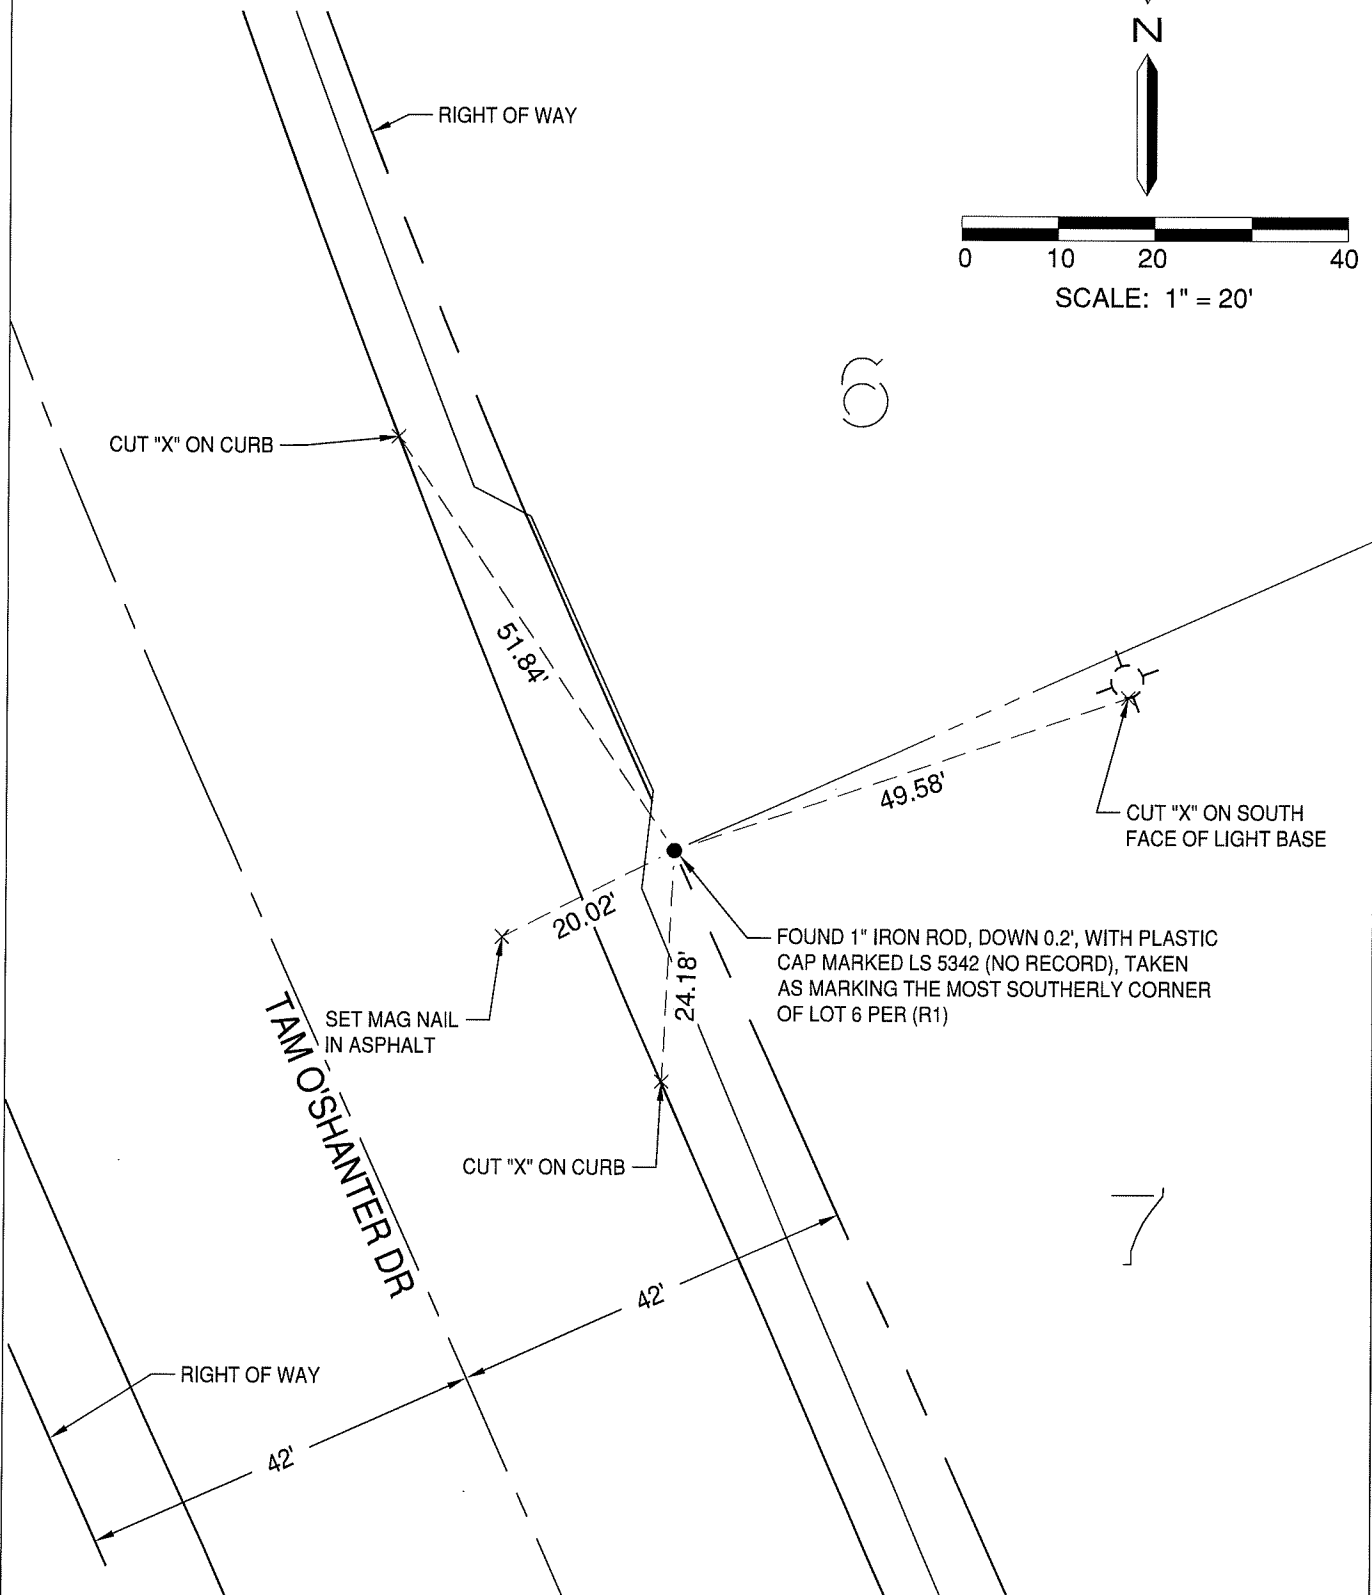
Found 1" iron rod, down 0.2', with plastic cap marked "LS 5342"(no record), located behind the sidewalk and next to a PG&E utility box, taken as marking the most southerly corner of Lot 6 per map of Tract No. 1695, Hammertown Unit No. 4, filed in Book 25 of Maps and Plats, at Page 108, San Joaquin County Records.

Set new ties; see reverse for details.
