# CORNER RECORD

Agency Index CR-21-133  
Document Number \_\_\_\_\_

City of \_\_\_\_\_ County of San Joaquin, California  
Brief Legal Description \_\_\_\_\_ NGS Benchmark E-799 (HS 0201)

Sec. 25, T.1S., R.6E.,  
M.D.B. & M.

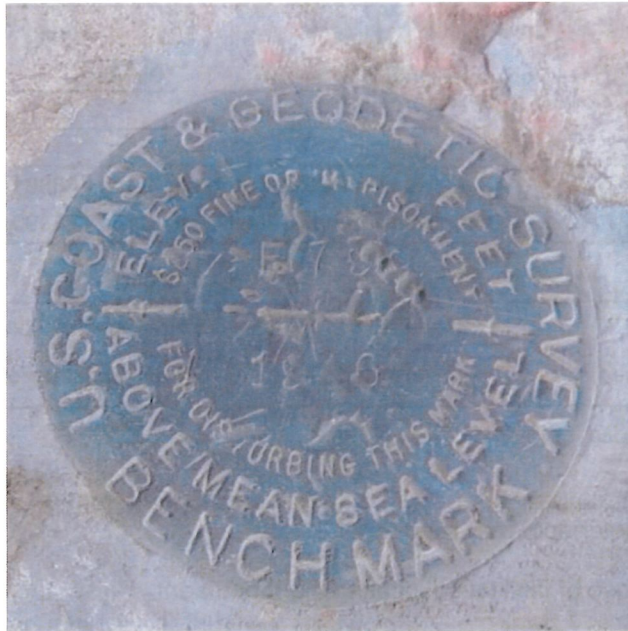
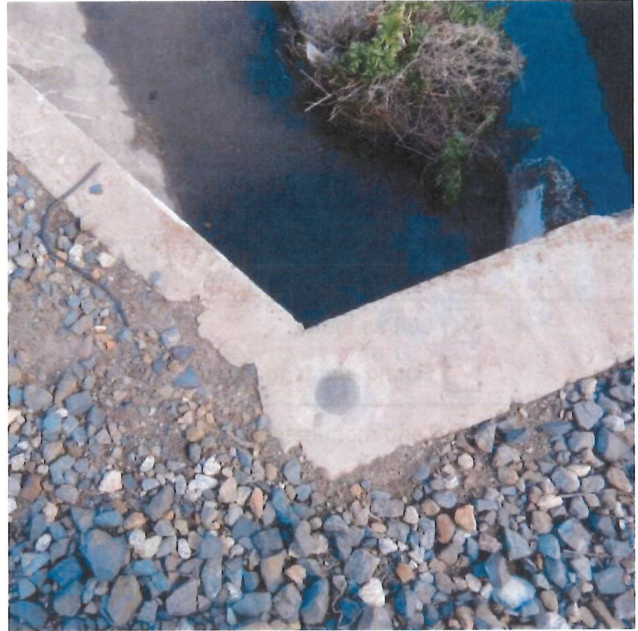
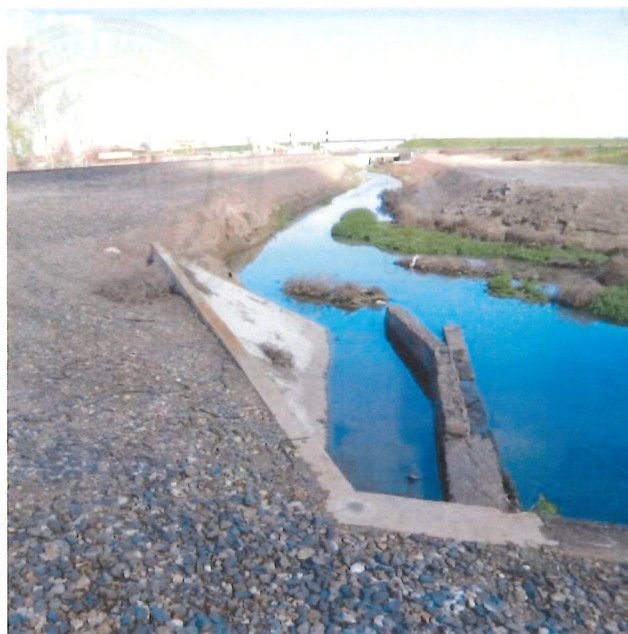
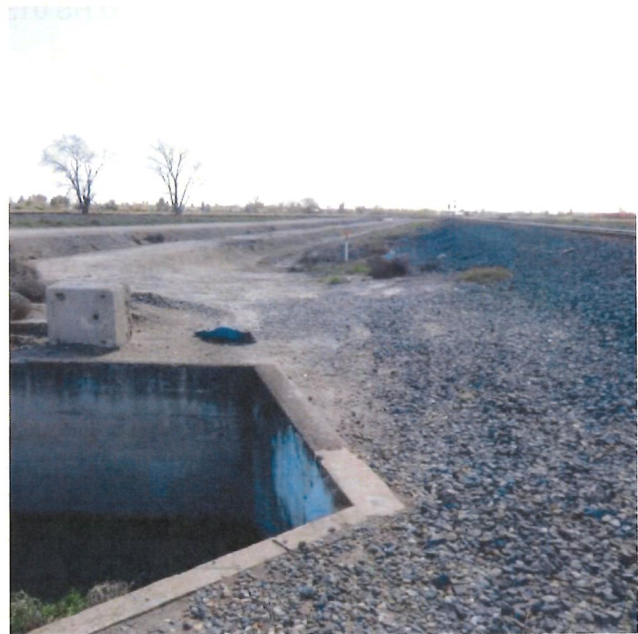
Found as described in NGS Datasheet for S-995 (PID HS 0135)

Southwesterly corner of a concrete drain ditch headwall, being North of the Union Pacific Railroad tracks and located in the East Half of Section 25, T.1S., R.6E., M.D.B. & M.
