CORNER RECORD

Agency Index CR-21-172
 Document Number _____

City of Manteca County of San Joaquin, California
 Brief Legal Description North half (N 1/2) Section 31, T.1S., R.7E., M.D.B.& M.

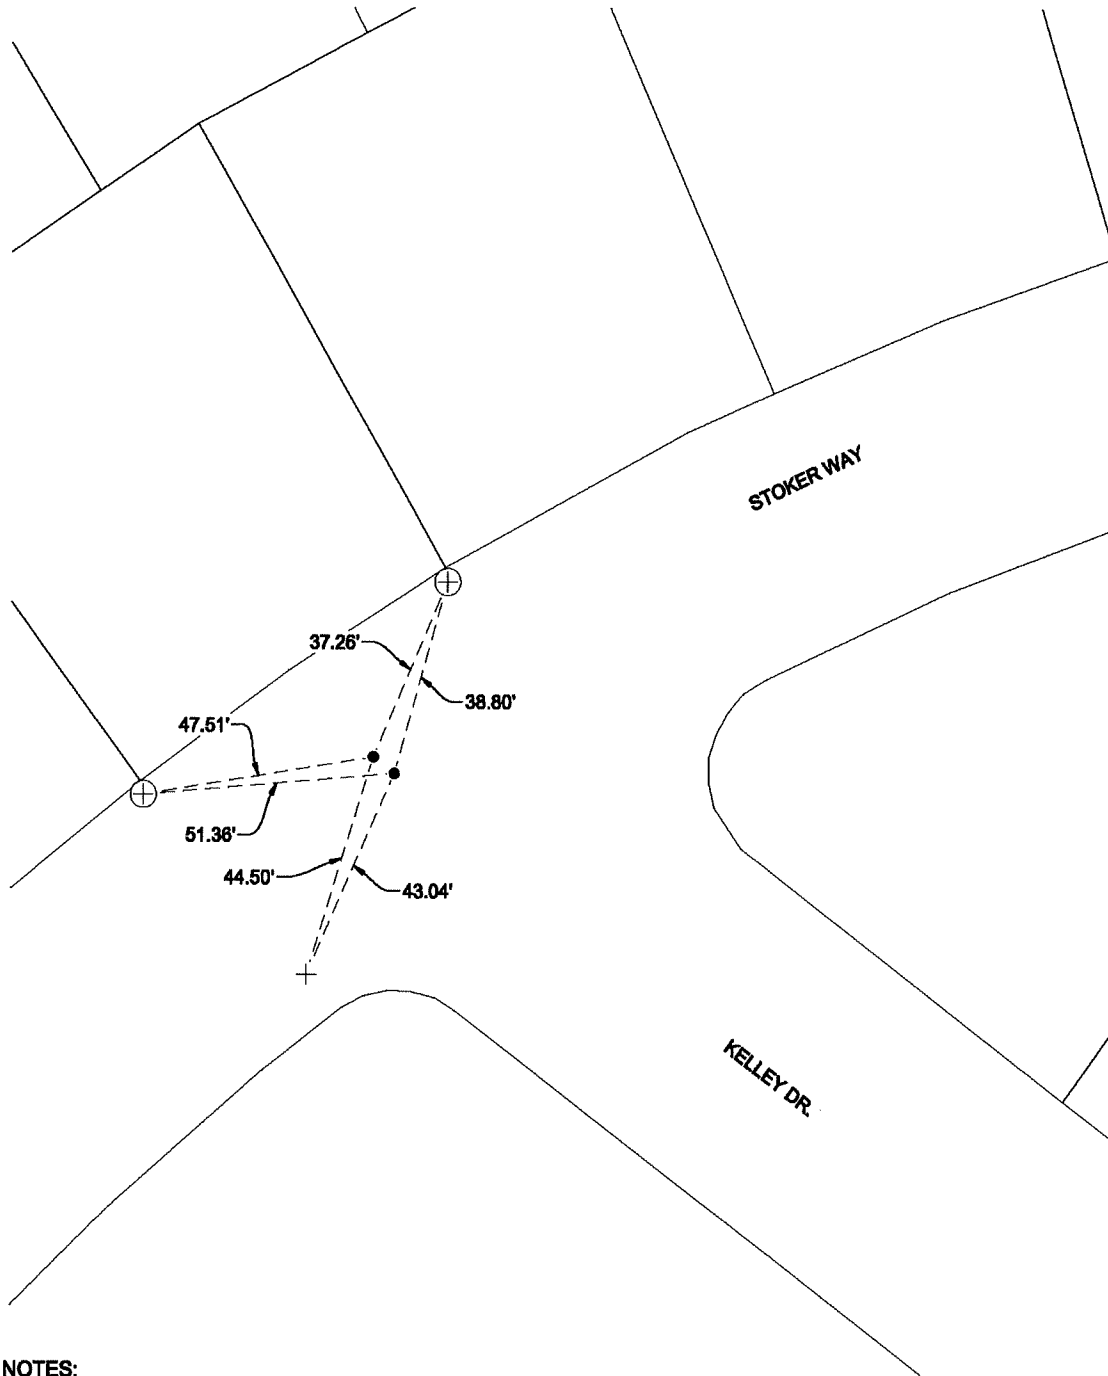
- FOUND MONUMENT: 3/4" REBAR STAMPED R.C.E. 14269 IN MONUMENT WELL, PER M&P 26-98 UNLESS OTHERWISE NOTED.
- + SET SAWCUT "+" IN CONCRETE ON TOP OF CURB
- ⊕ FOUND SAWCUT "+" ON SIDEWALK
- M&P MAP AND PLATS, SAN JOAQUIN COUNTY RECORDS
