CORNER RECORD

Agency Index CR-21-174
Document Number _____

City of Manteca County of San Joaquin, California
Brief Legal Description North half (N 1/2) Section 31, T.1S., R.7E., M.D.B. & M.

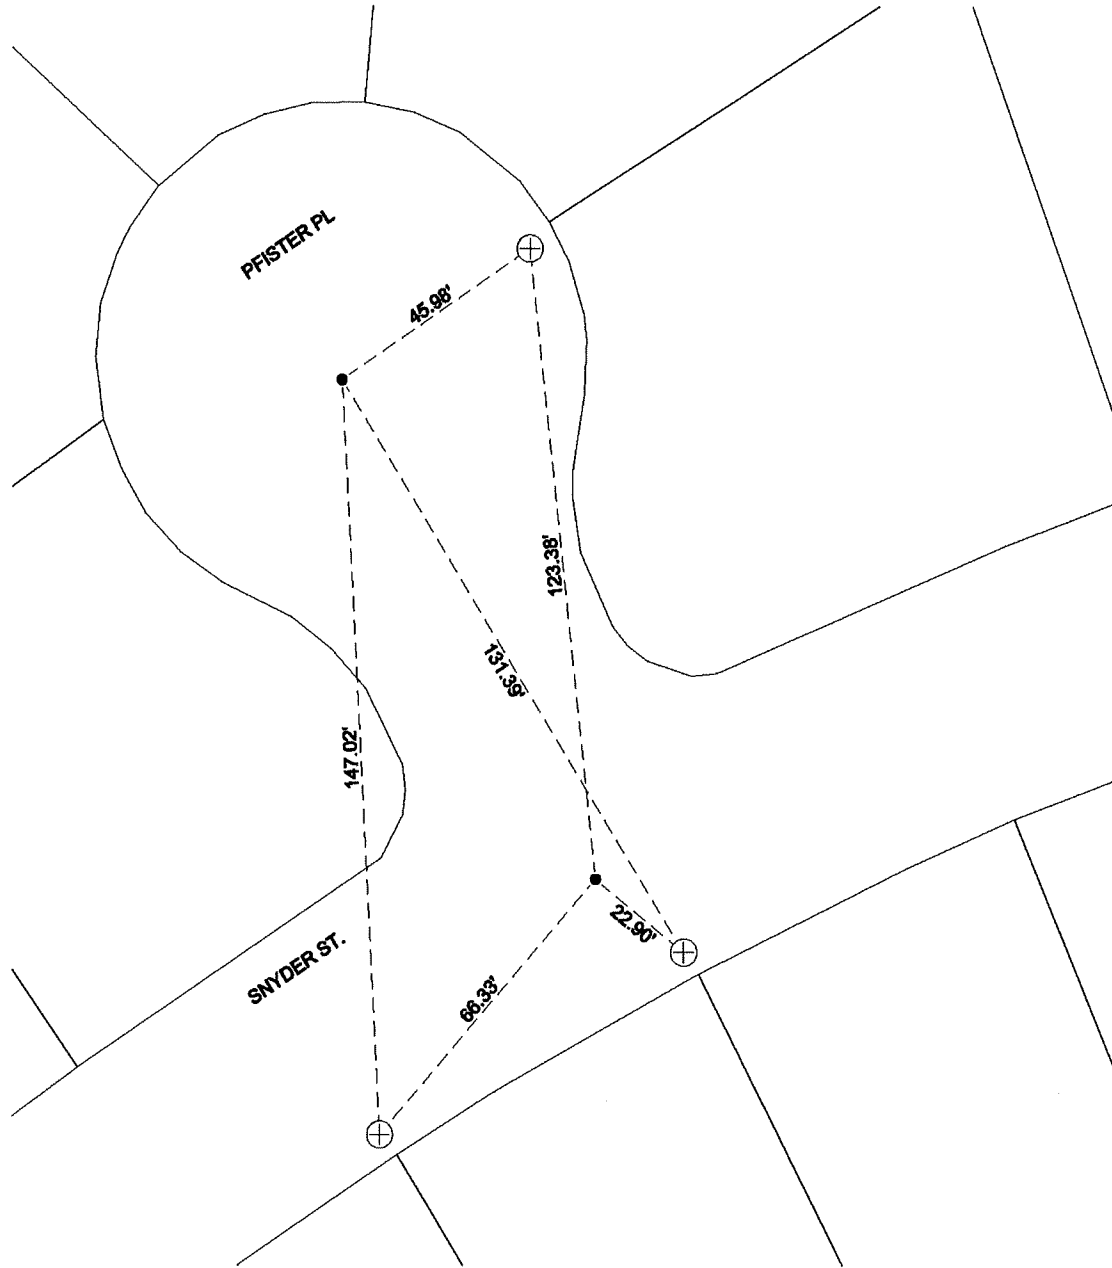
Narrative of corner identified and monument as found, set, reset, replaced, or removed:
 See sheet #2 for description(s):

- FOUND MONUMENT: 3/4" REBAR STAMPED R.C.E. 14269 IN MONUMENT WELL, PER M&P 26-98 UNLESS OTHERWISE NOTED.
 - + SET SAWCUT "+" IN CONCRETE ON TOP OF CURB
 - ⊕ FOUND SAWCUT "+" ON SIDEWALK
- M&P MAP AND PLATS, SAN JOAQUIN COUNTY RECORDS
