CORNER RECORD

Agency Index CR-21-175
Document Number _____

City of Manteca County of San Joaquin, California
Brief Legal Description North half (N 1/2) Section 31, T.1S., R.7E., M.D.B. & M.

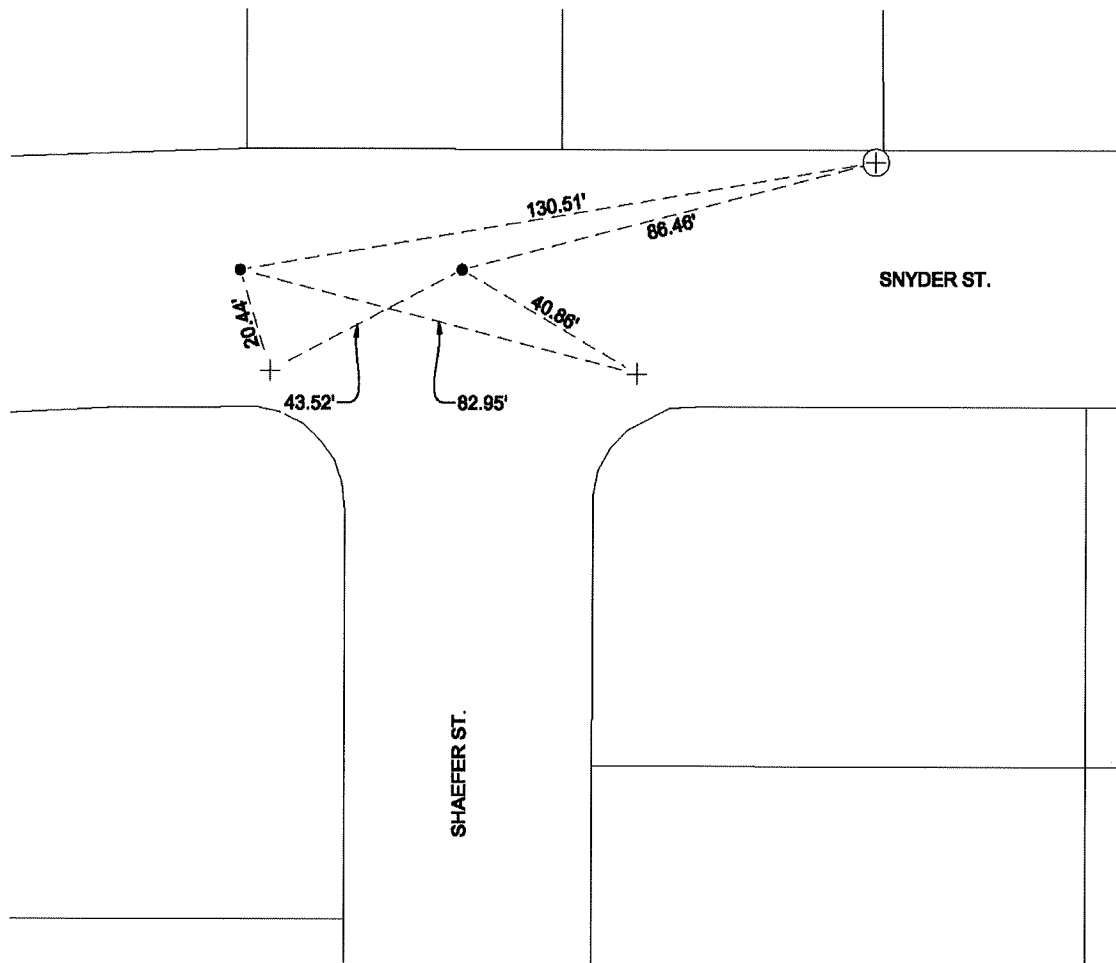
- FOUND MONUMENT: 3/4" REBAR STAMPED R.C.E. 14269 IN MONUMENT WELL, PER M&P 26-88 UNLESS OTHERWISE NOTED.
 - + SET SAWCUT "+" IN CONCRETE ON TOP OF CURB
 - ⊕ FOUND SAWCUT "+" ON SIDEWALK
- M&P MAP AND PLATS, SAN JOAQUIN COUNTY RECORDS
