CORNER RECORD

Agency Index CR-24-177
 Document Number _____

City of Manteca County of San Joaquin, California
 Brief Legal Description North half (N 1/2) Section 31, T.1S., R.7E., M.D.B. & M.

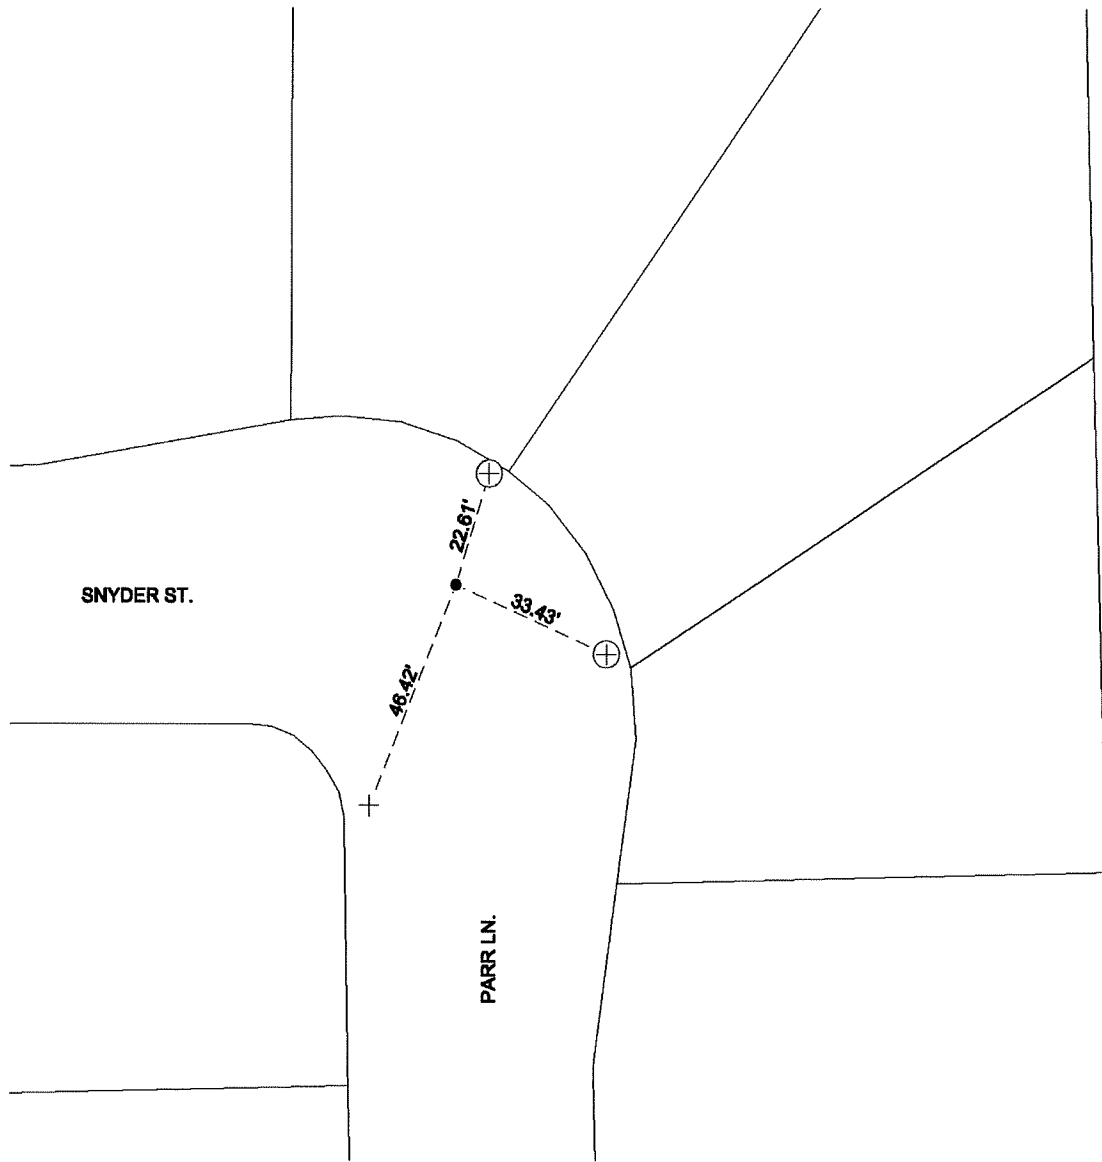
- FOUND MONUMENT: 3/4" REBAR STAMPED R.C.E. 14269 IN MONUMENT WELL, PER M&P 26-88 UNLESS OTHERWISE NOTED.
 - + SET SAWCUT "+" IN CONCRETE ON TOP OF CURB
 - ⊕ FOUND SAWCUT "+" ON SIDEWALK
- M&P MAP AND PLATS, SAN JOAQUIN COUNTY RECORDS

NOT TO SCALE

Narrative of corner identified and monument as found, set, reset, replaced, or removed:
 See sheet #2 for description(s):
