CORNER RECORD

Agency Index CR-21-179
Document Number _____

City of Manteca County of San Joaquin, California
Brief Legal Description North half (N 1/2) Section 31, T.1S., R.7E., M.D.B. & M.

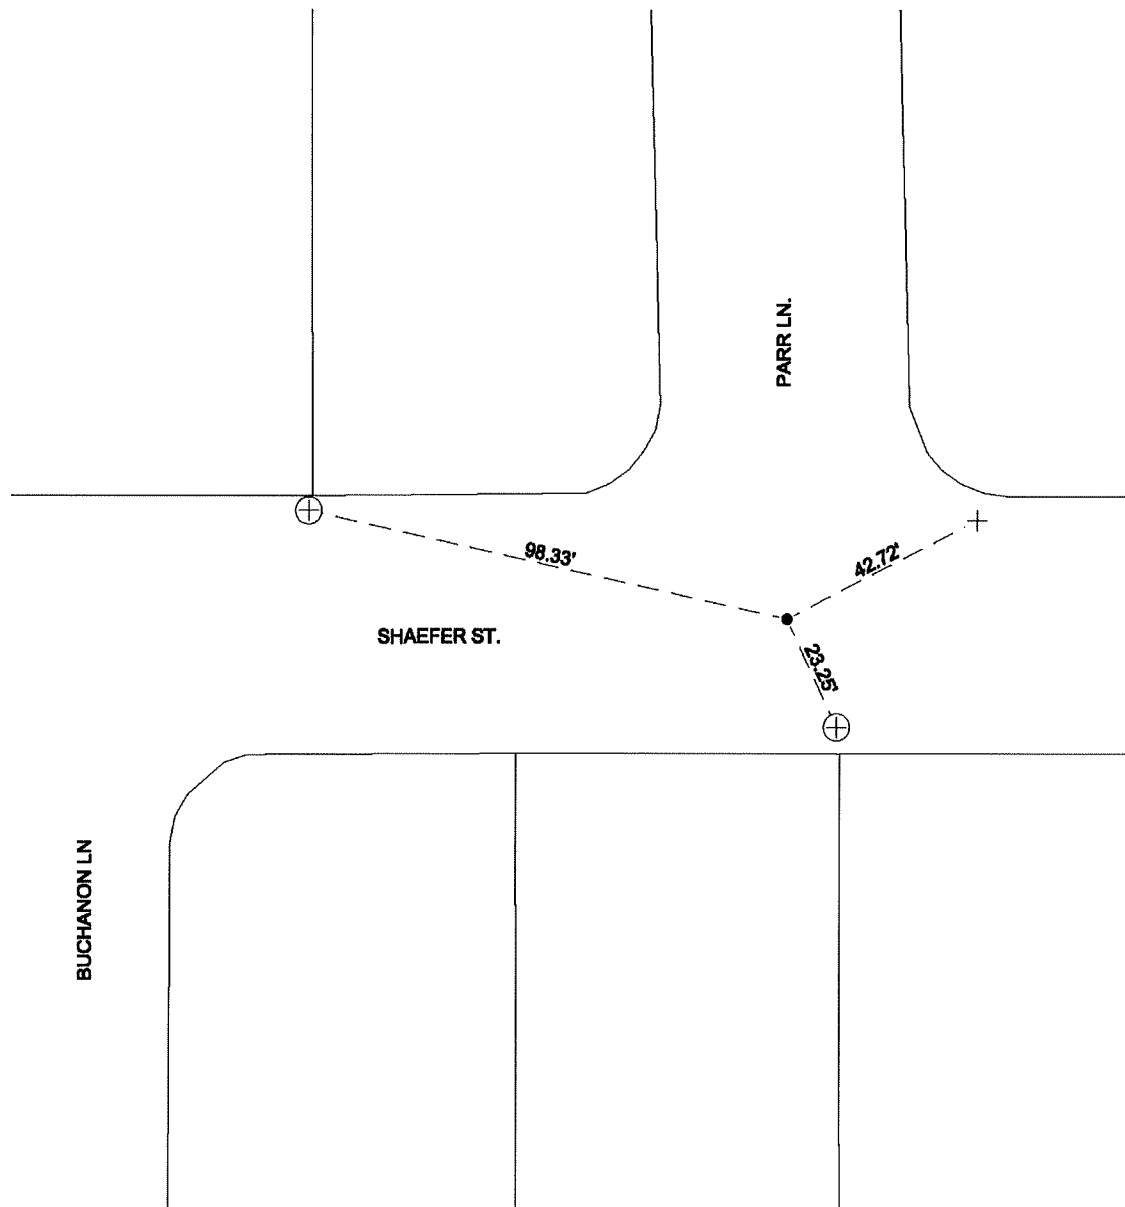
- FOUND MONUMENT: 3/4" REBAR STAMPED R.C.E. 14269 IN MONUMENT WELL, PER M&P 26-97 UNLESS OTHERWISE NOTED.
 - + SET SAWCUT "+" IN CONCRETE ON TOP OF CURB
 - ⊕ FOUND SAWCUT "+" ON SIDEWALK
- M&P MAP AND PLATS, SAN JOAQUIN COUNTY RECORDS
