CORNER RECORD

Agency Index CR-21-180
Document Number _____

City of Manteca County of San Joaquin, California
Brief Legal Description North half (N 1/2) Section 31, T.1S., R.7E., M.D.B. & M.

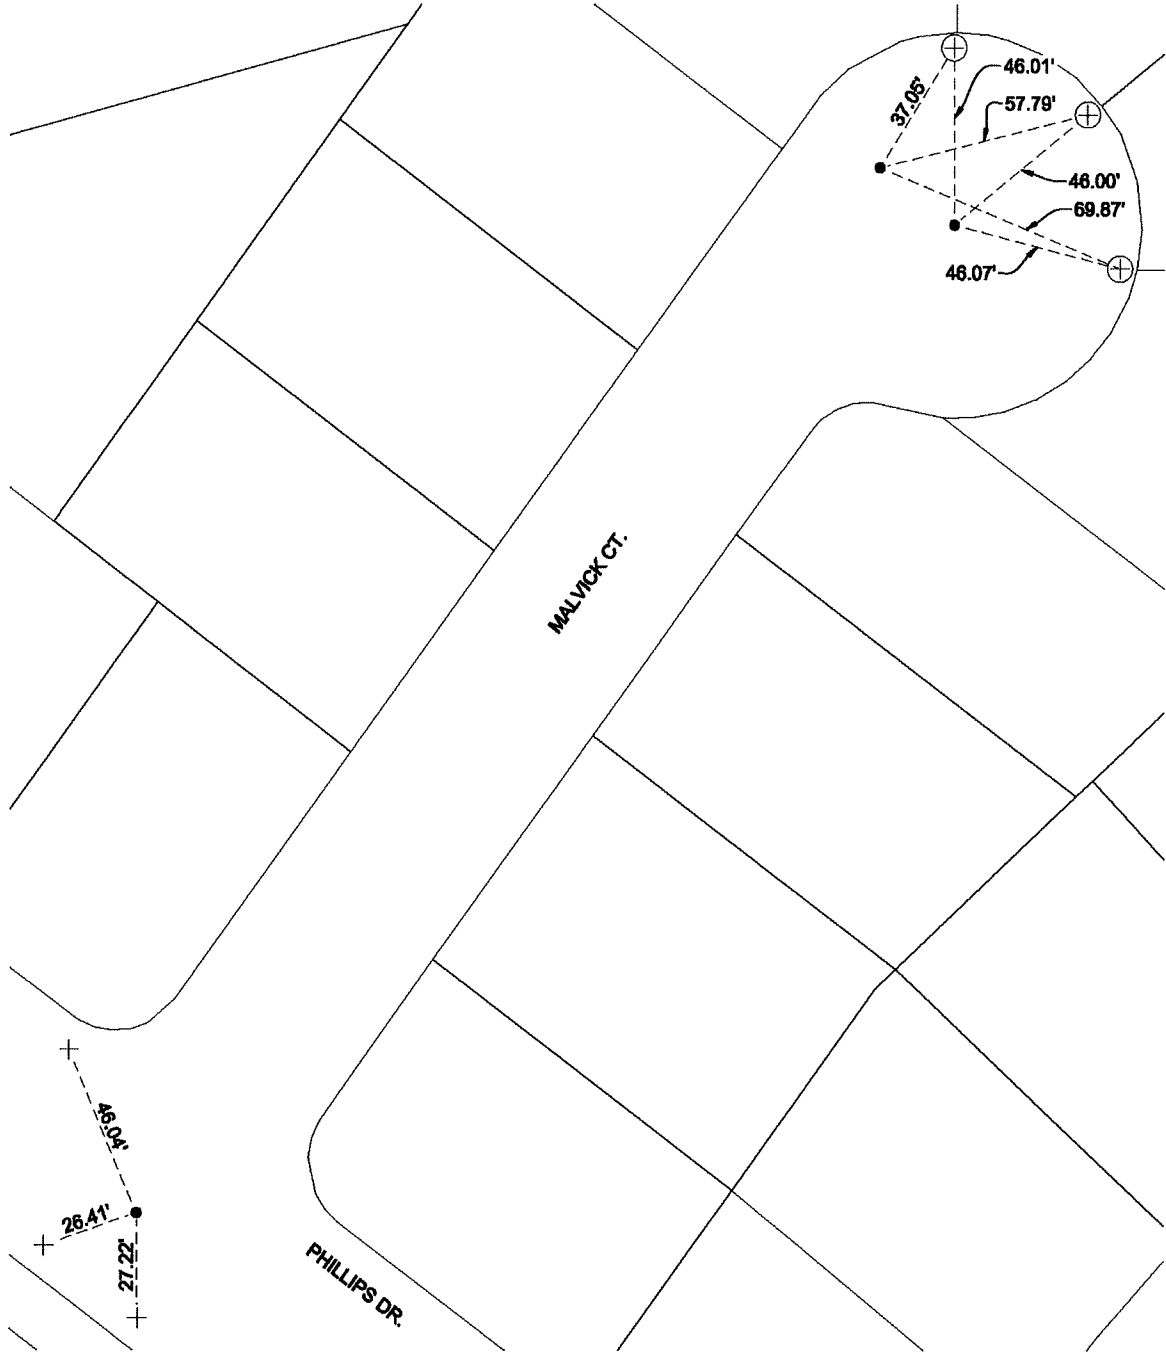
- FOUND MONUMENT: 3/4" REBAR STAMPED R.C.E. 14269 IN MONUMENT WELL, PER M&P 26-98 UNLESS OTHERWISE NOTED.
 - + SET SAWCUT "+" IN CONCRETE ON TOP OF CURB
 - ⊕ FOUND SAWCUT "+" ON SIDEWALK
- M&P MAP AND PLATS, SAN JOAQUIN COUNTY RECORDS

Narrative of corner identified and monument as found, set, reset, replaced, or removed:
 See sheet #2 for description(s):
