CORNER RECORD

Agency Index CR-21-181
Document Number _____

City of Manteca County of San Joaquin, California
Brief Legal Description North half (N 1/2) Section 31, T.1S., R.7E., M.D.B. & M.

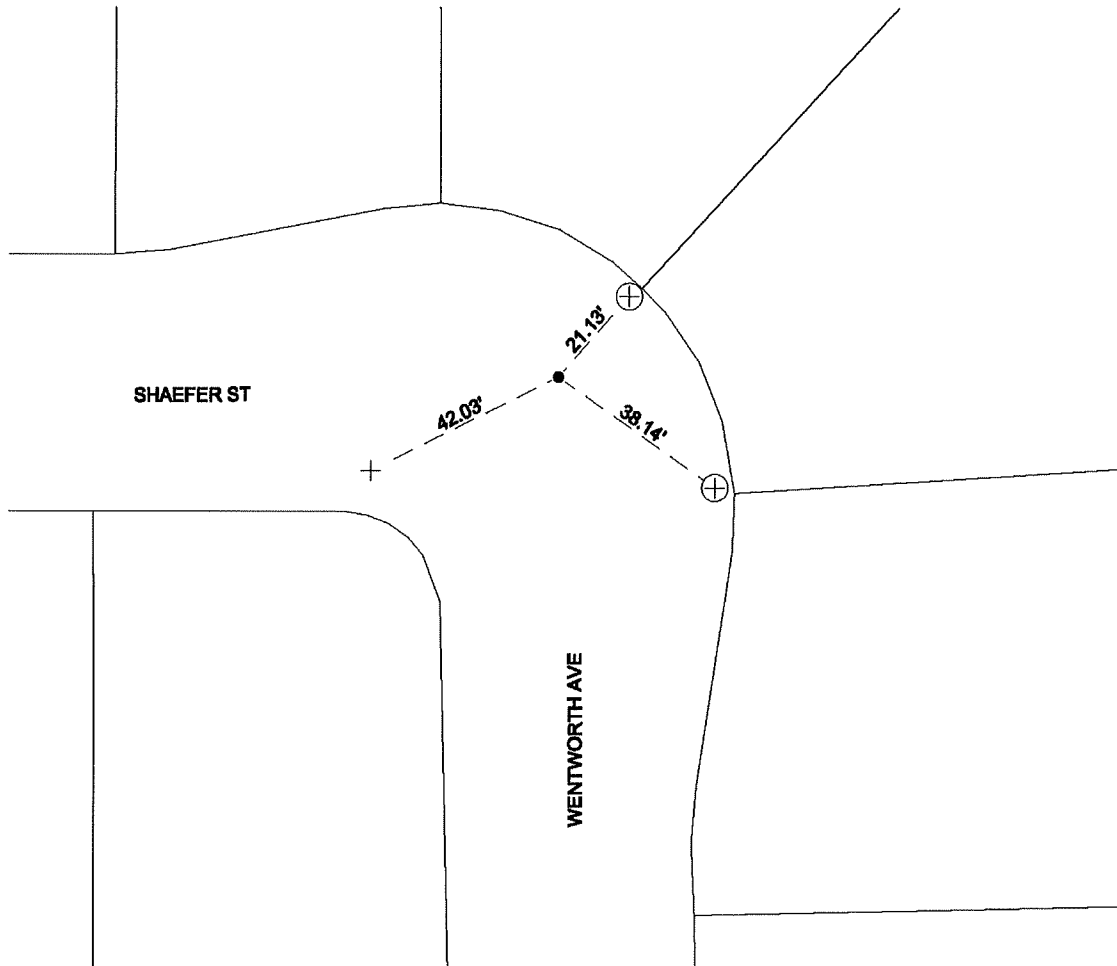
- FOUND MONUMENT: 3/4" REBAR STAMPED R.C.E. 14269 IN MONUMENT WELL, PER M&P 28-97 UNLESS OTHERWISE NOTED.
 - + SET SAWCUT "+" IN CONCRETE ON TOP OF CURB
 - ⊕ FOUND SAWCUT "+" ON SIDEWALK
- M&P MAP AND PLATS, SAN JOAQUIN COUNTY RECORDS
