CORNER RECORD

Agency Index CR-21-182
Document Number _____

City of Manteca County of San Joaquin, California
Brief Legal Description North half (N 1/2) Section 31, T.1S., R.7E., M.D.B. & M.

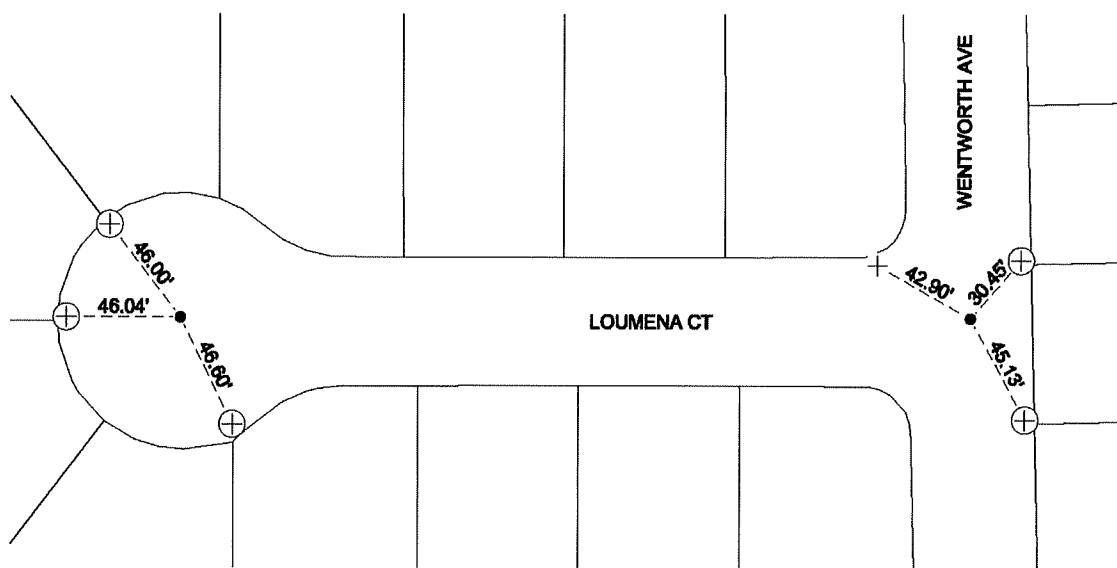
- FOUND MONUMENT: 3/4" REBAR STAMPED R.C.E. 14269 IN MONUMENT WELL, PER M&P 26-97 UNLESS OTHERWISE NOTED.
 - + SET SAWCUT "+" IN CONCRETE ON TOP OF CURB
 - ⊕ FOUND SAWCUT "+" ON SIDEWALK
- M&P MAP AND PLATS, SAN JOAQUIN COUNTY RECORDS
