# CORNER RECORD

Agency Index CR-21-183  
Document Number \_\_\_\_\_

City of Manteca County of San Joaquin, California  
Brief Legal Description North half (N 1/2) Section 31, T.1S., R.7E., M.D.B. & M.

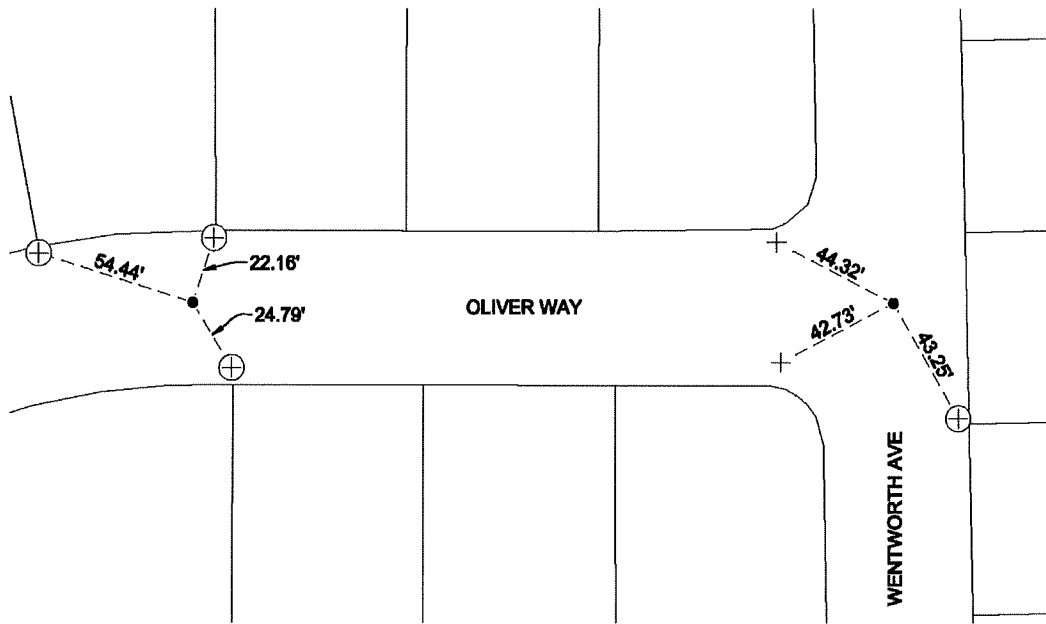
- FOUND MONUMENT: 3/4" REBAR STAMPED R.C.E. 14269 IN MONUMENT WELL, PER M&P 26-97 UNLESS OTHERWISE NOTED.
  - + SET SAWCUT "+" IN CONCRETE ON TOP OF CURB
  - ⊕ FOUND SAWCUT "+" ON SIDEWALK
- M&P MAP AND PLATS, SAN JOAQUIN COUNTY RECORDS
