CORNER RECORD

Agency Index CR-21-184
Document Number _____

City of Manteca County of San Joaquin, California
Brief Legal Description North half (N 1/2) Section 31, T.1S., R.7E., M.D.B. & M.

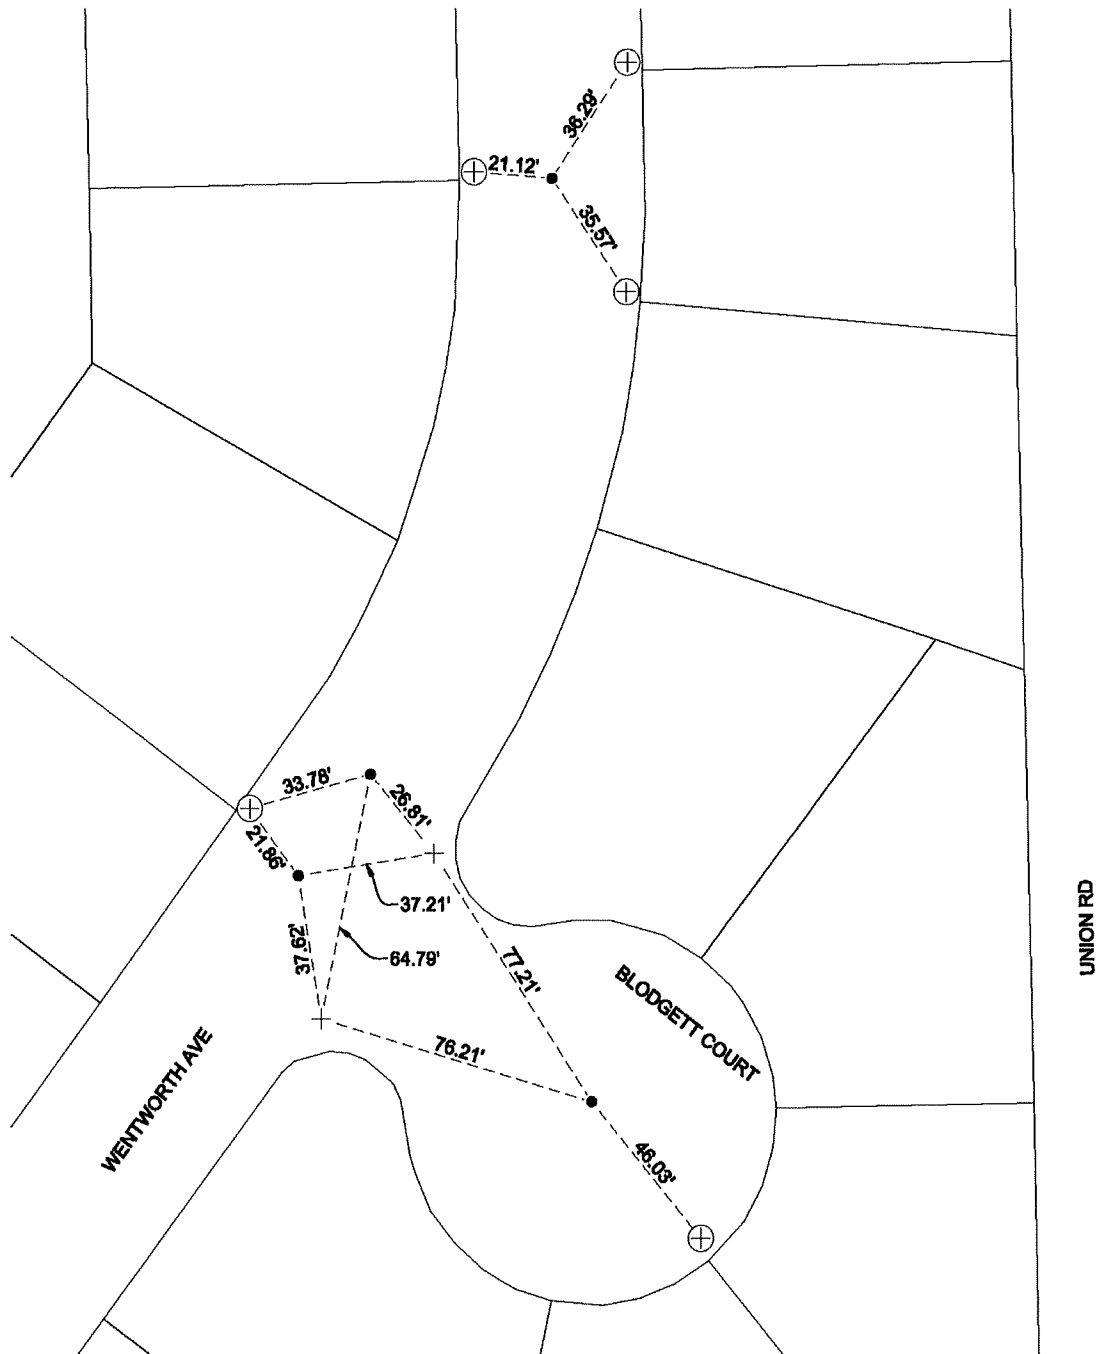
Narrative of corner identified and monument as found, set, reset, replaced, or removed:
 See sheet #2 for description(s):

- FOUND MONUMENT: 3/4" REBAR STAMPED R.C.E. 14269 IN MONUMENT WELL, PER M&P 26-97 UNLESS OTHERWISE NOTED.
 - + SET SAWCUT "+" IN CONCRETE ON TOP OF CURB
 - ⊕ FOUND SAWCUT "+" ON SIDEWALK
- M&P MAP AND PLATS, SAN JOAQUIN COUNTY RECORDS

NOT TO SCALE
