CORNER RECORD

Agency Index CR-21-186
Document Number _____

City of Manteca County of San Joaquin, California
Brief Legal Description North half (N 1/2) Section 31, T.1S., R.7E., M.D.B. & M.

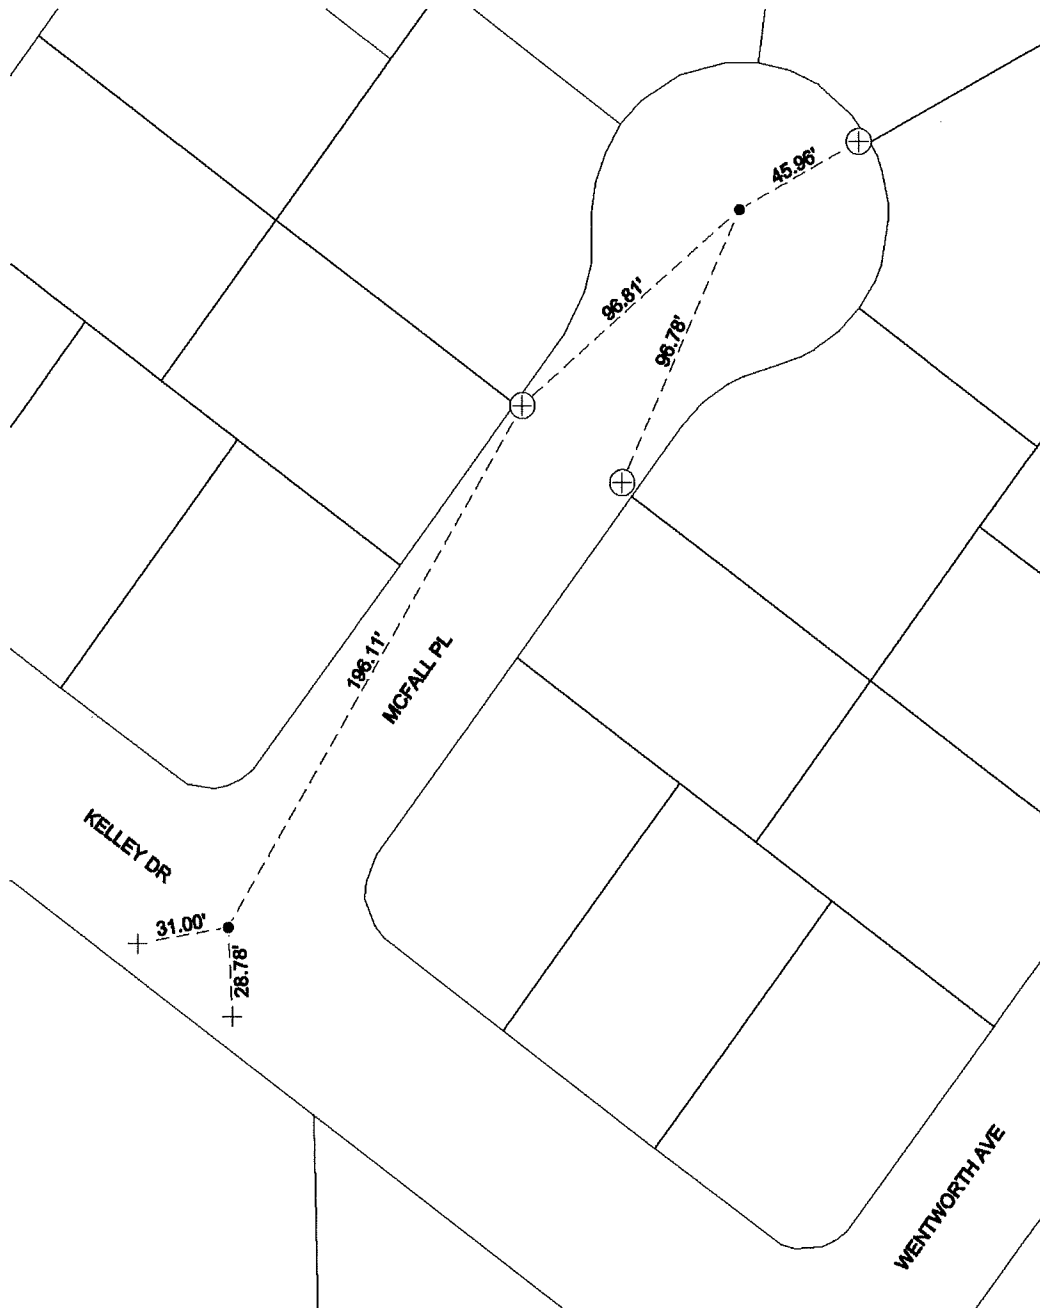
- FOUND MONUMENT: 3/4" REBAR STAMPED R.C.E. 14269 IN MONUMENT WELL, PER M&P 26-97 UNLESS OTHERWISE NOTED.
- + SET SAWCUT "+" IN CONCRETE ON TOP OF CURB
- ⊕ FOUND SAWCUT "+" ON SIDEWALK
- M&P MAP AND PLATS, SAN JOAQUIN COUNTY RECORDS
