CORNER RECORD

Agency Index CR-21-189
 Document Number _____

City of Manteca County of San Joaquin, California
 Brief Legal Description North half (N 1/2) Section 31, T.1S., R.7E., M.D.B. & M.

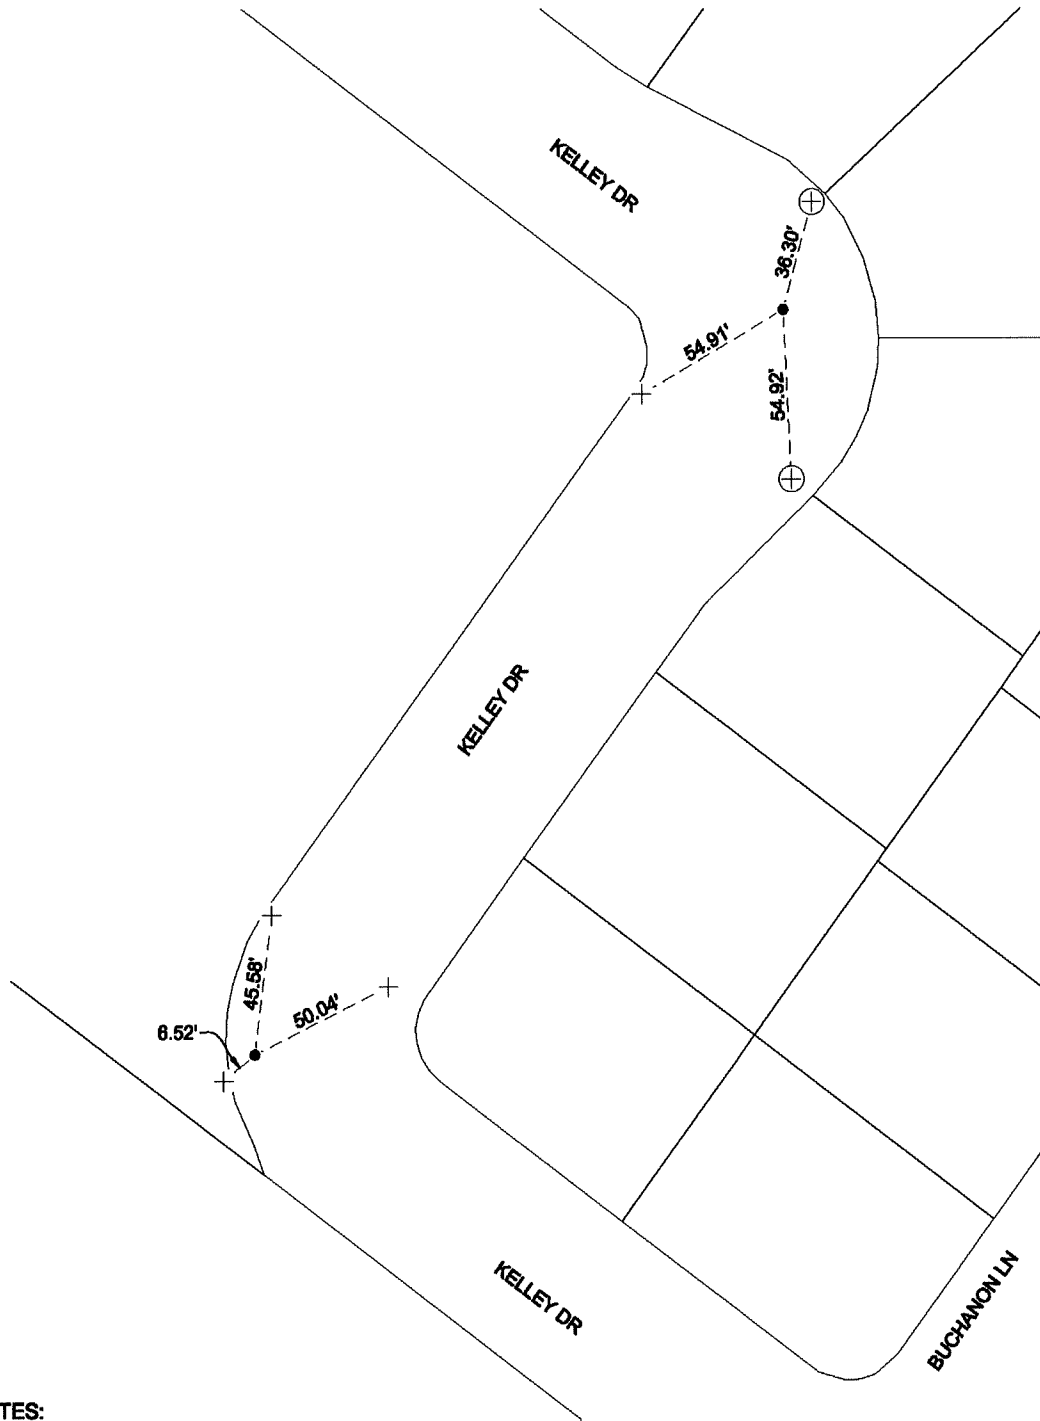
- FOUND MONUMENT: 3/4" REBAR STAMPED R.C.E. 14269 IN MONUMENT WELL, PER M&P 26-97 UNLESS OTHERWISE NOTED.
- + SET SAWCUT "+" IN CONCRETE ON TOP OF CURB
- ⊕ FOUND SAWCUT "+" ON SIDEWALK
- M&P MAP AND PLATS, SAN JOAQUIN COUNTY RECORDS
