CR-21-227 CORNER RECORD Agency Index: Document Number: County of _____SAN_JOAQUIN STOCKTON Brief Legal Description FOUND MONUMENT ON CHAUNCY CIRCLE COORDINATES (Optional) CORNER TYPE Government Corner Control Elevation Meander Property ☐ Metric U.S. Survey Foot Units Rancho · ○ Other Horizontal Datum Zone _____ Epoch Date _ 09-27-2021 Date of Survey Vertical Datum T.2N, R.6E Complies with Public Resources Code SS8801-8819 Complies with Public Resources Code SS8890-8902 Other: 8771 8773 8765(d) PLS Act Ref: □ Pre − Construction Established Rebuilt Corner/ Left as found Post-Construction □ Referenced Reestablished Found and Tagged Monument: Narrative of corner identified and monument as found, set, reset, replaced, or removed: See sheet #2 for description(s): FOUND ONE (1) CHISELED CROSS ON THE WEST SIDE OF CHAUNCY CIRCLE WITH NO REFERENCE. SET THREE (3) CONCRETE NAILS WITH BRASS TAG "L.S. 6953" AS WITNESS CORNERS, ALL AS SHOWN ON PAGE 2. SURVEYOR'S STATEMENT This Corner Record was prepared by me or under my direction in conformance with KENT A. HYSELL the Land Surveyors' Act on _____OCTOBER_1 ND, 6953 P.L.S. or R.C.E. Number 6953 COUNTY SURVEYOR'S STATEMENT This Corner Record was re

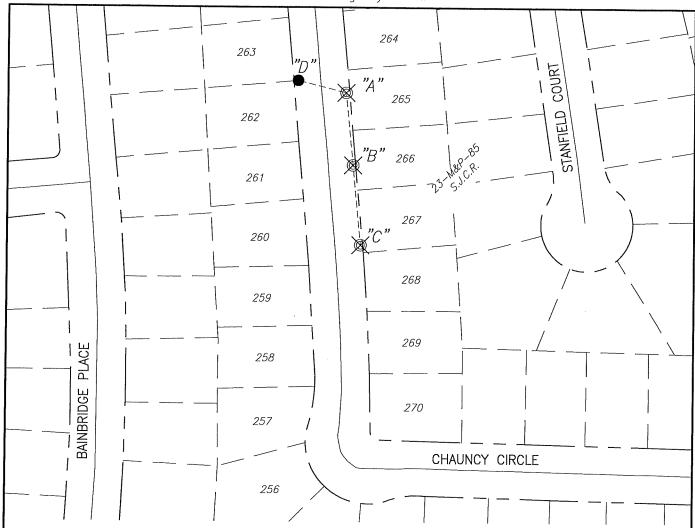
Ҳ AND DISTANCE TABLE		
BS-@-FS	4	FS DISTANCE
C-A-B	00'00'00"	79.32'(M)
C-A-C	00'00'00"	166.51'(M)
C-A-D	109'08'15"	49.64'(M)
