# CORNER RECORD

Agency Index CR-21-236

City of Lodi County of San Joaquin, California

Brief Legal Description Property monuments at Church Street & Locust Street, Section 1, T3N, R6E

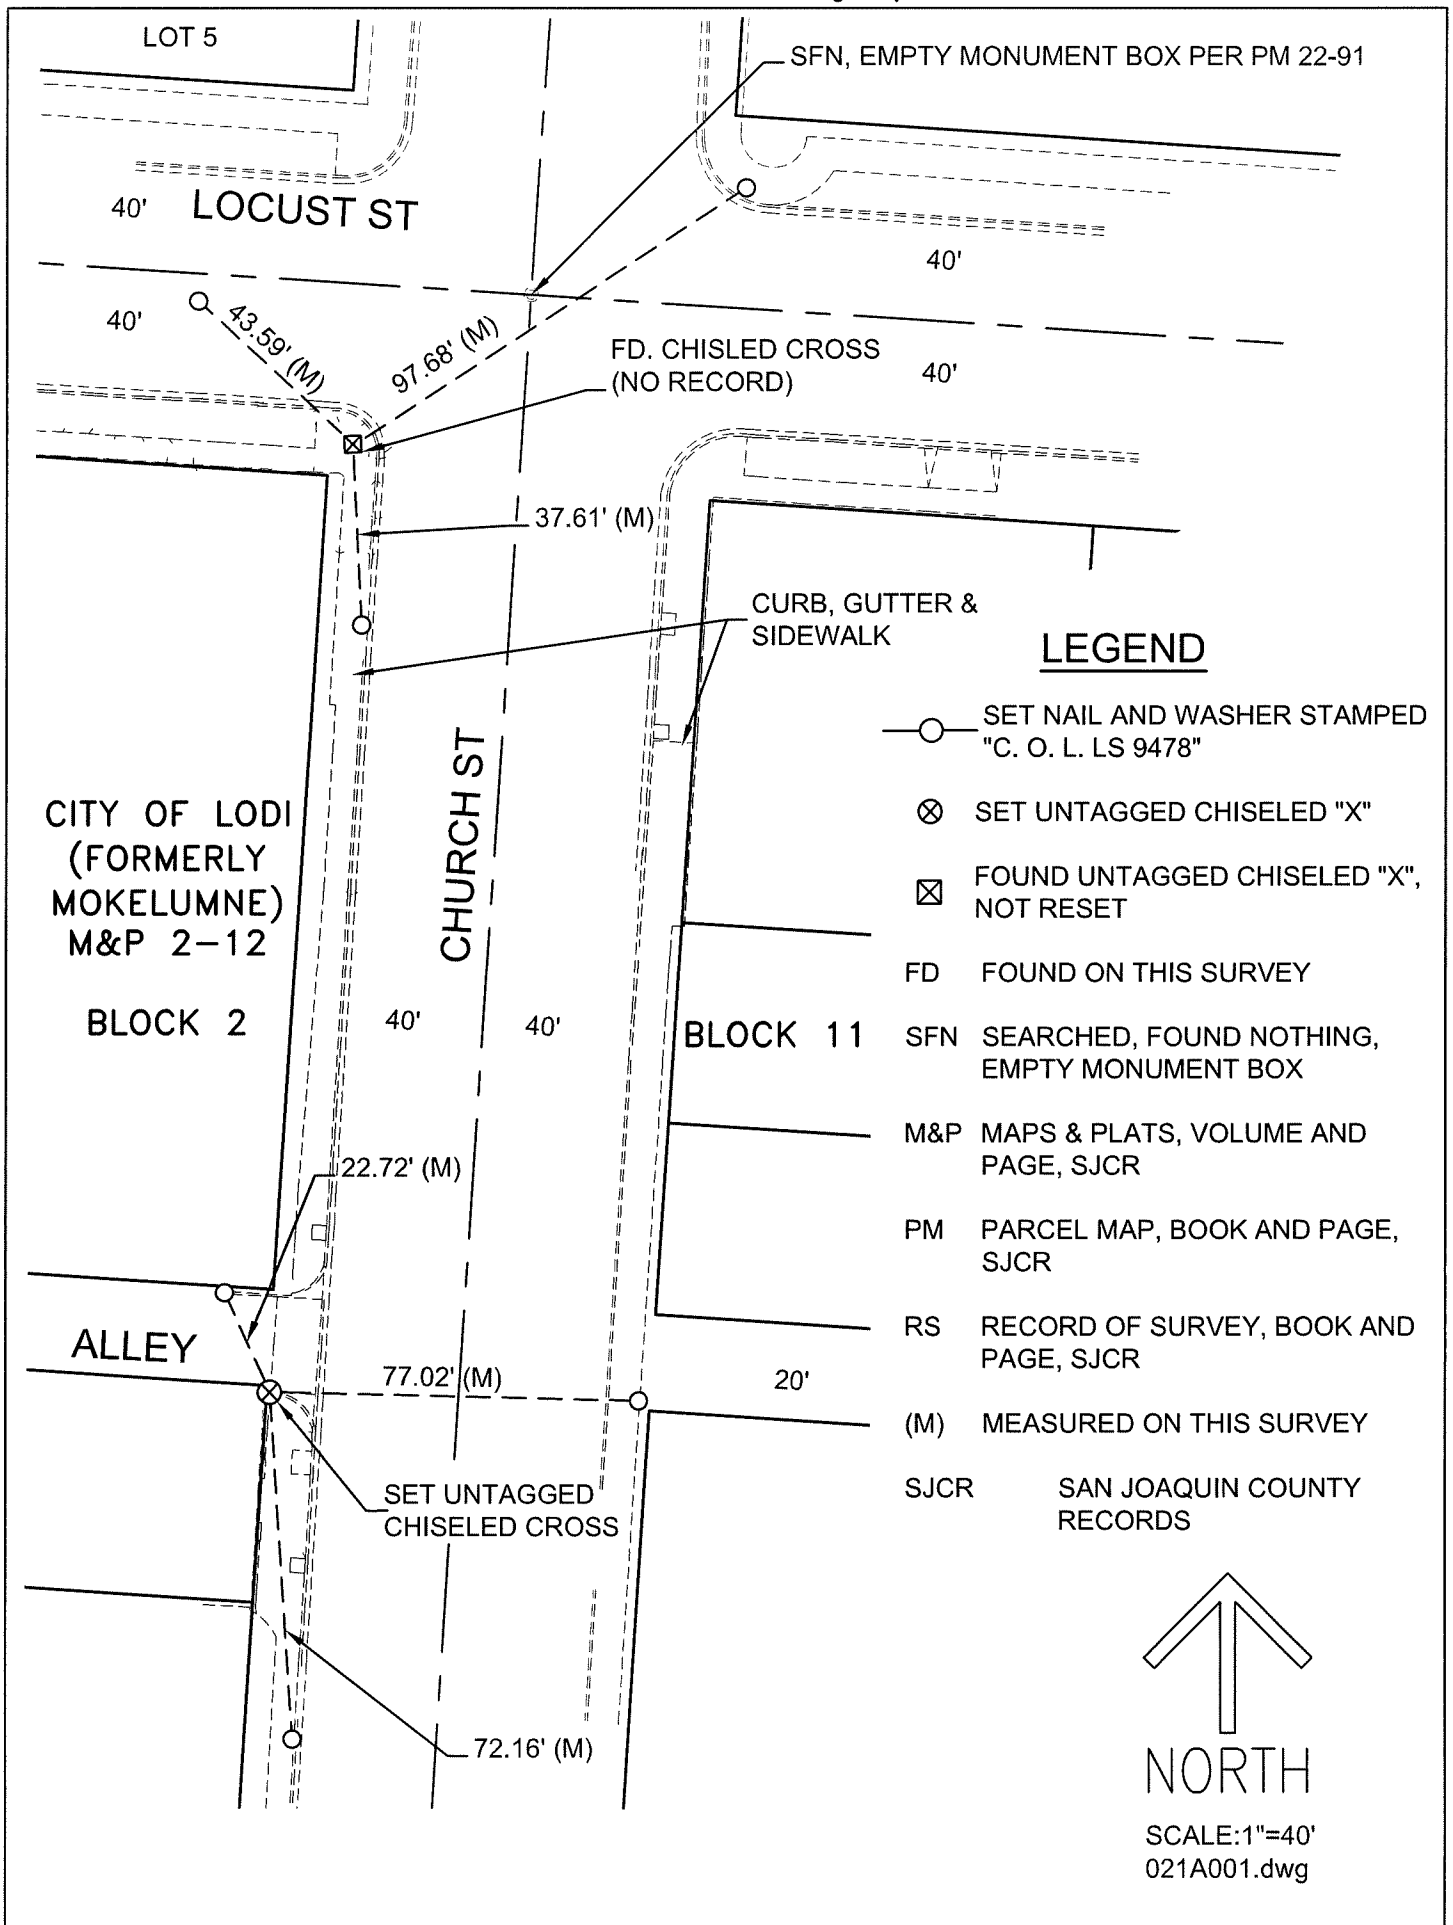
FOUND 5/8" IRON ROD PER RS 34-154 AT CHURCH STREET & ALLEY SOUTH OF LOCUST STREET. FOUND CHISELED CROSS AT CHURCH STREET & LOCUST STREET (NO RECORD). RESET UNTAGGED CHISELED CROSS AT ORIGINAL LOCATION PER RS 34-154. DID NOT RESET CHISELED CROSS OF NO RECORD AT CHURCH STREET AND LOCUST STREET. NO BOUNDARY ANALYSIS WAS PERFORMED.
