CORNER RECORD

Agency Index CR-22-053
Document Number _____

City of Manteca County of San Joaquin, California
Brief Legal Description North half (N 1/2) Section 31, T.1S., R.7E., M.D.B. & M.

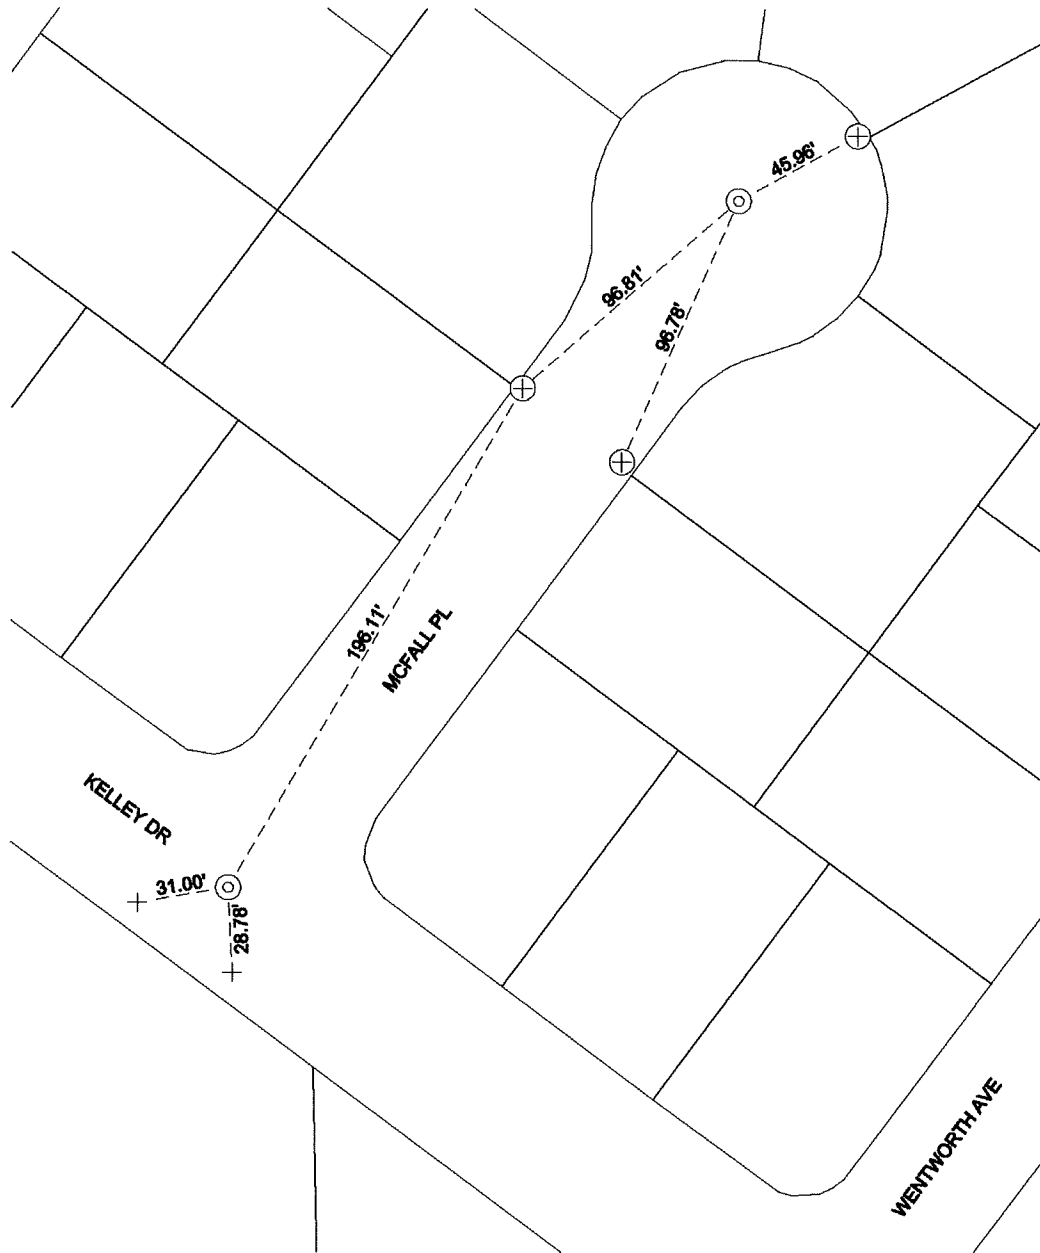
- ⊙ SET MONUMENT: 3/4" X 24" IRON PIPE STAMPED L.S. #8159 WITH PLASTIC CAP IN MONUMENT WELL.
- + FOUND SAWCUT "+" IN CONCRETE ON TOP OF CURB PER CR 21-186
- ⊕ FOUND SAWCUT "+" ON SIDEWALK PER CR 21-186
- CR CORNER RECORD, SAN JOAQUIN COUNTY SURVEYOR'S RECORDS
