CORNER RECORD

Agency Index CR-22-054
Document Number _____

City of Manteca County of San Joaquin, California
Brief Legal Description North half (N 1/2) Section 31, T.1S., R.7E., M.D.B. & M.

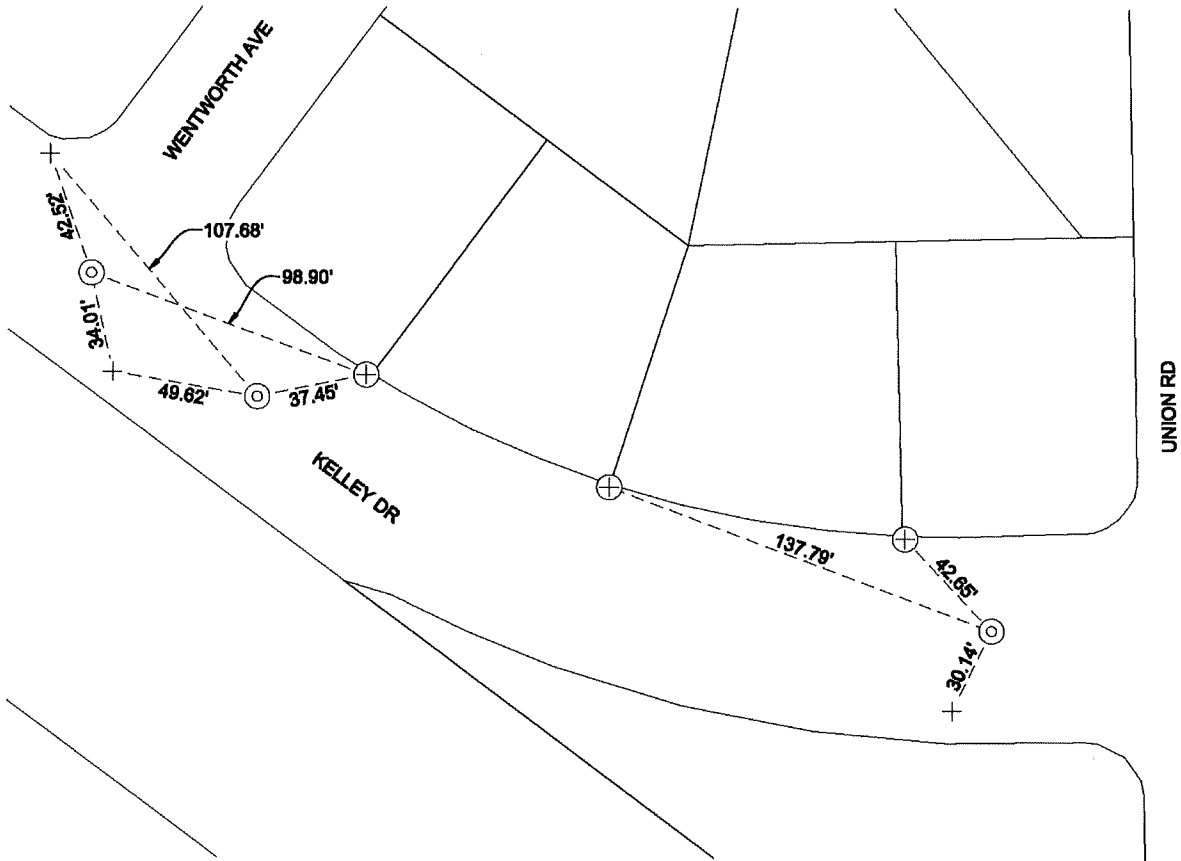
- ⊙ SET MONUMENT: 3/4" X 24" IRON PIPE STAMPED L.S. #8159 WITH PLASTIC CAP IN MONUMENT WELL.
- + FOUND SAWCUT "+" IN CONCRETE ON TOP OF CURB PER CR 21-185
- ⊕ FOUND SAWCUT "+" ON SIDEWALK PER CR 21-185
- CR CORNER RECORD, SAN JOAQUIN COUNTY SURVEYOR'S RECORDS
