CORNER RECORD

Agency Index CR-22-057
Document Number _____

City of Manteca County of San Joaquin, California
Brief Legal Description North half (N 1/2) Section 31, T.1S., R.7E., M.D.B. & M.

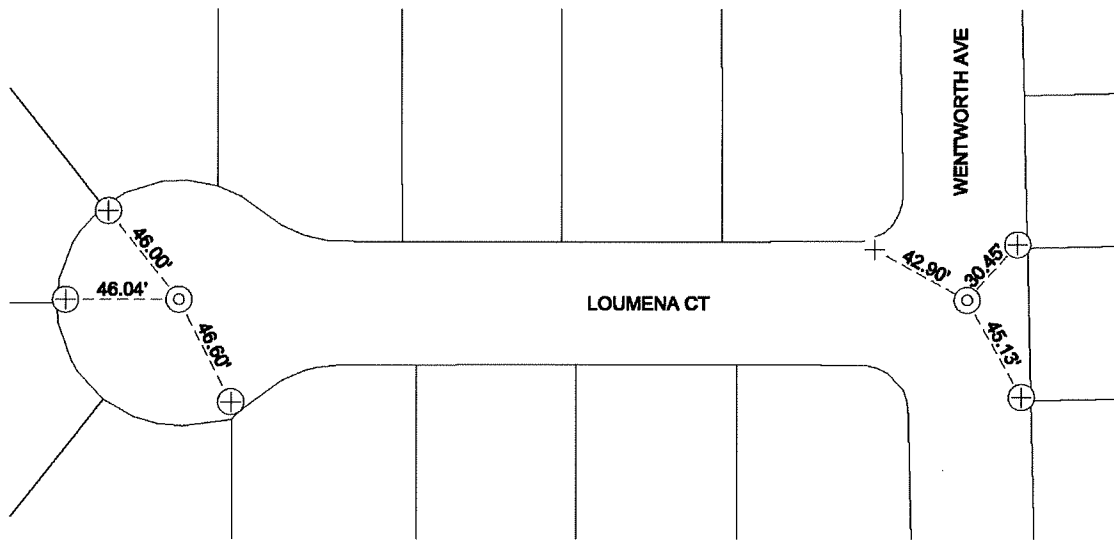
- ⊙ SET MONUMENT: 3/4" X 24" IRON PIPE STAMPED L.S. #8159 WITH PLASTIC CAP IN MONUMENT WELL.
- + FOUND SAWCUT "+" IN CONCRETE ON TOP OF CURB PER CR 21-182
- ⊕ FOUND SAWCUT "+" ON SIDEWALK PER CR 21-182
- CR CORNER RECORD, SAN JOAQUIN COUNTY SURVEYOR'S RECORDS
