CORNER RECORD Agency Index Document Number County of San Joaquin Manteca North half (N 1/2) Section 31, T.1S., R.7E., M.D.B.& M. Brief Legal Description **CORNER TYPE COORDINATES (Optional) Government Corner** Control Elevation X U.S. Survey Foot Meander Property Units Metric Other Rancho **Horizontal Datum** Epoch Date Zone Date of Survey November 19, 2021 Vertical Datum Complies with Public Resources Code §§8801-8819 Complies with Public Resources Code §§8890-8902 **X** 8771 PLS Act Ref.: 8765(d) Other: Established Pre-Construction Left as found Rebuilt Corner/ **Monument:** Reestablished Referenced Post-Construction Found and tagged Narrative of corner identified and monument as found, set, reset, replaced, or removed: See sheet #2 for description(s): SURVEYOR'S STATEMENT This Corner Record was prepared by me or under my direction in conformance with the Professional Land Surveyors Act on January 11, 2022 Signed **COUNTY SURVEYOR'S STATEMENT**

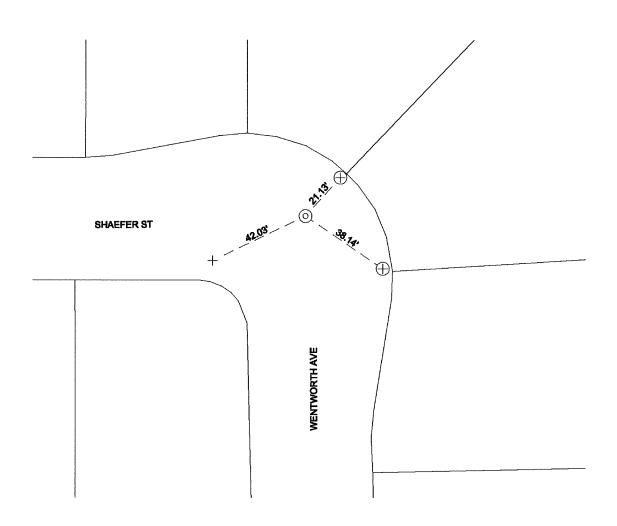
- SET MONUMENT: 3/4" X 24" IRON PIPE STAMPED L.S. #8159 WITH PLASTIC CAP IN MONUMENT WELL.
- + FOUND SAWCUT "+" IN CONCRETE ON TOP OF CURB PER CR 21-181
- → FOUND SAWCUT "+" ON SIDEWALK PER CR 21-181
- CR CORNER RECORD, SAN JOAQUIN COUNTY SURVEYOR'S RECORDS
