CORNER RECORD

Agency Index CR-22-062

City of Manteca County of San Joaquin, CaliforniaBrief Legal Description North half (N 1/2) Section 31, T.1S., R.7E., M.D.B.& M.**CORNER TYPE****COORDINATES (Optional)**

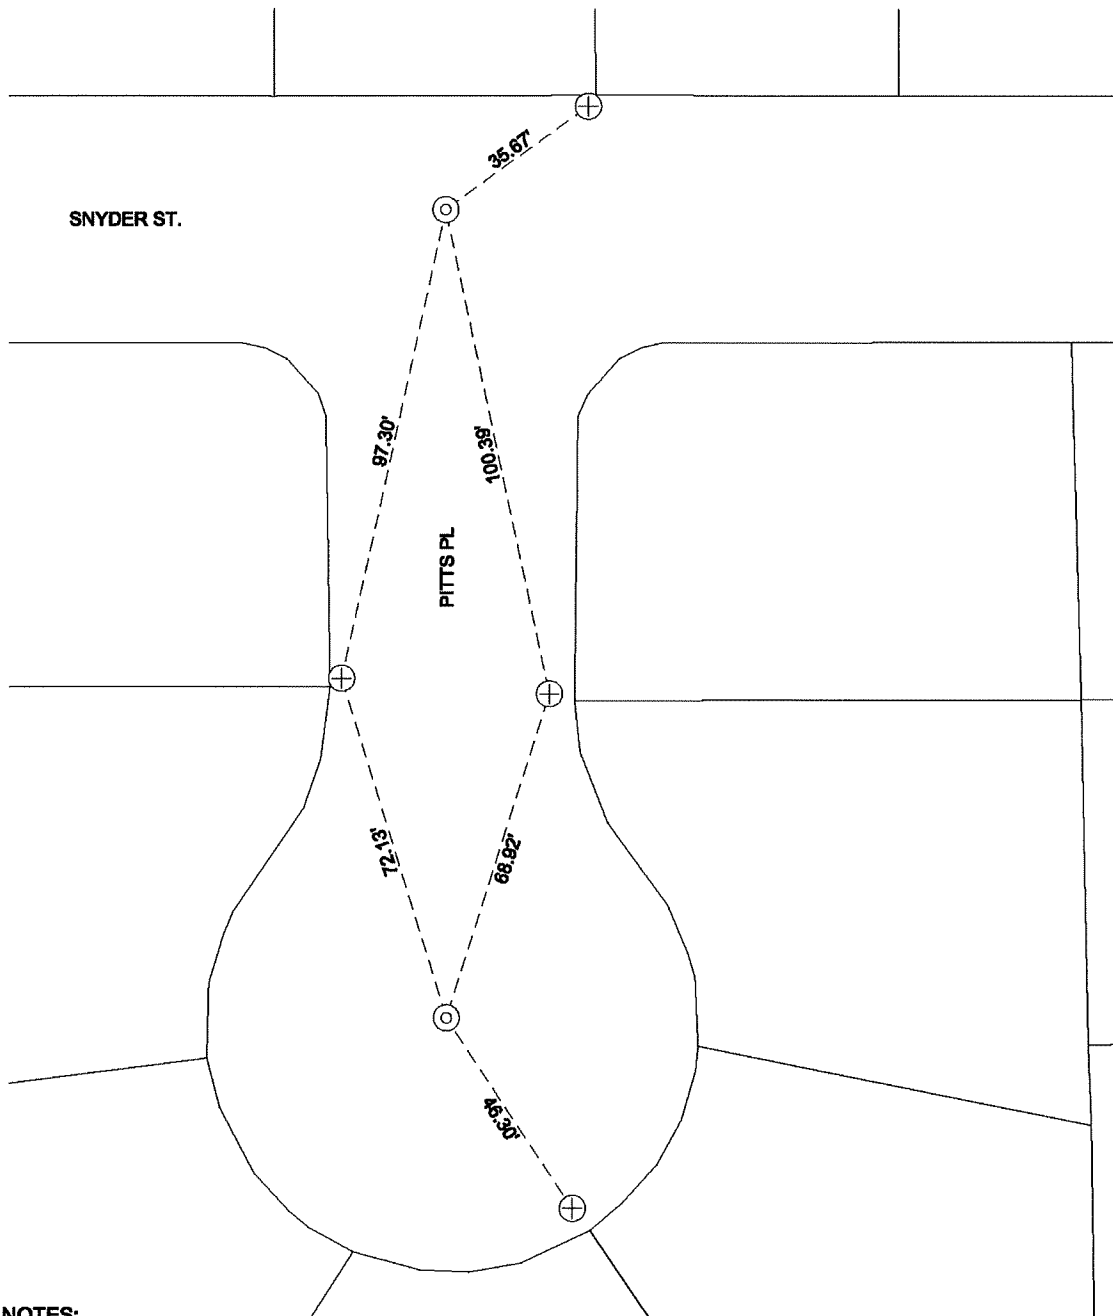
- ⊙ SET MONUMENT: 3/4" X 24" IRON PIPE STAMPED L.S. #8159 WITH PLASTIC CAP IN MONUMENT WELL.
- + FOUND SAWCUT "+" IN CONCRETE ON TOP OF CURB PER CR 21-176
- ⊕ FOUND SAWCUT "+" ON SIDEWALK PER CR 21-176
- CR CORNER RECORD, SAN JOAQUIN COUNTY SURVEYOR'S RECORDS
