CORNER RECORD

Agency Index CR-22-064
Document Number _____

City of Manteca County of San Joaquin, California
Brief Legal Description North half (N 1/2) Section 31, T.1S., R.7E., M.D.B. & M.

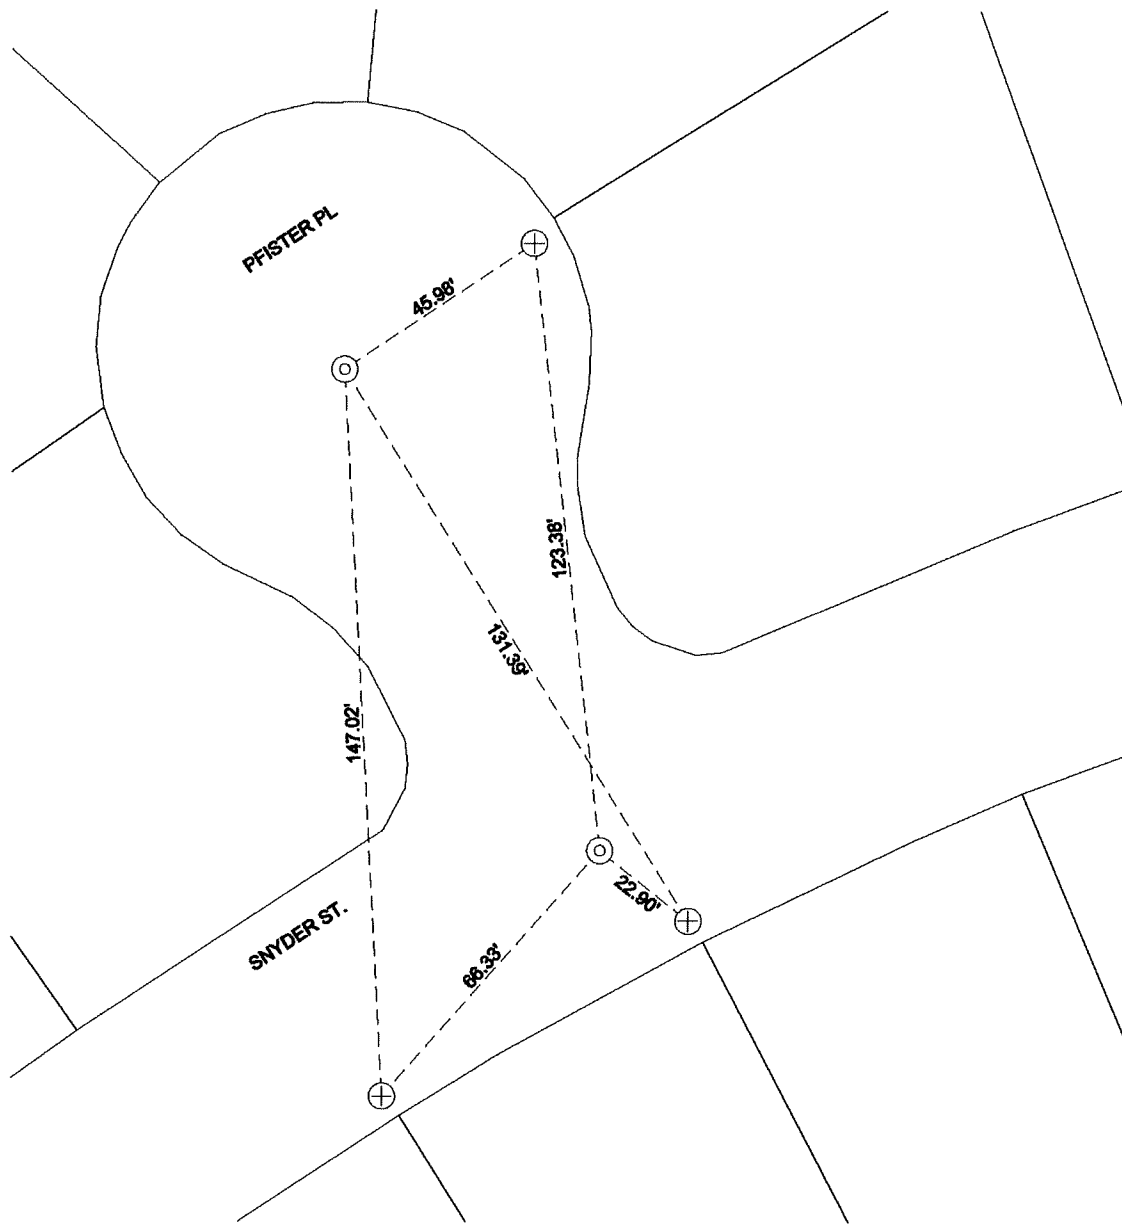
- ⊙ SET MONUMENT: 3/4" X 24" IRON PIPE STAMPED L.S. #8159 WITH PLASTIC CAP IN MONUMENT WELL.
- + FOUND SAWCUT "+" IN CONCRETE ON TOP OF CURB PER CR 21-174
- ⊕ FOUND SAWCUT "+" ON SIDEWALK PER CR 21-174
- CR CORNER RECORD, SAN JOAQUIN COUNTY SURVEYOR'S RECORDS
