CORNER RECORD

Agency Index CR-22-065
Document Number _____

City of Manteca County of San Joaquin, California
Brief Legal Description North half (N 1/2) Section 31, T.1S., R.7E., M.D.B. & M.

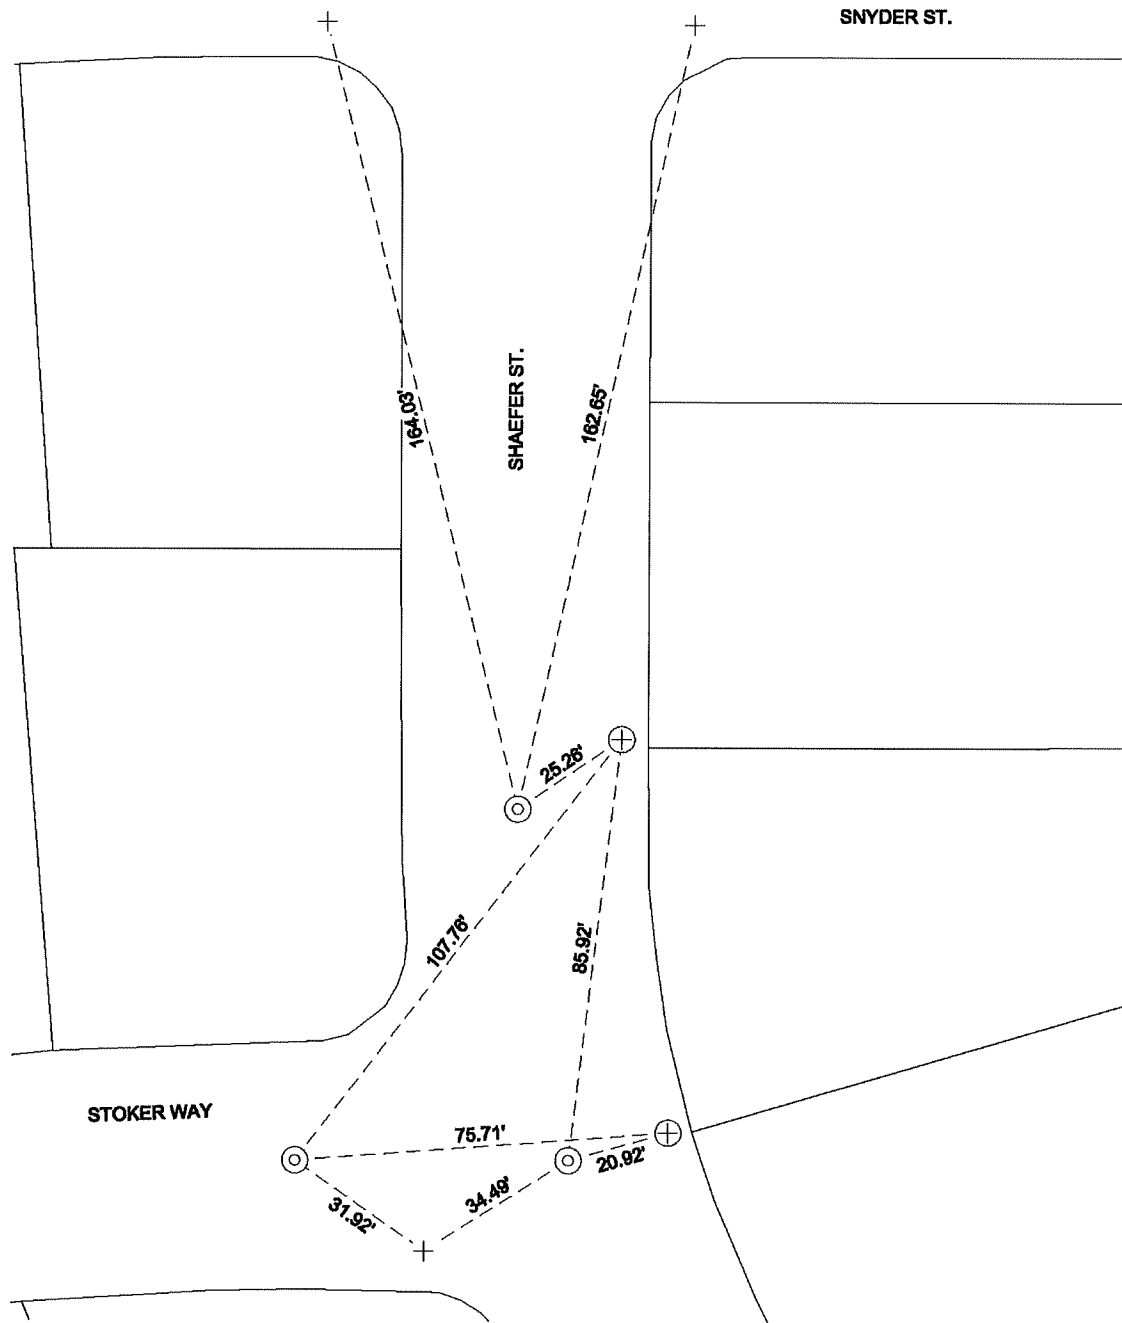
- ⊙ SET MONUMENT: 3/4" X 24" IRON PIPE STAMPED L.S. #8159 WITH PLASTIC CAP IN MONUMENT WELL.
- + FOUND SAWCUT "+" IN CONCRETE ON TOP OF CURB PER CR 21-173
- ⊕ FOUND SAWCUT "+" ON SIDEWALK PER CR 21-173
- CR CORNER RECORD, SAN JOAQUIN COUNTY SURVEYOR'S RECORDS
