CORNER RECORD

Agency Index CR-22-066
Document Number _____

City of Manteca County of San Joaquin, California
Brief Legal Description North half (N 1/2) Section 31, T.1S., R.7E., M.D.B.& M.

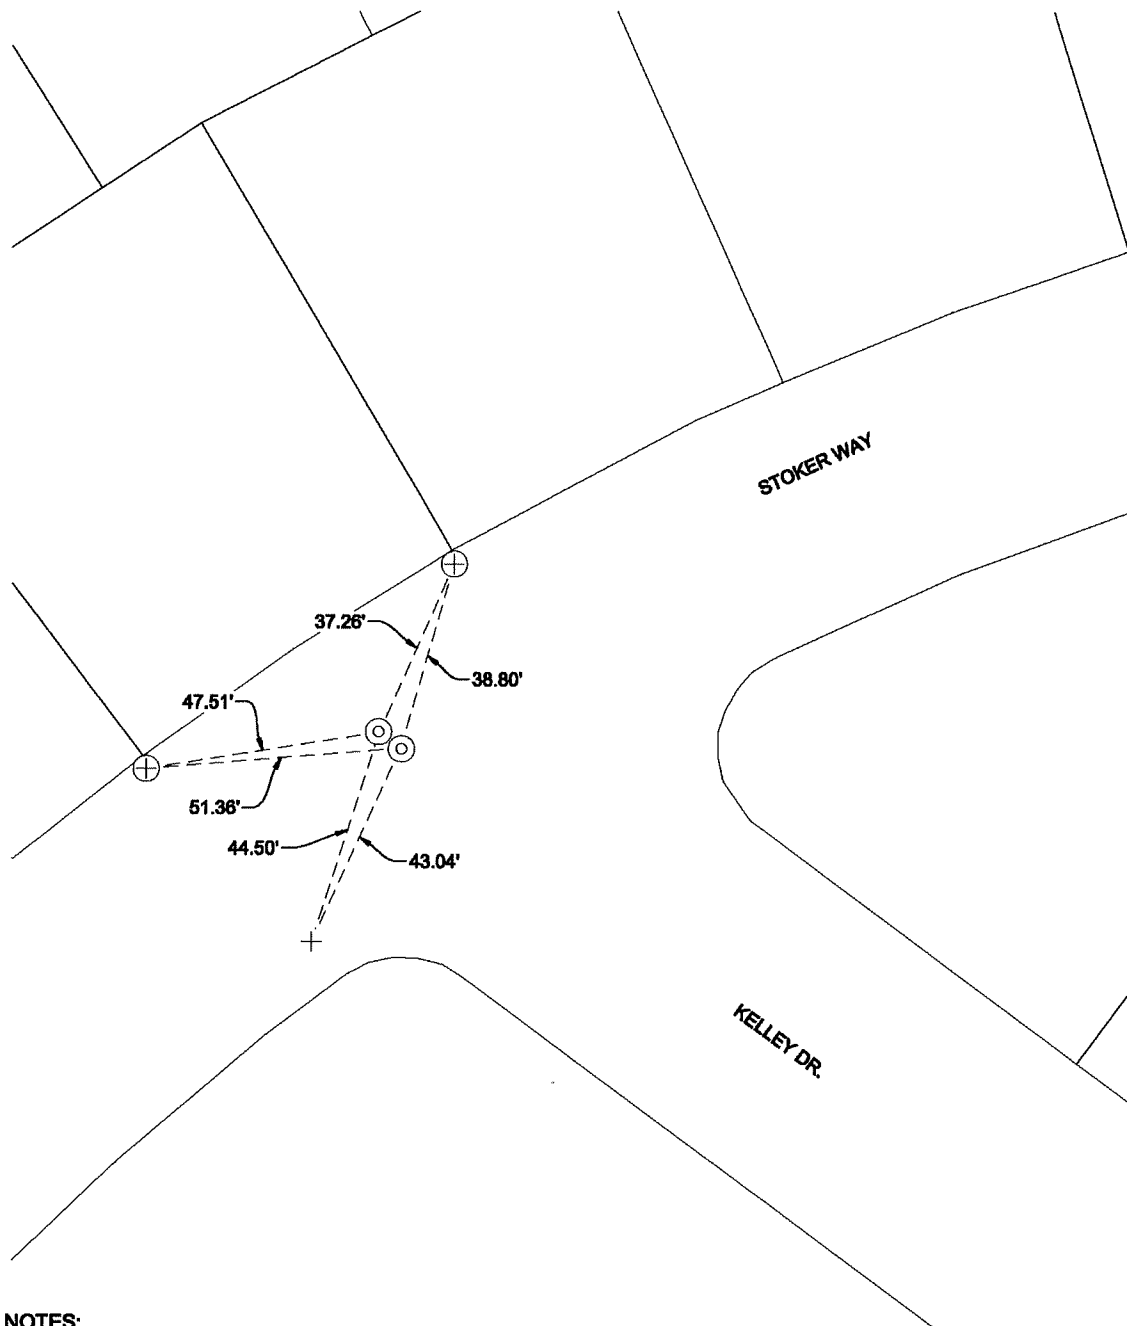
- ⊙ SET MONUMENT: 3/4" X 24" IRON PIPE STAMPED L.S. #8159 WITH PLASTIC CAP IN MONUMENT WELL.
- + FOUND SAWCUT "+" IN CONCRETE ON TOP OF CURB PER CR 21-172
- ⊕ FOUND SAWCUT "+" ON SIDEWALK PER CR 21-172
- CR CORNER RECORD, SAN JOAQUIN COUNTY SURVEYOR'S RECORDS

NOT TO SCALE

Narrative of corner identified and monument as found, set, reset, replaced, or removed:
 See sheet #2 for description(s):
