CR-22-068 **CORNER RECORD** Agency Index Document Number _ County of San Joaquin City of Manteca Brief Legal Description North half (N 1/2) Section 31, T.1S., R.7E., M.D.B.& M. **CORNER TYPE COORDINATES (Optional) Government Corner** Control Elevation X U.S. Survey Foot Meander Property Units Metric Other Rancho **Horizontal Datum** Epoch Date Zone Date of Survey November 19, 2021 Vertical Datum Complies with Public Resources Code §§8801-8819 Complies with Public Resources Code §§8890-8902 **X** 8771 PLS Act Ref.: 8765(d) Other: Established Pre-Construction Left as found Rebuilt Corner/ **Monument:** Found and tagged Reestablished Referenced Post-Construction Narrative of corner identified and monument as found, set, reset, replaced, or removed: ✓ See sheet #2 for description(s):

SURVEYOR'S STATEMENT

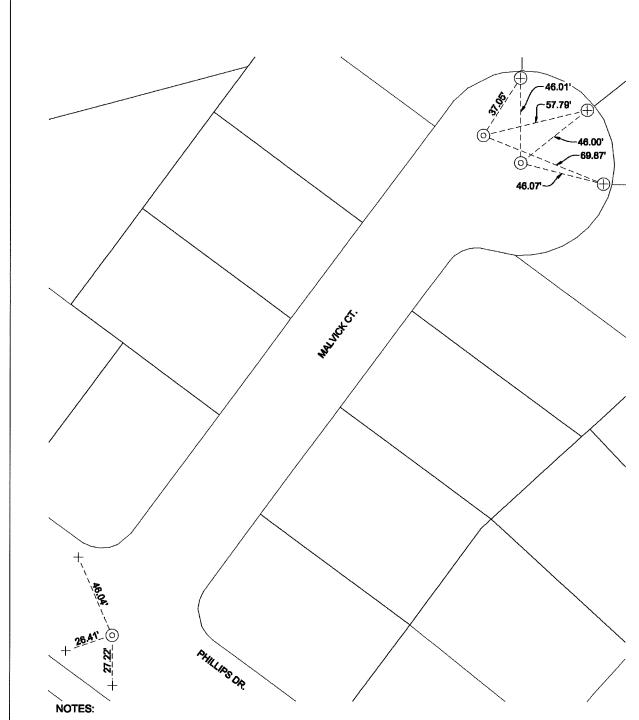
- O SET MONUMENT: 3/4" X 24" IRON PIPE STAMPED L.S. #8159 WITH PLASTIC CAP IN MONUMENT WELL.
- + FOUND SAWCUT "+" IN CONCRETE ON TOP OF CURB PER CR 21-180
- \bigoplus FOUND SAWCUT "+" ON SIDEWALK PER CR 21-180
- CR CORNER RECORD, SAN JOAQUIN COUNTY SURVEYOR'S RECORDS
