CORNER RECORD

Agency Index CR-22-069

City of Manteca County of San Joaquin, CaliforniaBrief Legal Description North half (N 1/2) Section 31, T.1S., R.7E., M.D.B. & M.**CORNER TYPE****COORDINATES (Optional)**

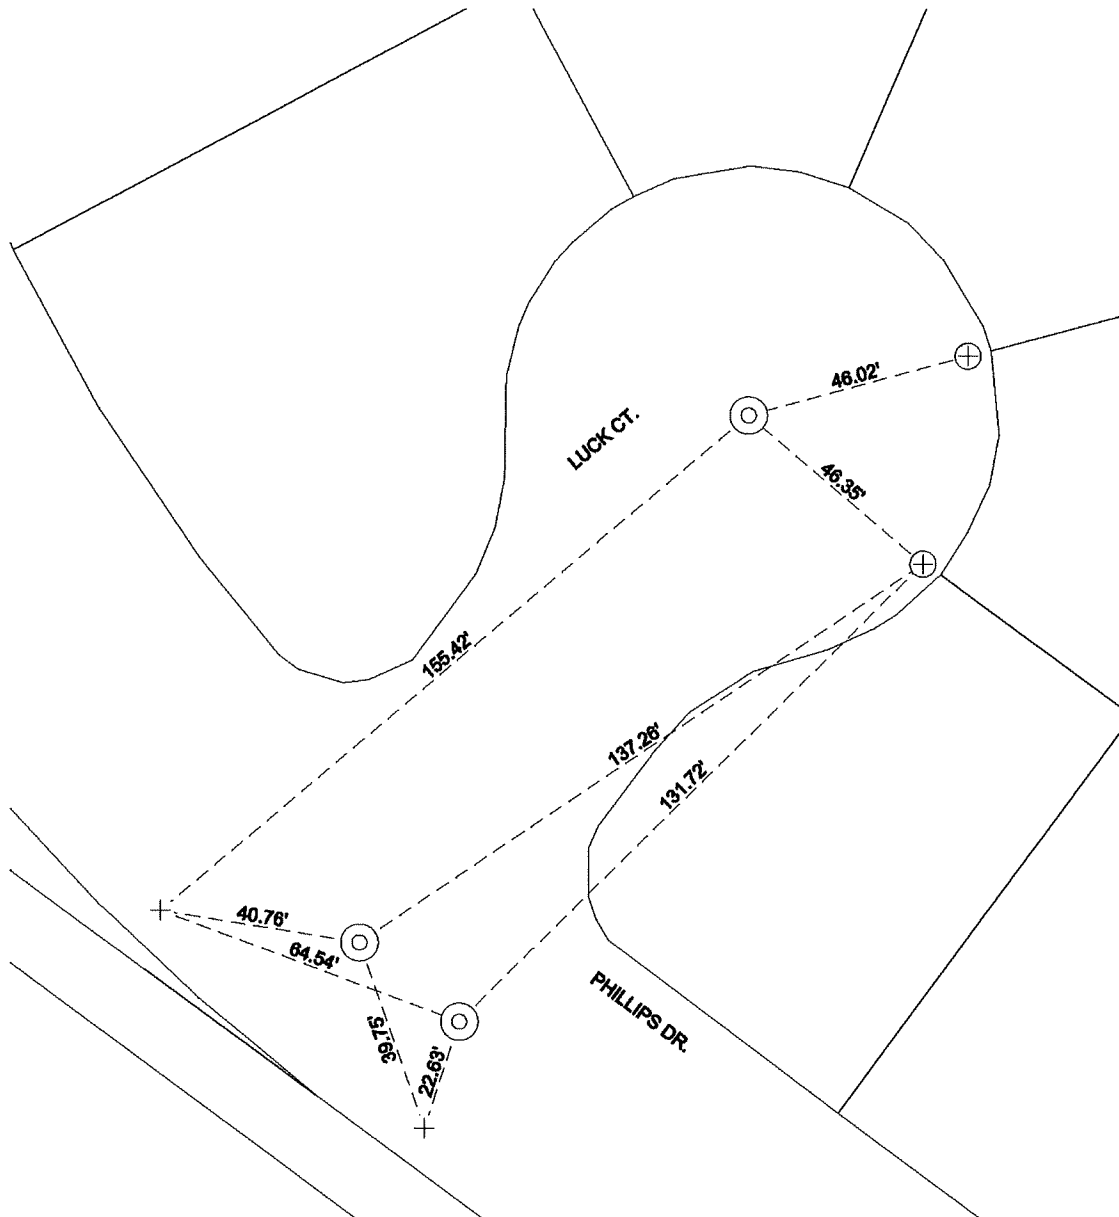
- ⊙ SET MONUMENT: 3/4" X 24" IRON PIPE STAMPED L.S. #8159 WITH PLASTIC CAP IN MONUMENT WELL.
- + FOUND SAWCUT "+" IN CONCRETE ON TOP OF CURB PER CR 21-170
- ⊕ FOUND SAWCUT "+" ON SIDEWALK PER CR 21-170
- CR CORNER RECORD, SAN JOAQUIN COUNTY SURVEYOR'S RECORDS
