# CORNER RECORD

Agency Index CR-22-170  
Document Number \_\_\_\_\_

City of Stockton County of San Joaquin, California  
Brief Legal Description Intersection of North Madison Street and West Willow Street.

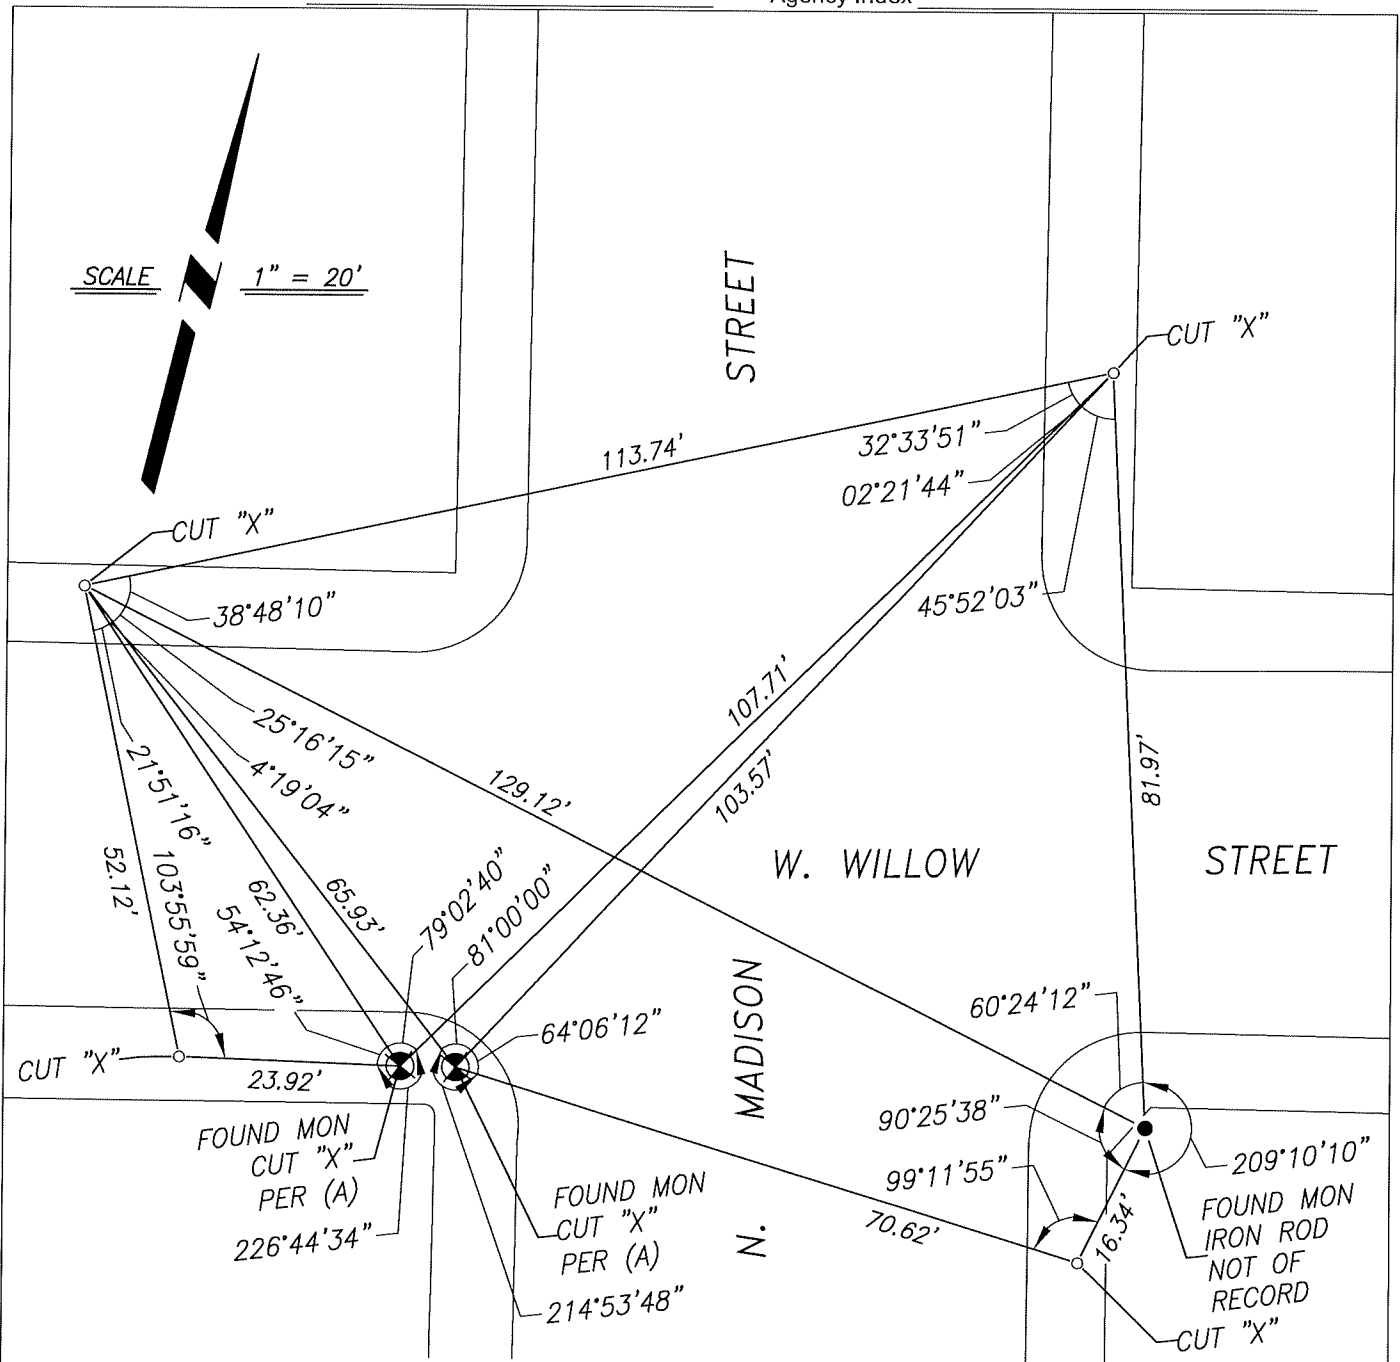
Narrative of corner identified and monument as found, set, reset, replaced, or removed:  
 See sheet #2 for description(s):

- FOUND MONUMENT NAIL, NO TAG
- ⊗ FOUND MONUMENT, CUT "X" ON CONCRETE SIDEWALK
- SET CUT "X" ON CONCRETE SIDEWALK AS REFERENCE POINT
